DOT HS 812 550

**Special Crash Investigations  
Remote Non-Traffic  
Surveillance Fatal  
Hyperthermia Investigation  
Vehicle: 1998 Volkswagen  
Beetle  
Location: South Carolina  
Incident Date: June 2015**

**NON-TRAFFIC SURVEILLANCE  
SPECIAL CRASH INVESTIGATIONS  
CASE NO. CR16035  
REMOTE HYPERTHERMIA FATALITY INVESTIGATION  
VEHICLE: 1998 VOLKSWAGEN BEETLE  
LOCATION: SOUTH CAROLINA  
INCIDENT DATE: JUNE 2015**

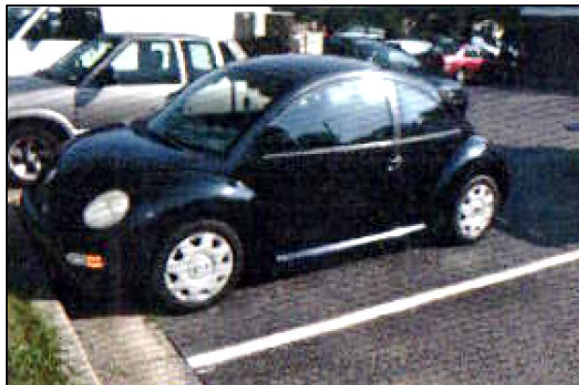
**Figure 1: The 1998 Volkswagen Beetle parked at the apartment complex. (Image supplied by the investigating police department.)**

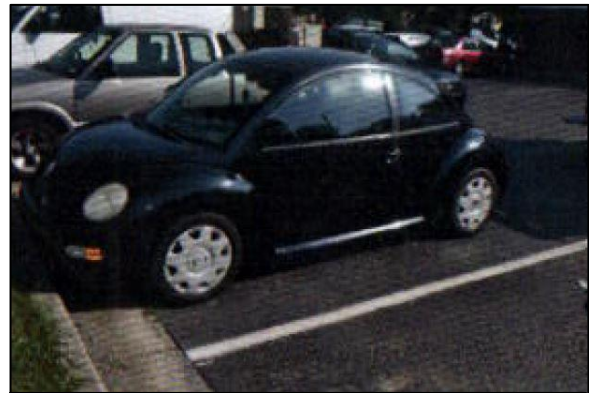
The involved vehicle in this hyperthermia fatality investigation was a 1998 Volkswagen Beetle (**Figure 3**). The two-door hatchback identified by Vehicle Identification Number 3VWBB61C2WMxxxxxx. On-scene police images identified the vehicle as black in color, configured with a two-tone interior consisting of black seating surfaces, upper instrument panel and upper door panels. The lower instrument panel and door panels were gray in color. Specifications for this vehicle listed the power train as a 2.0-liter gasoline engine and an automatic transmission with a console-mounted shifter. The service brakes were power-assisted four-wheel disc brakes with ABS. The seating consisted of front bucket seats with adjustable head restraints and a split back second row seat with a folding back.

**Figure 3. Left side view of the 1998 Volkswagen Beetle. Image provided by the police agency.**

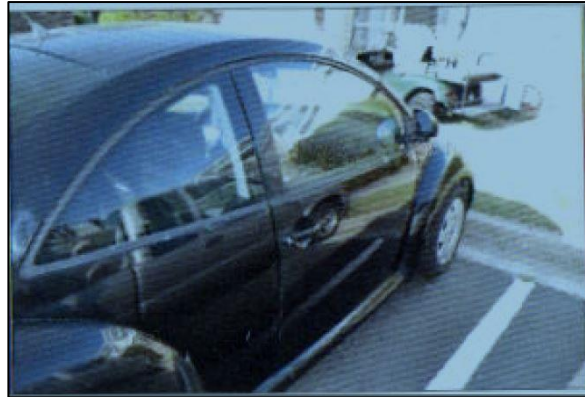
The Volkswagen was configured with an AS1 laminated windshield, operable AS2 door windows, fixed AS2 second row quarter windows, and a fixed AS2 backlight glazing (**Figure 4**). There was no roof glazing in this vehicle. None of the glazing panels were covered with aftermarket window tint. The front door windows were power-operable. The driver's door panel was configured with two vertically-mounted power window rocker switches in the forward aspect of the door panel forward of the door closure pull handle. These switches operated the driver's and right door window. Downward pressure opened the window while upward switch pressure closed the respective window. Twelve-volt battery power with the ignition switch placed in the accessory or run positions was required to operate the windows. During this incident, with a depleted battery, the power windows were inoperative.

**Figure 4. Right plane door glazing of the Volkswagen. Image provided by the police agency.**

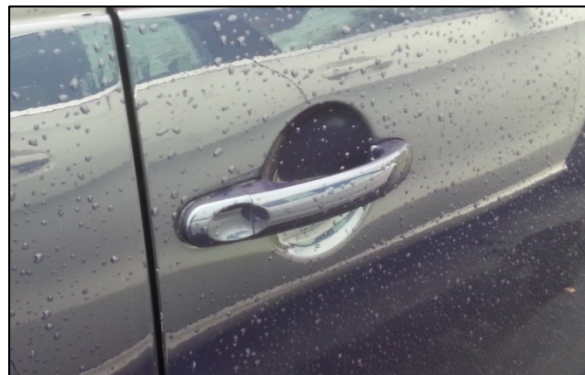
The two doors of the Volkswagen Beetle were equipped with pull-style exterior door handles (**Figure 5**) that required a horizontal pull force to open. Based on an exemplar vehicle inspection, the door handles were 81 to 84 cm (32 to 33.25 in) above the pavement. The hinge point of the door handle was at the forward aspect. The driver's door handle was configured with a key lock. The ignition key could be inserted to lock or unlock the front doors. The right front door was not equipped with a key lock.

**Figure 5. Exterior door handle of an exemplar vehicle.**

The police tested the door-mounted power window switches and found the windows systems to be fully operational. They did report that the exterior door handles seemed awkward, requiring some pull force to open. It was further reported that the doors seemed heavy and required some force to open and close. Based on this police testing, it is unknown if the child victim was assisted in opening and closing the doors of the Volkswagen.

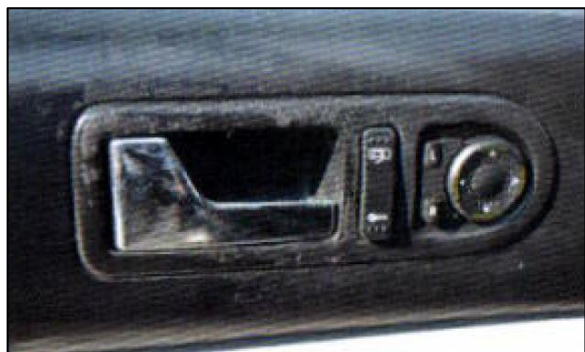
The interior door panels were configured with flush-mounted door release levers located in the forward-third aspect of the door panels (**Figure 6**). The interior length of the Volkswagen door panel was 97 cm (38.25 in) with a hinge point of the horizontal pull handle located 52 cm (20.5 in) forward of the aft edge of the door panel. The L-shaped release lever was 8 cm (3 in) in length and 4 cm (1.6 in) in height. Based on the SCI inspection of the exemplar vehicle, and other Volkswagens having the same door latch and release lever configurations, it was common for the door latch to release the second stage of the door latch with a fast

**Figure 6. Driver side interior door lever of the involved 1998 Volkswagen Beetle. Image provided by the police agency.**

pull of the interior release lever as the door would not “pop” open on its own. A second pull force of the interior release lever was required with a push force against the interior door panel to open the door. The police reported that the doors on the involved Volkswagen were heavy, requiring some force to open.

The interior door release lever, when activated, would override the locking system regardless of battery power and the method of how the doors were locked. This would prevent a person from inadvertently locking themselves inside the vehicle. No additional steps were required to open a locked door from the inside other than pulling on the door release lever and pushing the door open.

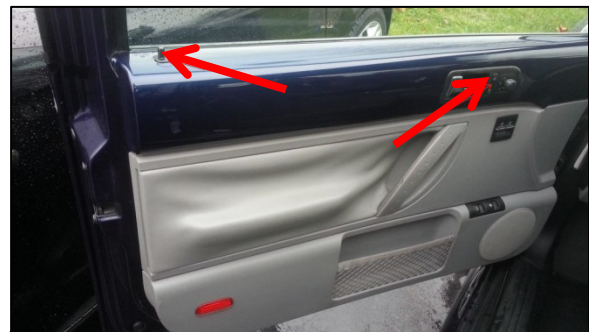
The interior door panel was configured with two modes of locking (**refer to arrows in Figure 7**). Both doors were equipped with a rocker power locking switch that would lock or unlock both doors with one engagement of the switch. These switches were located immediately forward of the interior door release lever and were 4 cm (1.5 in) in height and 1 cm (0.5 in) in width. The upper aspect of the rocker switch was the unlock mode while the lower aspect of the vertically oriented switch was the lock mode. Unlike the power window switches that had a protruding finger hold, the lock switches were flush with the door panel. Icons depicting an open door and a key designated the unlock and lock positions respectively. Vehicle 12-volt battery power was obviously required to operate this system.

**Figure 7. Locking modes (arrows) of an exemplar vehicle.**

The top aft aspect of each door panels was configured with a locking stalk. These stalks were 6 mm (0.25 in) in diameter and were 2 cm (0.75 in) in height. These stalks would recess flush with the top of the door panel when the power lock system was enabled. A person on the inside of the Volkswagen could not grasp this stalk to unlock the door. The stalk could be manually pushed down to lock the door in the event of a power loss or to lock the door without utilizing the power locking feature.

The police conducted a post-incident inspection of the Volkswagen and determined that the vehicle's 12-volt battery was completely drained of charge, which had rendered the power locking and power window systems inoperative. The vehicle was towed from the incident site and was impounded for further police evaluation. The investigating officer stated to the SCI team that the vehicle was started using an auxiliary battery jump box. Once started, the power lock system was evaluated. The driver's power lock rocker switch was found to be inoperative and would not lock or unlock the doors with the engine running or not running. The front right door power lock rocker switch was fully functional in both the running and non-running modes. These switches would actuate the power locking system regardless of ignition status, even with the key removed and the ignition switch in the off position.

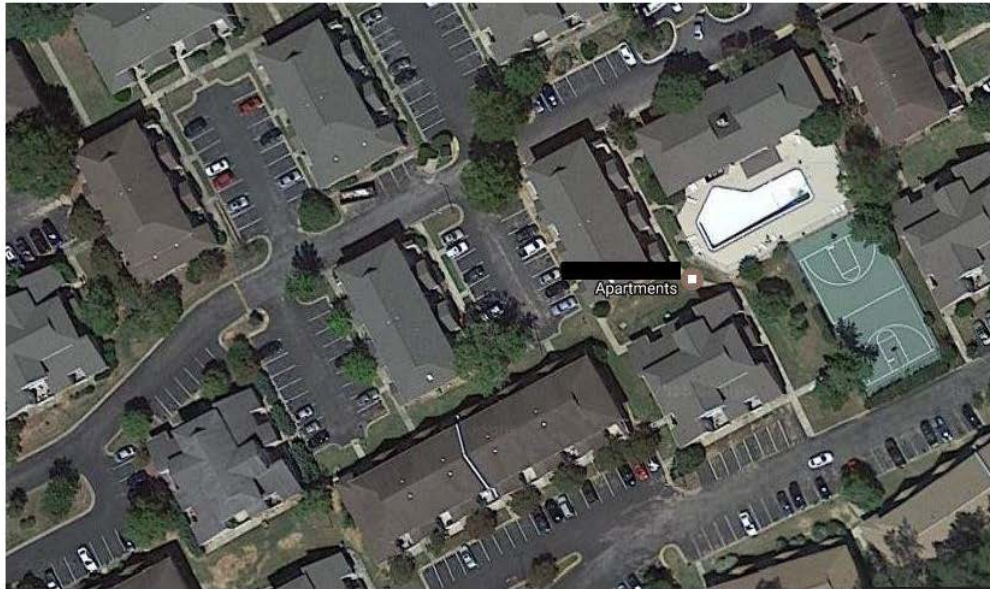
**INCIDENT SITE DIAGRAM**

**Incident Site:  
Apartment Complex Parking Lot**

**V1: 1998 Volkswagen Beetle**
