Applies To: **2007–08 TL** – Check the iN VIN status for eligibility

August 10, 2012

**Safety Recall: 2007–08 TL Power Steering Feed Hose Leak**  
(Supersedes 12-020, dated June 27, 2012; see REVISION SUMMARY)**REVISION SUMMARY**

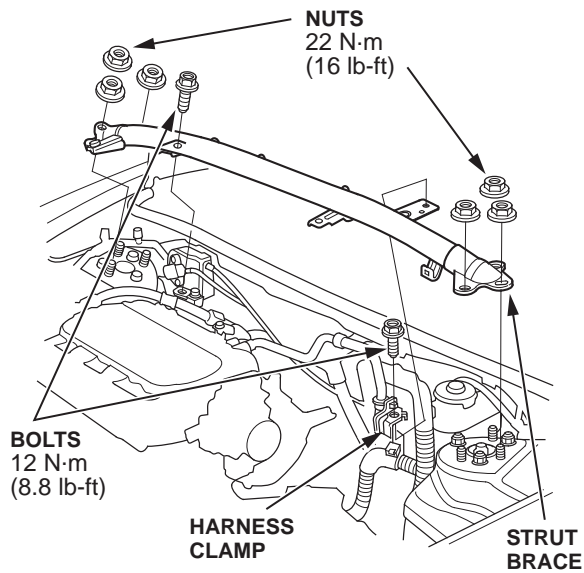
7. Remove the strut brace:
  - Remove the harness clamp.
  - Remove the two bolts.
  - Remove the six nuts.

51. Reinstall the strut brace. Torque the nuts to **22 N·m (16 lb-ft)** and the bolts to **12 N·m (8.8 lb-ft)**.
52. Reinstall the throttle cable bracket and the underhood fuse/relay box.

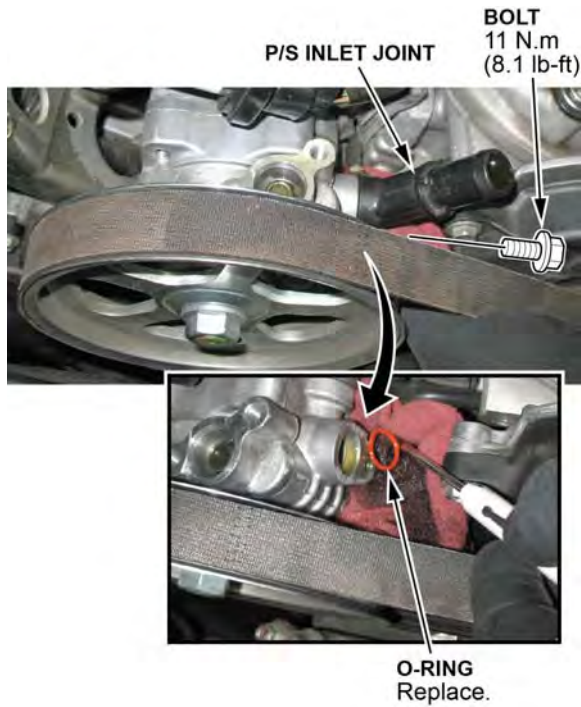
11. Replace the P/S pump inlet joint O-ring:
  - Remove the inlet joint from the pump (one bolt).
  - Remove the O-ring from the inlet joint.
  - Lubricate a new O-ring with clean P/S fluid, then install it on the end of the joint.
  - Reinstall the inlet joint, and torque its bolt to **11 N·m (8 lb-ft)**.

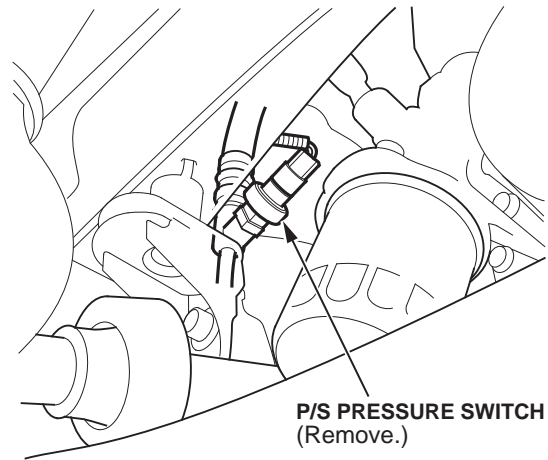
13. Disconnect the P/S pressure switch connector, then remove the pressure switch from the feed hose.

NOTE: To prevent fluid from dripping, stuff the end of a clean shop towel into the feed hose coupler.

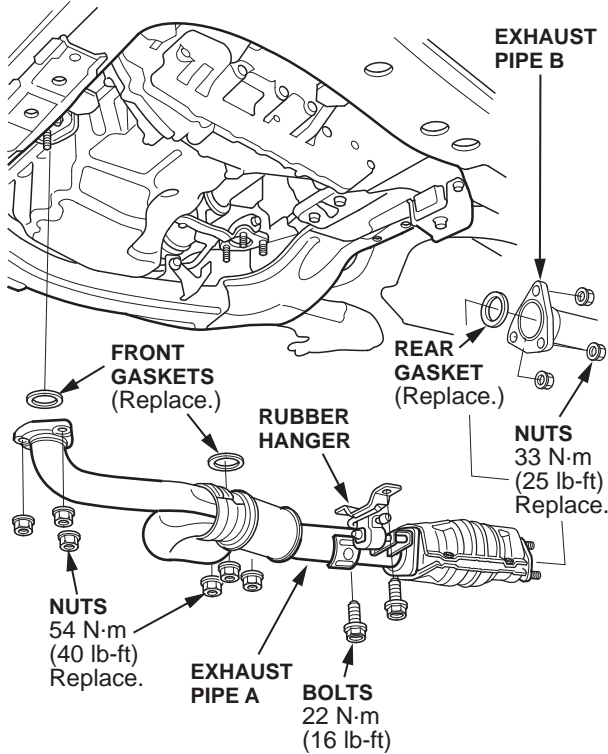
17. Remove exhaust pipe A:

- Remove the rubber exhaust hanger from the subframe.
- Remove exhaust pipe A along with the three way catalytic converter (TWC) (nine self-locking nuts). The nuts *will not* be reused.
- Support exhaust pipe B with a stand.

42. Reattach exhaust pipe A and the TWC using new gaskets and self-locking nuts. Use the torque specs in step 17.
43. Reinstall the rubber exhaust hanger to the subframe.

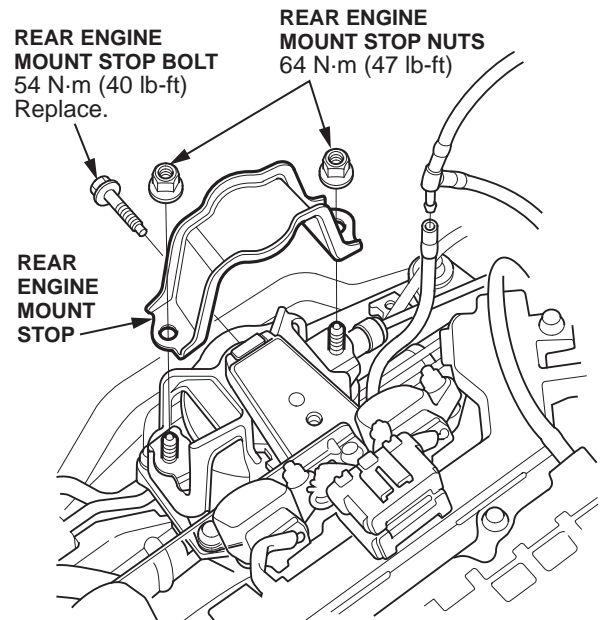
20. *M/T only*. Remove the rear engine damper bolt. The bolt *will not* be reused.

21. Remove the heat shield bolt from the front of the rear engine mount. The bolt is next to the secondary O2 sensor (bank 1, sensor 2).

22. Remove the rear engine mount stop (two nuts), then remove the rear engine mount stop bolt. The stop bolt *will not* be reused.

44. Reinstall the heat shield bolt from the front of the rear engine mount.
45. Reinstall feed hose holder B.
46. Reinstall the rear engine mount stop. Torque the new bolt to **54 N·m (40 lb-ft)**, and the nuts to **64 N·m (47 lb-ft)**.

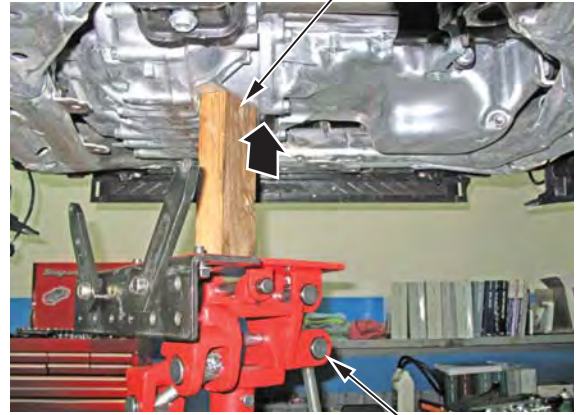
**TRANSMISSION JACK STAND**

30. Using a transmission jack and a block of wood, position the wood in a secure area on the engine/transmission assembly, then *slightly* lift the assembly.

Position the wood in a secure area on the engine/transmission assembly.

35. Lower the transmission jack, and remove the block of wood.
36. *M/T models only:* Install four new transmission front/rear lower mount nuts, and torque them to **44 N·m (33 lb-ft)**.

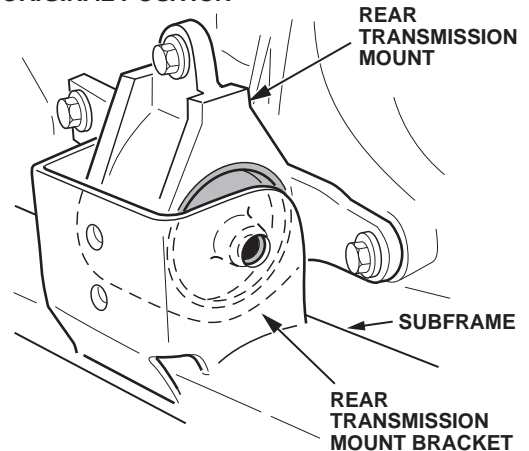
**ORIGINAL POSITION**

- To minimize the stress damage on the other engine/transmission mounts, do not lift the assembly too much.
- *A/T models only*: The maximum allowable lift is reached when you see the lower part of the mount's bolt hole through the bracket hole (see below).
