REPORT NUMBER: SNCAP-CAL-07-01

**NEW CAR ASSESSMENT PROGRAM
SIDE IMPACT TEST**

**MAZDA MOTOR CORPORATION
2007 MAZDA CX-7
SUV**

FINAL REPORT

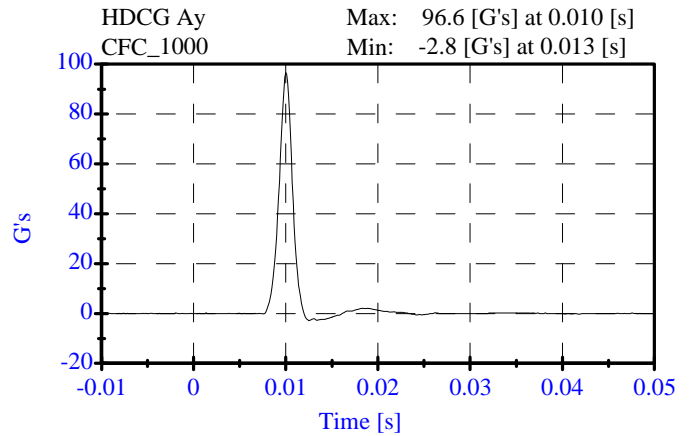
**Head Drop
Pre-Test**

<u>TEST PARAMETER</u>	<u>SPECIFICATION</u>	<u>TEST RESULTS</u>	<u>STATUS</u>
Lab Temperature:	18.9-25.6 C	21.1 C	Passed
Lab Humidity:	10-70 %	36.00 %	Passed
Peak Resultant Accel.:	120-150 Gs	142.68 Gs	Passed
Peak Lateral Accel.:	15 Gs Max	5.36 Gs	Passed
Curve PerCent NonModal:	< 15%	2.35 %	Passed
