**REMOTE AIR BAG RELATED CHILD PASSENGER FATALITY INVESTIGATION
SCI TECHNICAL SUMMARY REPORT**

VERIDIAN CASE NO. CA00-052

SUBJECT VEHICLE: 1994 NISSAN ALTIMA

CRASH DATE - DECEMBER 1999

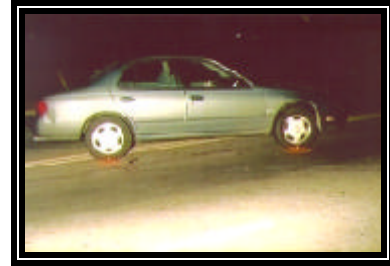
Figure 1. 1994 Nissan Altima

This remote investigation focused on a 1994 Nissan Altima (**Figure 1**) which was equipped with air bags for the driver and front right positions that deployed as a result of a frontal impact with a 1989 Oldsmobile 98 Regency. The Altima was occupied by a 26-year-old female driver, a 16-year-old female front right passenger, a 6-year-old male on the lap of the front right passenger, and three male children in the rear seat ranging from 2 to 16 years of age. The 2-year-old was reportedly restrained in a child safety seat, however, the remaining occupants were unrestrained. The driver of the Oldsmobile initiated a left turn across the path of the Altima and the front right area of the

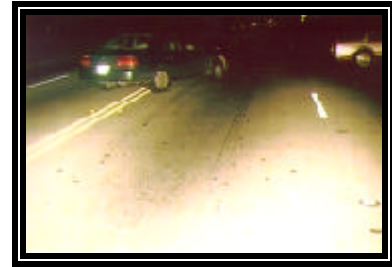
The 26-year-old female driver of the 1994 Nissan Altima was operating the vehicle on the inboard northbound lane of a four-lane roadway. Police reported that the driver of the 1989 Oldsmobile 98 Regency was intoxicated. The inattentive driver of the 98 Regency was operating the vehicle in the southbound inboard lane and initiated a left turn across the path of the Nissan. The driver of the Nissan realized the impending event and applied the brakes in full lockup. Skid marks were noted in the Nissan's trajectory in the on-scene police photographs (**Figure 2**). Estimated lengths of the skid marks were approximately 15 m (50').

Figure 2. On-scene photograph showing skid marks from the Altima

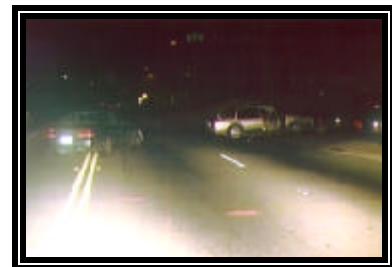
As the Oldsmobile Regency crossed the centerline, the front right area of the Nissan Altima impacted the front right area of the Oldsmobile. Impact resulted in minor damage to both vehicles. The front right corner of the Altima slightly underrode the front right corner of the Regency due to pre-crash braking. The resultant directions of force were in the 12 o'clock sector for the Altima and in the 1 o'clock sector for the Regency. The impact induced deceleration was sufficient to deploy the frontal air bag system in the Altima. The damage algorithm of the WinSMASH program computed total velocity changes of 17.0 km/h (10.6 mph) for the Altima and 15.0 km/h (9.3 mph) for the Regency based on the estimated crush profiles of both vehicles. The longitudinal and lateral components were -16.7 km/h (-10.4 mph) and 3.0 km/h (1.8 mph), respectively for the Altima. The longitudinal and lateral components were -13.0 km/h (-8.1 mph) and -7.5 km/h (-4.7 mph), respectively for the Regency. The results obtained from the WinSMASH program appear conservative given the crash configuration. The Missing Vehicle and Barrier routines were also used to compute velocity changes for comparison. The results were slightly higher for the Barrier routine and slightly lower for the Missing Vehicle routine, each within 3.2 km/h (2.0 mph) of the original output. The Nissan was redirected rearward and rotated clockwise (CW) approximately 30 degrees. It came to rest straddling the centerline facing northeast (**Figure 3**). The

Figure 3. Crash site showing final rest positions

Regency rotated counterclockwise (CCW) approximately 50 degrees from impact to final rest. It came to rest facing east straddling a private driveway.

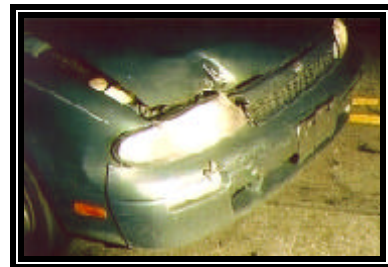
The 1994 Nissan Altima sustained minor frontal damage as a result of the impact with the Oldsmobile Regency. The direct contact damage began approximately 20 cm (8") to the right of the centerline and extended laterally along the frontal plane to the right bumper corner (**Figure 4**). The combined direct and induced damage involved the entire frontal plane of the vehicle. The bumper fascia was abraded and crushed rearward on the right side from direct contact (**Figure 5**). The maximum crush was estimated to be 8 cm (3") and was located at C6 on the front right bumper corner. The right headlamp assembly was displaced. The grille was separated on the right side. The hood was displaced rearward and buckled on the right side. A depression and abrasions were noted on the hood above the right edge of the grille from engagement against the front right corner of the Regency. The Collision Deformation Classification (CDC) for the impact with the Regency was 12-FREW-1. Six crush

Figure 4. Frontal damage to the Nissan Altima

measurements were estimated along the Altima's bumper and were as follows: C1 = 0 cm, C2 = 1 cm (.5"), C3 = 3 cm (1"), C4 = 5 cm (2"), C5 = 5 cm (2"), C6 = 8 cm (3").

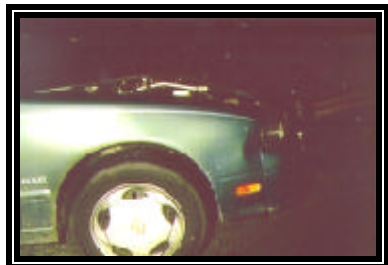
Figure 5. Right side view of frontal damage

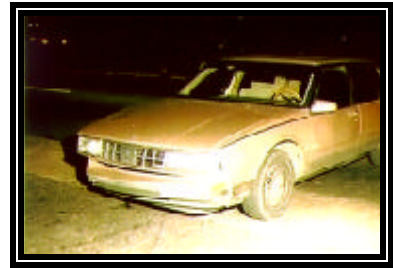
The 1989 Oldsmobile Regency sustained minor frontal damage as a result of the impact with the Nissan Altima. The Regency was equipped with Energy Absorbing Devices (EAD's) behind the front bumper. The status of the EAD's could not be determined from the available police photographs. The direct damage began approximately 65 cm (25.6") to the right of the centerline and extended laterally to the right bumper corner (**Figure 6**). The combined direct and induced damage involved the entire frontal width of the vehicle. The front right bumper corner was crushed downward and rearward. The maximum crush was estimated to be 25 cm (10") and was located at C6 at the front right bumper corner. The entire bumper fascia was displaced to the left. The right front fender was slightly buckled inward from rearward displacement. The CDC for the impact with the Altima was 01-FREE-2. Six crush measurements along the bumper were estimated from the police photographs and were as follows: C1 = 2 cm (1"), C2 = 5 cm (2"), C3 = 10 cm (4"), C4 = 15 cm (6"), C5 = 20 cm (8"), C6 = 25 cm (10").

Figure 6. Frontal damage to Oldsmobile 98 Regency

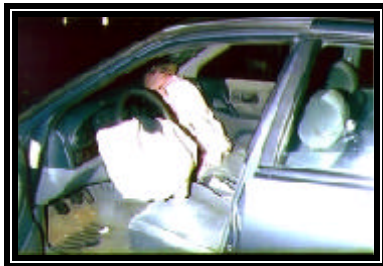
The 1994 Nissan Altima was equipped with frontal air bags for the driver and front right passenger positions (**Figure 7**) that deployed as a result of the impact with the 1989 Oldsmobile Regency. The driver's air bag was housed in the center of the steering wheel with a single cover flap design hinged at the top aspect. The air bag was vented by two ports located at the 11 and 1 o'clock positions.

Figure 7. Frontal air bag system in the Nissan Altima
