**REMOTE ADVANCED OCCUPANT PROTECTION SYSTEMS INVESTIGATION  
SCI TECHNICAL SUMMARY REPORT**

**NASS/SCI COMBO CASE NO. 01-41-005K**

**VEHICLE - 2001 AUDI TT**

**CRASH DATE - JANUARY 2001**

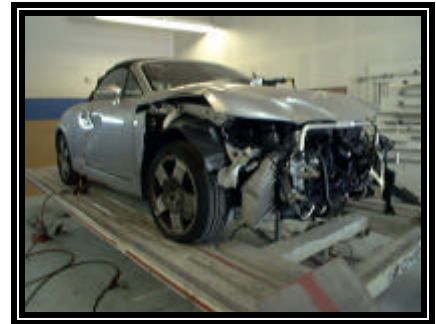
**Figure 1. Front and side damage to the 2001 Audi TT**

This remote investigation focused on a 2001 Audi TT Roadster that was equipped with an Advanced Occupant Protection System (AOPS). The Audi was occupied by an unrestrained 32-year-old male driver. The Audi (**Figure 1**) was involved in an intersection collision with a subsequent sideslap with a 1988 Pontiac Grand Am. The Audi's frontal impact resulted in the deployment of the driver's dual stage air bag and fired both frontal seat belt pretensioners. The driver of the Audi sustained a forehead abrasion from contact with the deployed driver's air bag. He also sustained a right knee laceration and contusion from contact with the knee bolster and the left aspect of the center console. The driver refused treatment at the scene.

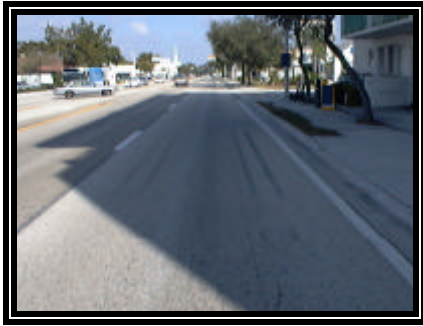
The driver of the Audi TT was operating the vehicle northbound on the outboard lane on approach to the four-leg intersection (**Figure 2**) at a police-reported speed of 56 km/h (35 mph). The driver of the Pontiac Grand Am was operating the vehicle westbound on the two-lane roadway on approach to the four-leg intersection (**Figure 3**) at a police reported speed of 24 km/h (15 mph). The driver of the Grand Am disregarded the stop sign at the intersection and proceeded into the intersection across the path of the Audi. It was not known if either vehicle attempted any avoidance maneuvers.

**Figure 2. Northbound trajectory for the 2001 Audi TT**

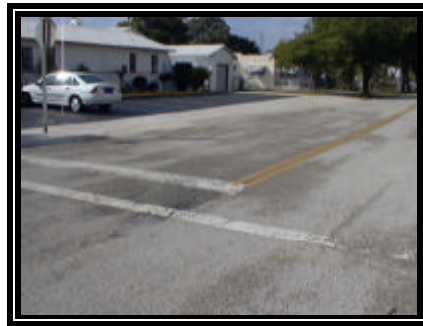
**Figure 3. Westbound trajectory for the 1998 Pontiac Grand Am**

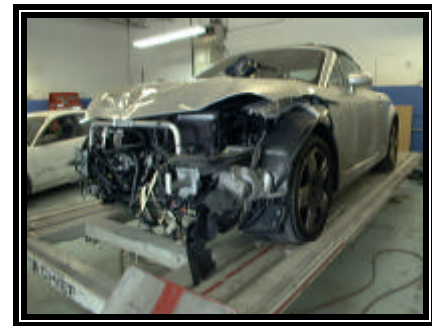
The 2001 Audi TT sustained moderate damage as a result of the primary impact with the Grand Am. At the time of the NASS vehicle inspection, the Audi was undergoing repairs and a crush profile could not be obtained. The crush appeared to be uniform across the frontal plane based on the NASS photographs (**Figure 4**). The bumper assembly, frontal trim, headlight assemblies, and both front fenders were separated from the vehicle, but it was not known if it was crash related or due to repair. The Audi appeared to have energy absorbing devices on the outboard sides for the front bumper system. The piston travel distances could not be determined. The hood was slightly buckled and uniformly displaced rearward. Due to the unknown extent of the damage, the Collision Deformation Classification (CDC) for this event was 99-F9999.

**Figure 4. Frontal damage to the 2001 Audi TT**

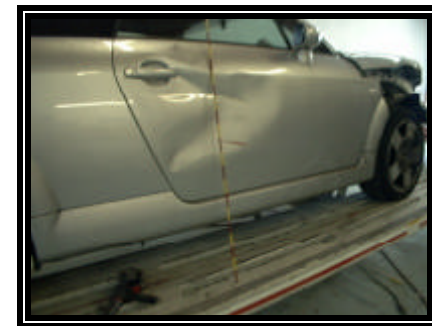
The Audi was involved in a secondary sideslap impact as the vehicles were deflected by the initial impact. The lateral impact to the right side door resulted in minor damage (**Figure 5**). The direct damage for this impact began 93 cm (37") forward of the right rear axle and extended forward 24 cm (9") along the right door. The combined direct and induced damage began 74 cm (29") forward of the right rear axle and extended 116 cm (46") forward along the side plane. The rear aspect of the right door sustained longitudinal

**Figure 5. Right side sideslap damage to the 2001 Audi TT**

abrasions and minor crush. The CDC for this secondary impact was 03-RPEN-1. The NASS researcher estimated a crush profile based on a visual inspection of the damage that was as follows: C1 = 0 cm, C2 = 1 cm (0.5"), C3 = 1 cm (0.5"), C4 = 0cm, C5 = 0 cm, C6 = 0 cm.

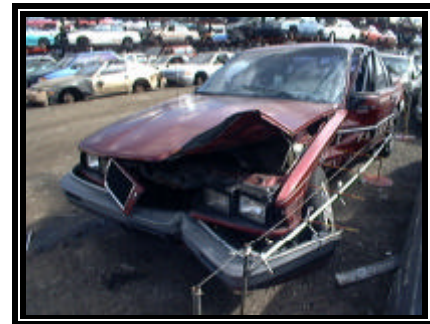
The 1988 Pontiac Grand Am sustained moderate left side damage as a result of the primary impact with the Audi. The direct damage began 112 cm (44") forward of the left rear axle and extended forward 115 cm (45") along the side plane. The combined direct and induced damage began 101 cm (40") forward of the left rear axle and extended forward 215 cm (85"). Six crush measurements were taken at the mid-door level and were as follows: C1 = 3 cm (1"), C2 = 25 cm (10"), C3 = 39 cm (15"), C4 = 20 cm (8"), C5 = 9cm (4"), C6 = 0 cm.

The Pontiac Grand Am sustained frontal damage from a third impact with a breakaway sign post. The direct damage began 40 cm (16") to the right of the front left bumper corner and extended laterally 12 cm (5"). The maximum crush for the third impact was 26 cm (10") and was located 48 cm (19") to the right of the front left bumper corner.

**Figure 6. Left side damage from the primary impact and frontal damage from the breakaway sign post**

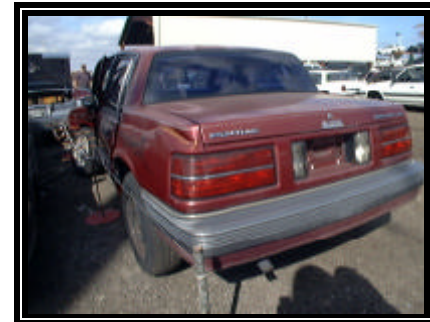
The secondary sideslap impact resulted in minor deformation to the left rear quarter panel and left rear corner on the Grand Am (**Figure 7**). There was no measurable crush from the impact.

**Figure 7. Sideslap damage to the 1988 Pontiac Grand Am**

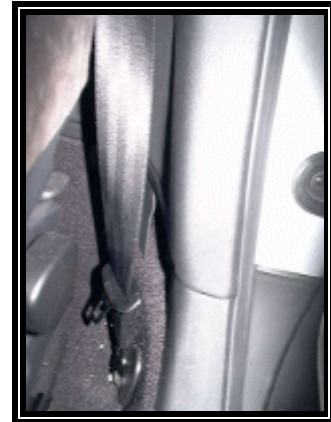
Each manual restraint was configured with retractor-mounted pretensioners. The NASS vehicle inspection identified both manual restraints as locked in the stowed position (**Figure 8**) due to the firing of the retractor pretensioners, which suggested that the manual belts were not utilized in the crash.

**Figure 8. Driver's manual restraint locked in stowed position**

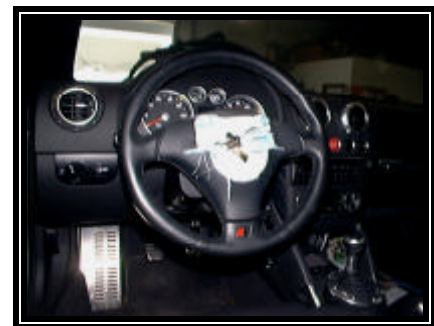
The driver's air bag was housed in the center of the steering wheel. The cover flap had been removed from the module. The outline of the opening for the air bag measured 15 cm (6") in width and 14 cm (6") in height. The driver's air bag was cut away from the module at the time of the NASS vehicle inspection (**Figure 9**). Therefore it was unknown if the air bag sustained any damage or contacts. Based on the lack of restraint usage by the driver, the both stages of the air bag most likely deployed.

**Figure 9. Driver's air bag module**

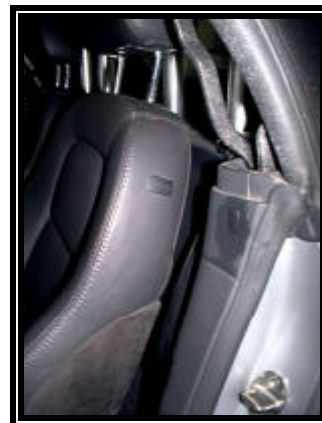
The 2001 Audi TT was equipped with seat back-mounted side impact head/torso air bags for the driver and front right passenger positions (**Figure 10**). The secondary sideslap impact did not produce a lateral delta-V high enough to reach the deployment threshold for the side air bag system.

**Figure 10. Driver's side air bag module**
