On-scene Investigation / Vehicle to Vehicle
Dynamic Science, Inc. / Case Number: DS01-004
2000 Ford Taurus SE four-door
North Carolina
November, 2000

1. Report No. DS01-004		2. Government Accession No.		3. Recipient Catalog No.	
4. Title and Subtitle In-Depth Accident Investigation				5. Report Date	
				6. Performing Organization Report No.

Dynamic Science, Inc.
Accident Investigation
Case Number: DS01-004

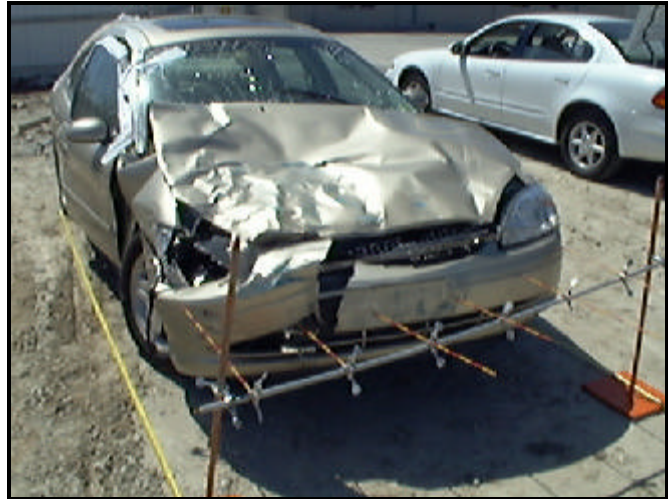
Figure 2. Exterior damage to case vehicle.

Description:	2000 Ford Taurus SE four-door	
VIN:	1FAFP56S7YAxxxxxx	
Odometer:	22,216 km (13,805 miles)	
Engine:	3.0 L V6	
Reported Defects:	None noted	
Cargo:	None	
Damage Description:	Moderate rearward crush mostly on the right front. Towed from the scene. Insurance company declared it a total loss.	
CDC:	12FDEW2	
Delta V:	Total	46.4 km/h (28.8 mph)
	Longitudinal	-46.2 km/h (-28.7 mph)
	Latitudinal	4.0 km/h (2.5 mph)
	Energy	89,776 joules (66,226 ft-lbs)

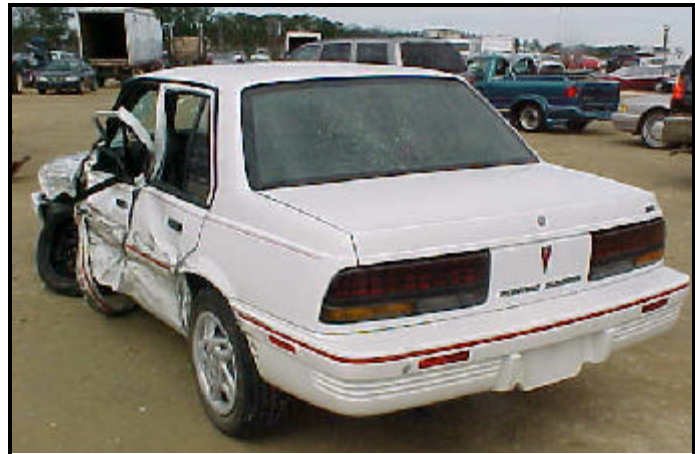
Figure 3. Rear left of other vehicle (Pontiac)

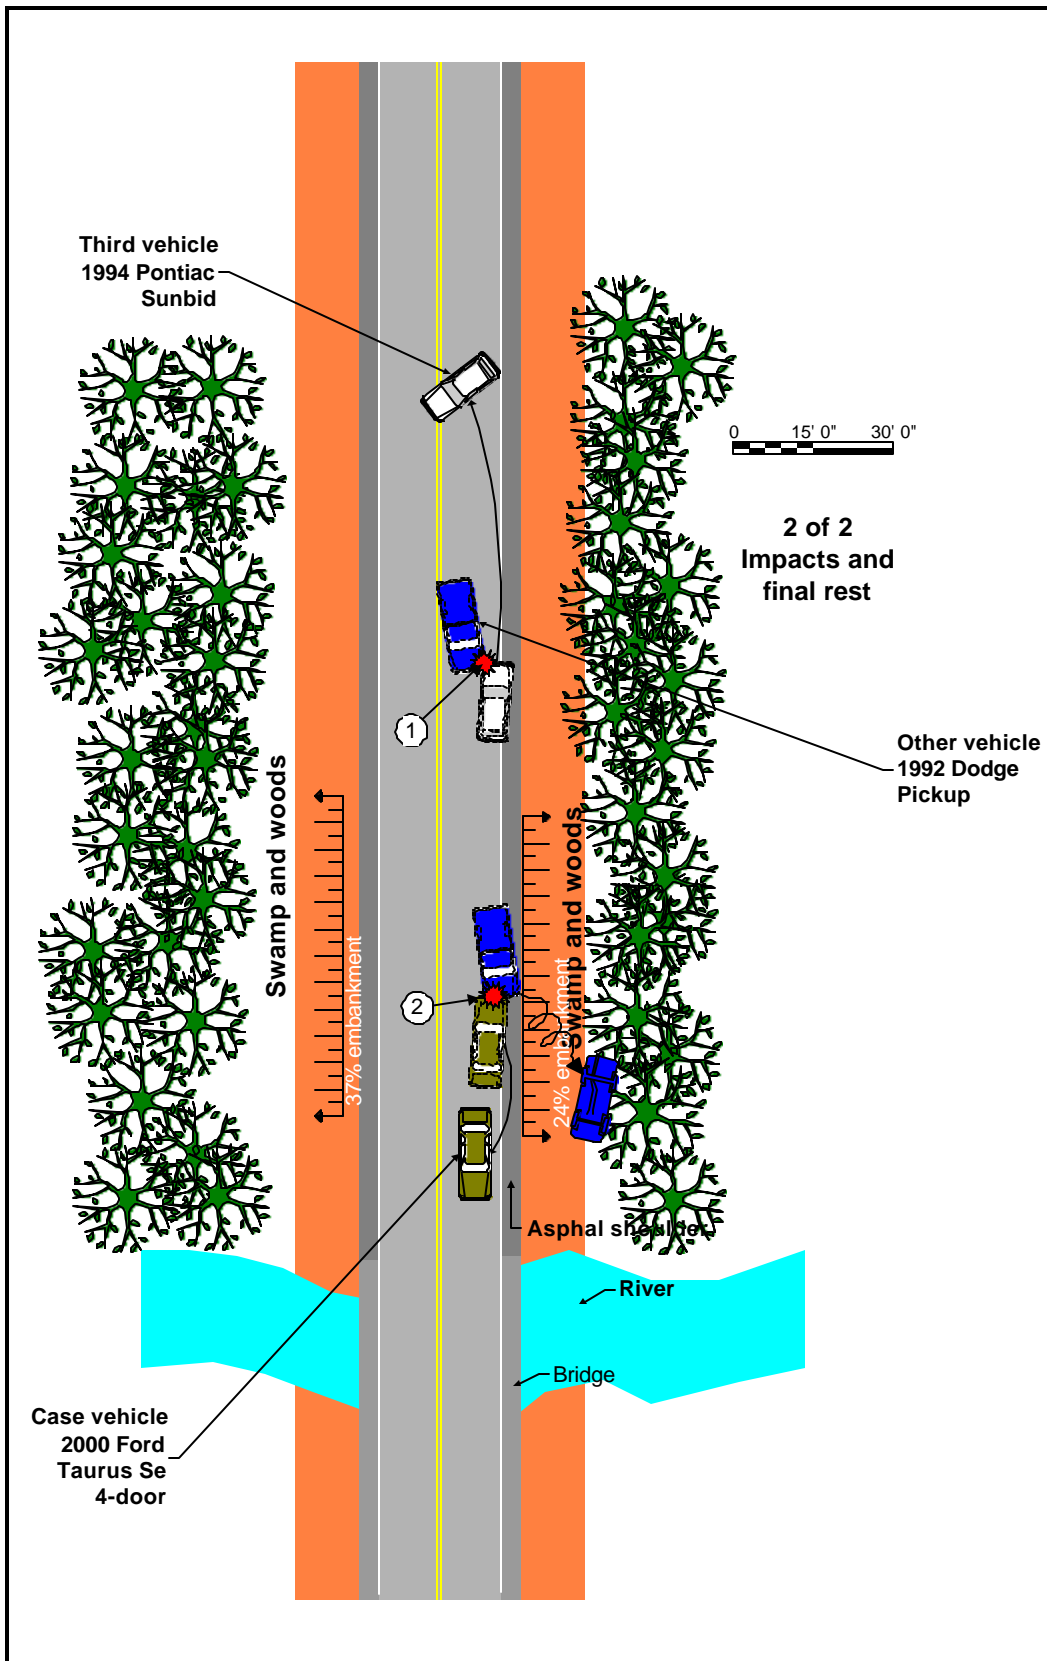
Figure 5. Scene diagram (2 of 2)

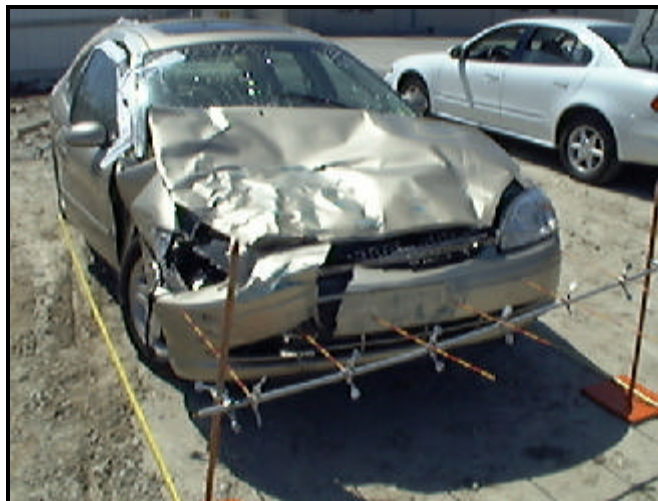
Figure 6. Exterior damage to case vehicle.

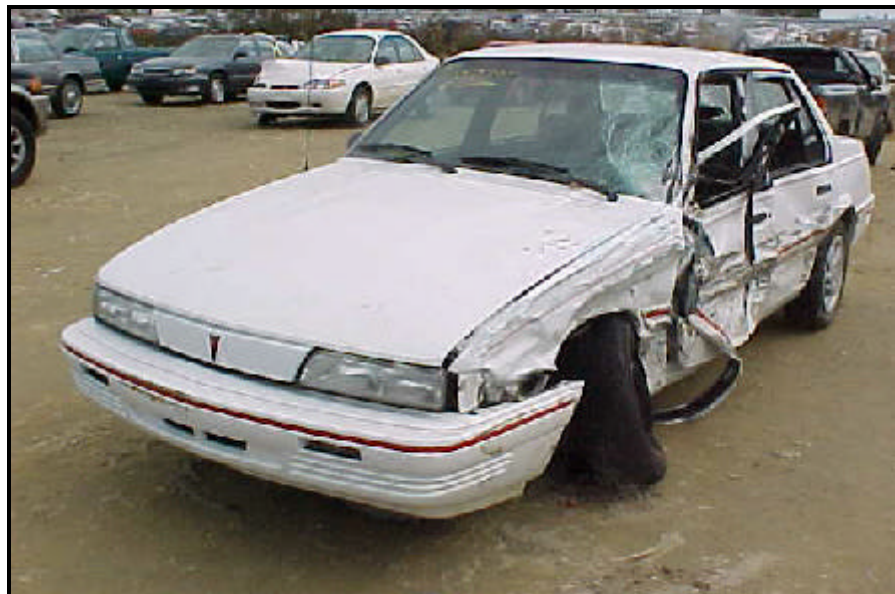
Damage Description: Left side, left doors. Towed from the scene.
Insurance company declared it a total loss.

Figure 7. Left side, other vehicle (Pontiac)

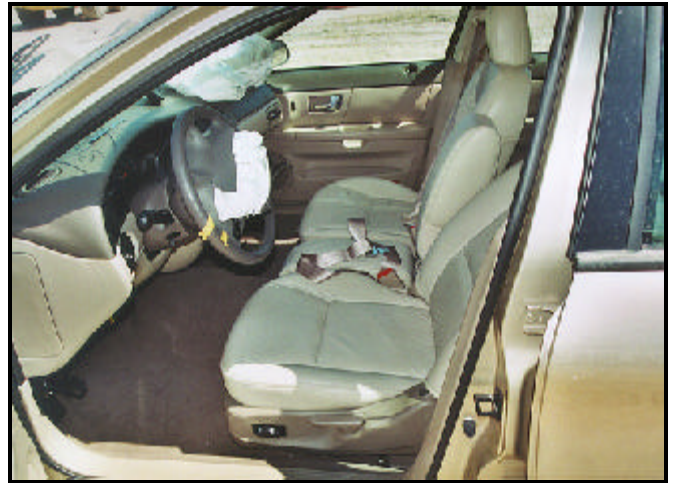
Figure 8. Driver's seated position

The 42-year-old male driver of the case vehicle was seated in a normal, upright fashion in a fabric covered bucket seat. The seat was adjusted to between middle and rear most track position. He was wearing the available lap and shoulder belt. Prior to the crash this vehicle had stopped. The driver's right foot is presumed to be on brake and the left foot on floor. At impact, the driver seat belt pretensioner fired—tightening the seat belt. The driver pitched forward and loaded the seat belt. His left knee contacted and deformed the left lower instrument panel. His face and torso likely engaged the deployed air bag. His right hand may have struck and dislodged the center mirror. The mirror had been broken and there was blood evidence on the right side of the driver's seat cushion. The driver sustained a "B" type injury (evident) according to the police report. He was transported by ground ambulance to a local hospital. The extent of his injuries is not known.

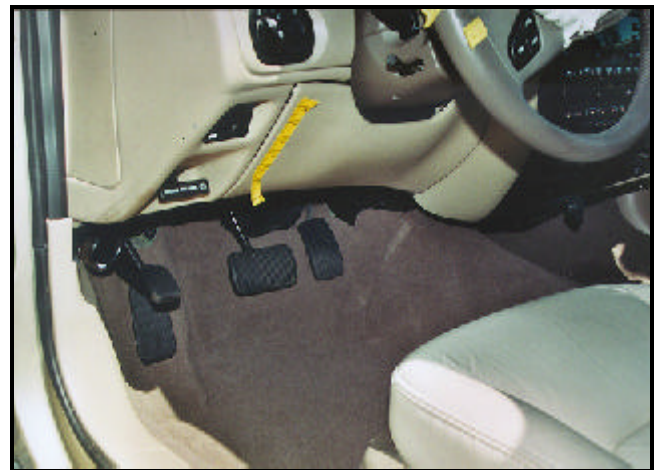
Figure 9. Left knee contact.

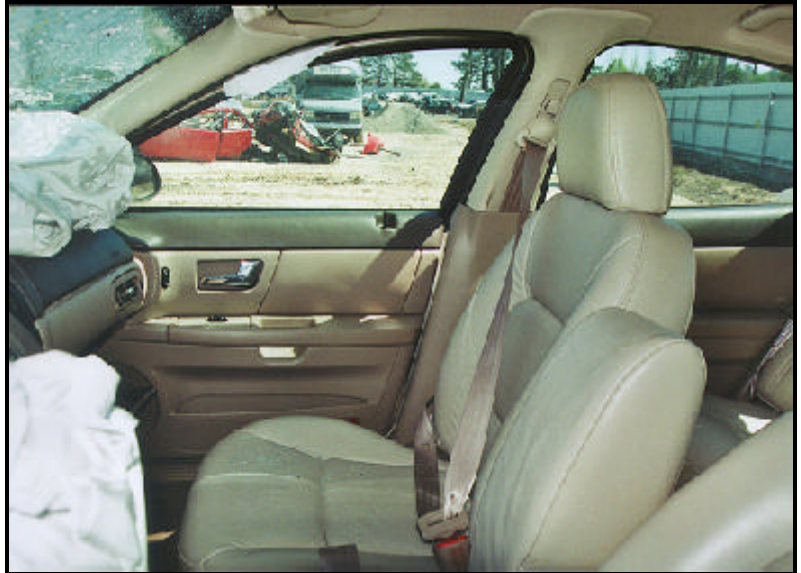
Figure 10. Front right occupant seated position (note the seat belt latch)

The 46-year-old female front right occupant of the case vehicle was seated in a normal, upright fashion in a fabric covered bucket seat. The seat was adjusted to the rear most track position. She was wearing the available lap and shoulder belt. Prior to the crash this vehicle had stopped. At impact, the front right passenger seat belt pretensioner fired—tightening the seat belt. This occupant pitched forward and loaded the seat belt. The seat belt "roped" in the latch and became lodged in the latch. This would have prevented the belt from threading through the latch properly. It is not clear if this occurred as a result of the pretensioning or during the driver loading. This occupant's face and torso likely engaged the deployed air bag to some degree. This occupant sustained a B type injury (evident) according to the police report. She was transported by ground ambulance to a local hospital. The extent of her injuries is not known.

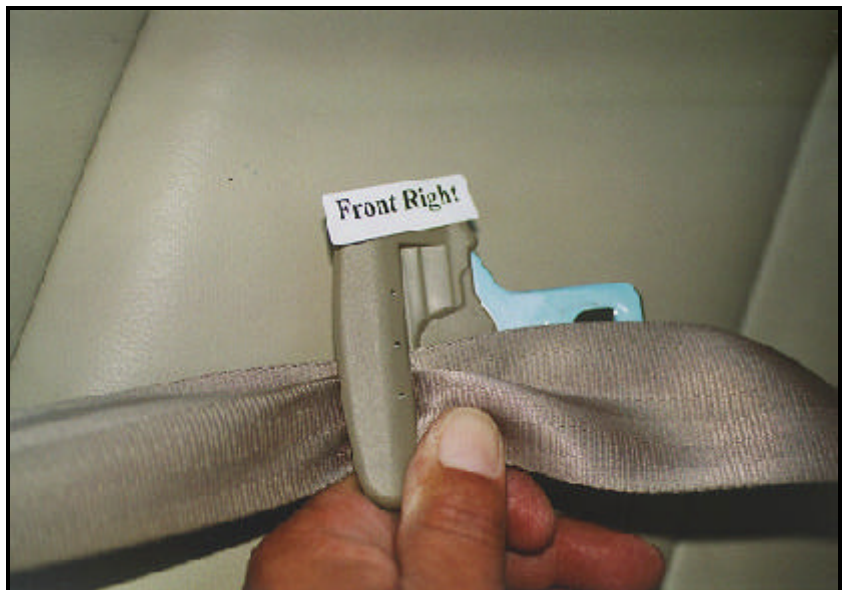
Figure 11. Front right seat belt latch

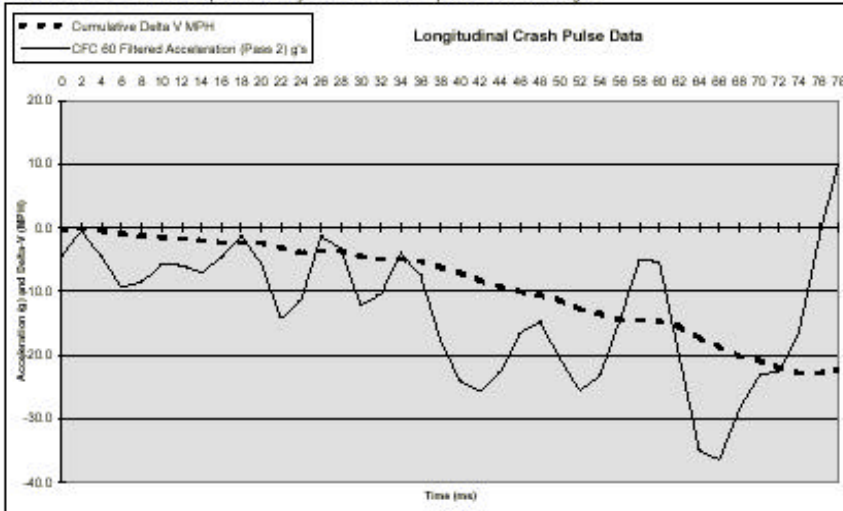
Longitudinal Cumulative Delta-V

Time (ms)	0	10	20	30	40	50	60	70	78
Delta-V (MPH)	-0.4	-1.0	-2.3	-4.0	-7.3	-11.4	-14.7	-20.8	-22.3

The case vehicle sustained a total delta v of 46.4 km/h (28.8 mph), a longitudinal delta v of -46.2 km/h (-28.7 mph), and a latitudinal delta v of 4.0 km/h (2.5 mph) as calculated by WinSmash. The downloaded Electronic Data Recorder (EDR) data indicates a cumulative longitudinal delta v of -35.9 km/h (-22.3 mph) at the 78 ms mark. The EDR report is included as an attachment to this report.

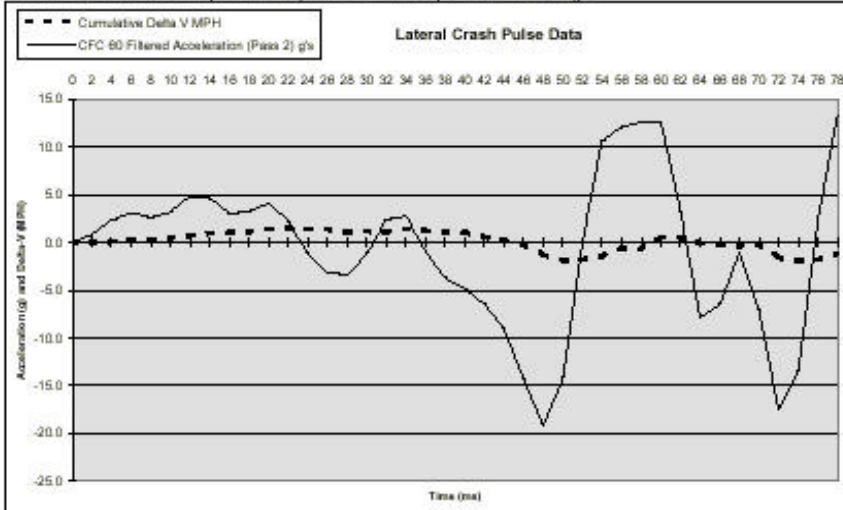
Lateral Cumulative Delta-V

Time (ms)	0	10	20	30	40	50	60	70	78
Delta-V (MPH)	0.0	0.1	1.4	1.2	1.1	-1.8	0.5	-0.1	-1.3
