On-scene Investigation / Vehicle to Vehicle  
Dynamic Science, Inc. / Case Number: DS02007  
1997 Nissan Altima four-door  
Arizona  
April, 2002

1. Report No. DS02007	2. Government Accession No.	3. Recipient Catalog No.	
4. Title and Subtitle In-Depth Accident Investigation		5. Report Date August 23, 2002	6. Performing Organization Report No.

**Dynamic Science, Inc.**  
**Accident Investigation**  
**Case Number: DS02007**

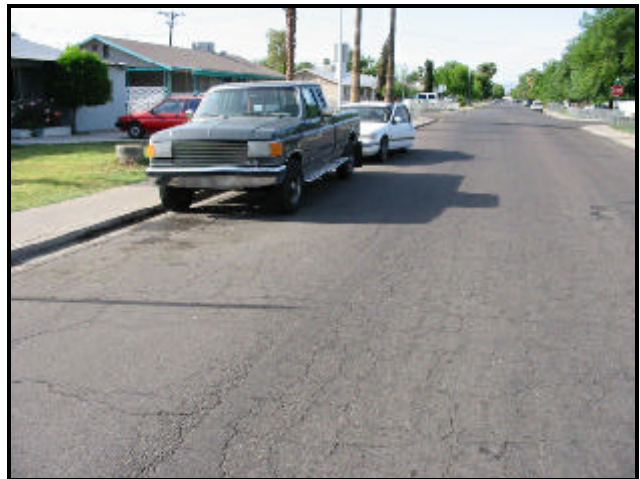
**Figure 1.** Struck parked vehicle

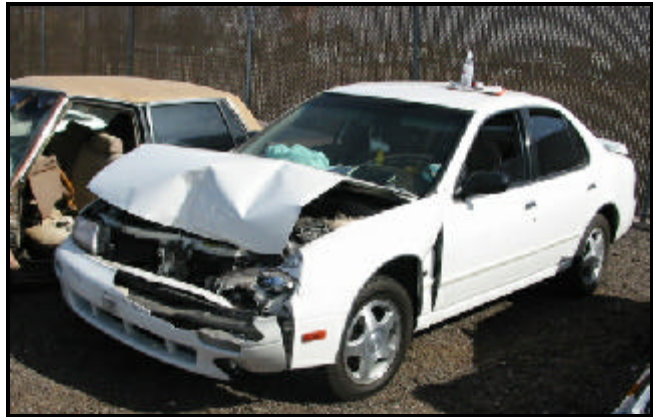
**Figure 2.** Front left, case vehicle

The front of the case vehicle (12FDEW1) struck the front of the parked vehicle (11FYEW1). The case vehicle had 118 cm (46.4 in) of direct contact beginning at the front right bumper corner and had a maximum crush<sup>3</sup> of 11 cm (4.3 in) at C1. The case vehicle sustained a total delta v of 24 km/h (14.9 mph), a longitudinal delta v of -24 km/h (-14.9 mph), a lateral delta v of 0 km/h (0 mph), and a barrier equivalent speed of 24.3 km/h (15 mph)<sup>4</sup>. Both front air bags in the case vehicle deployed at impact.

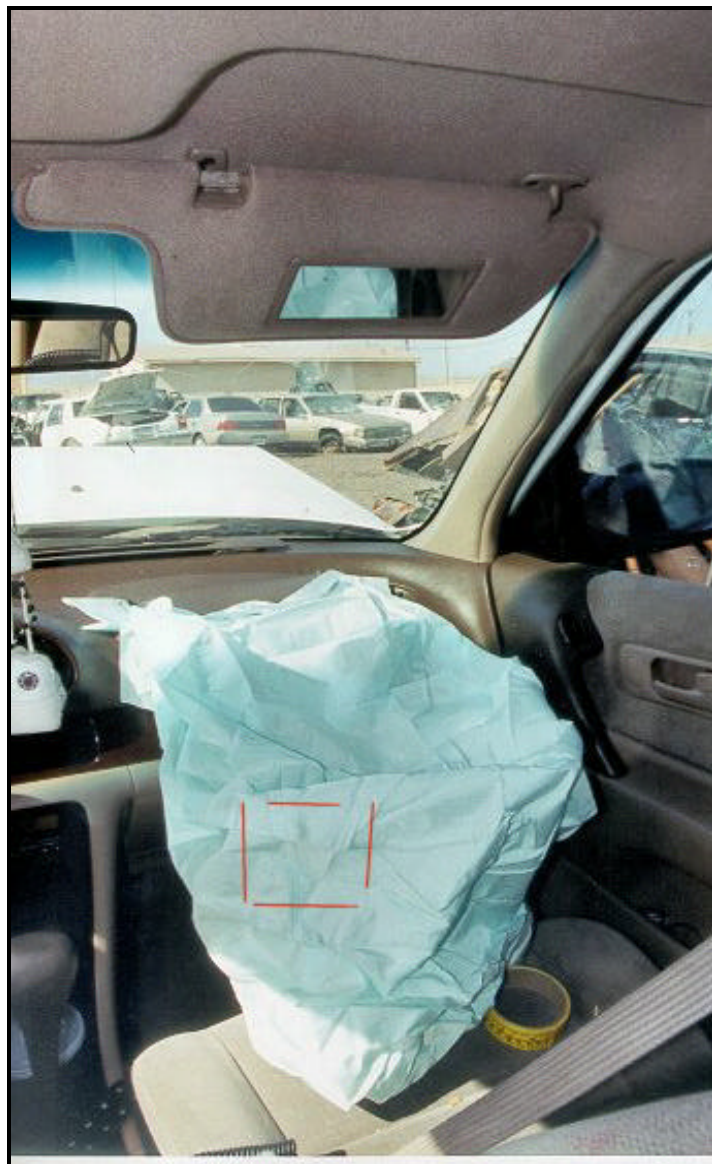
There was a possible skin transfer/contact to the left seam of the passenger air bag. There were no indications of any contact to the module cover. There was a light smear contact to the right side glass, but this may have been there for some time. There were no other specific indications of contact in the immediate seating area.

**Figure 3.** Passenger air bag—possible skin transfer

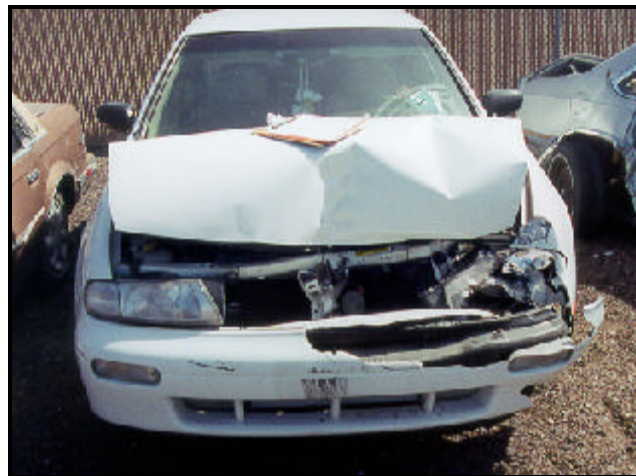
Description:	1997 Nissan Altima four-door	
VIN:	1N4BU31D9VCxxxxxx	
Odometer:	Unknown	
Engine:	146 CID, 4 cylinder	
Reported Defects:	None	
Cargo:	None	
Damage Description:	Moderate bumper and above bumper crush. Radiator damaged.	
CDC:	12FDEW1	
Impact Speed:	37 km/h (23 mph) - police estimate	
Delta V:	Total	24 km/h (14.9 mph)
	Longitudinal	-24.0 km/h (-14.9 mph)
	Latitudinal	0 km/h (0 mph)
	Energy	30,151 joules (22,238 ft-lbs)

**Figure 5.** Front of case vehicle

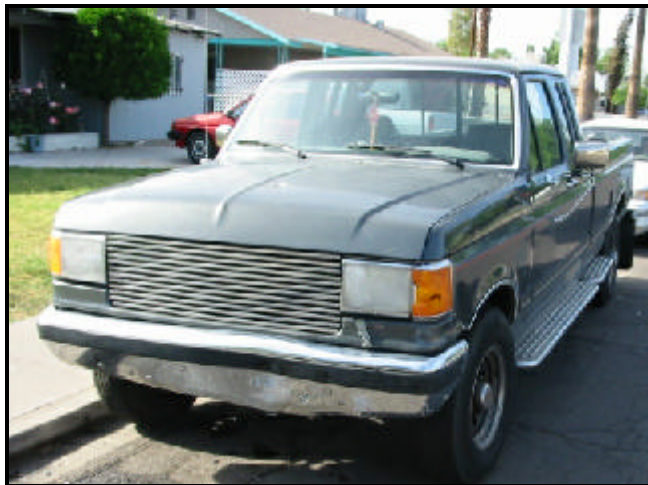
Description: 1988 Ford F250 4 x 2 pickup  
VIN: 1FTHX25G0JKxxxxxxx  
Odometer: Unknown  
Engine: 460 CID, 8  
Reported Defects: None  
Cargo: Unknown  
Damage Description: Minor frontal damage to bumper.  
CDC: 11FYEW1  
Delta V:  
Total 16.0 km/h (9.9 mph)  
Longitudinal -15.0 km/h (-9.3 mph)  
Latitudinal 5.5 km/h (3.4 mph)  
Energy 20,971 joules  
(15,467 ft-lbs)

**Figure 6.** Close up of damage to parked Ford pickup

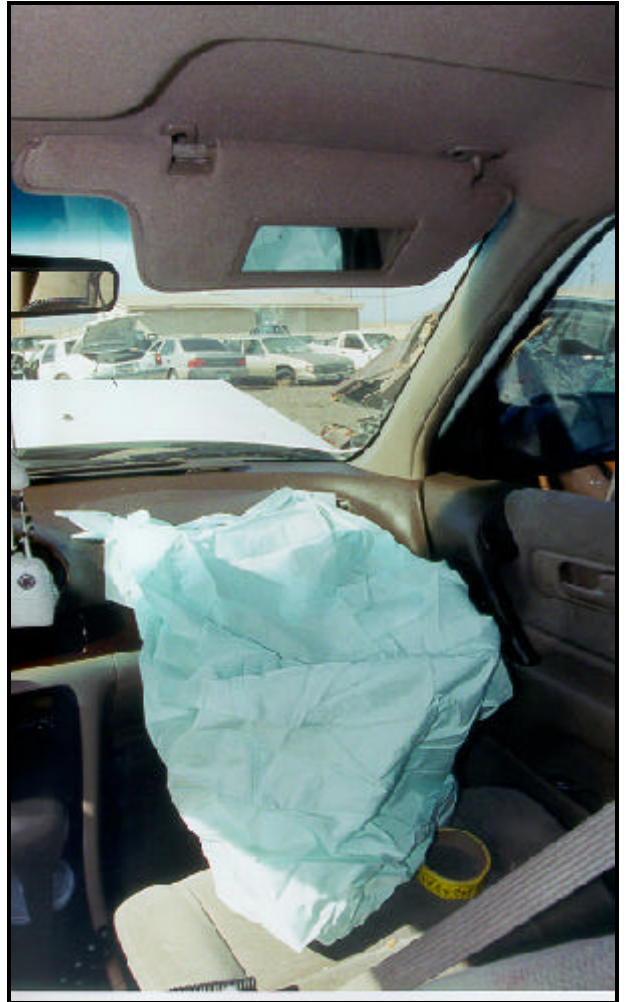
The front right seat was occupied by a 19-month-old male (87.3 cm/34.5 in, 11.8 kg/26 lbs). The front right occupant was originally seated in a forward facing fashion in the fabric covered bucket seat. The seat track was adjusted to the middle track position. Based on the driver's statement it would appear that this occupant was initially wearing the available lap and shoulder belt. The shoulder belt upper anchorage was in the full up position. Based on his estimated erect sitting height (54.5 cm/21.4 in<sup>7</sup>), the top of the child's head would have been just below the top of the seat back. His arms would have been above the diagonal of the torso belt. It is this investigator's opinion that the child had put the torso portion behind him and was attempting to get up. He still had the lap portion on. At this point, the driver leaned over to control the child. The case vehicle veered to the left and struck the left front of the parked pickup at a police-calculated impact speed of 37 km/h (23 mph). There was no pre-impact braking. At impact, both frontal air bags deployed. The front right passenger air bag is 40 cm (15.7 in) wide, 60 cm (23.6 in) tall, and had a maximum post-crash excursion of 72 cm (28.3 in). This put the leading edge of the air bag 20 cm (7.9 in) from the face of the seat back.

**Figure 7.** Front right occupant seated area

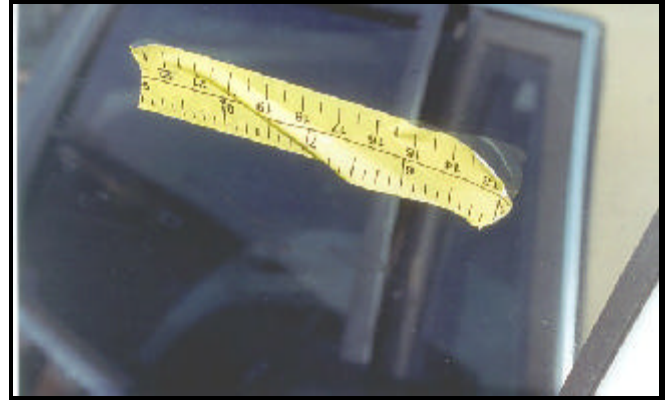
**Figure 9.** Close up of skin oil transfer to side glass

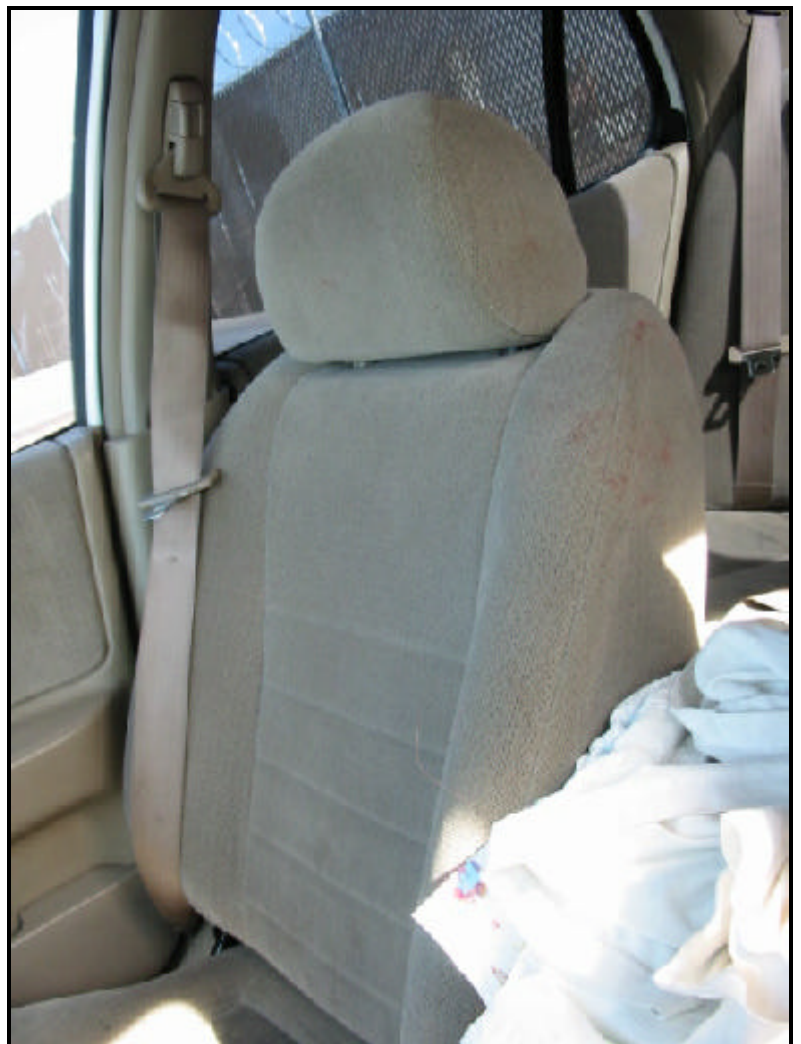
**Figure 10.** Front right seat (red markings are paint or nail polish)
