On Site Advanced 208-Compliant Investigation / Vehicle to Vehicle
Dynamic Science, Inc. / Case Number: DS02032
2003 Chevrolet Silverado pickup
Washington
December, 2002

1. Report No. DS02032		2. Government Accession No.		3. Recipient Catalog No.	
4. Title and Subtitle Advanced 208-Compliant Investigation				5. Report Date January 17, 2004

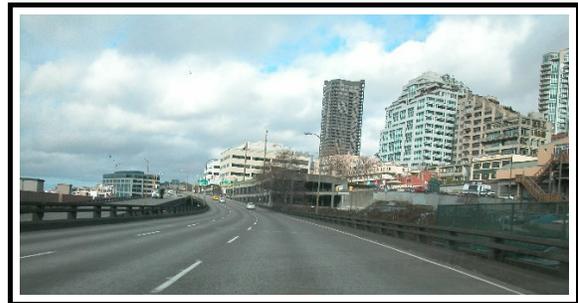
Figure 1. Approximate impact area (north)

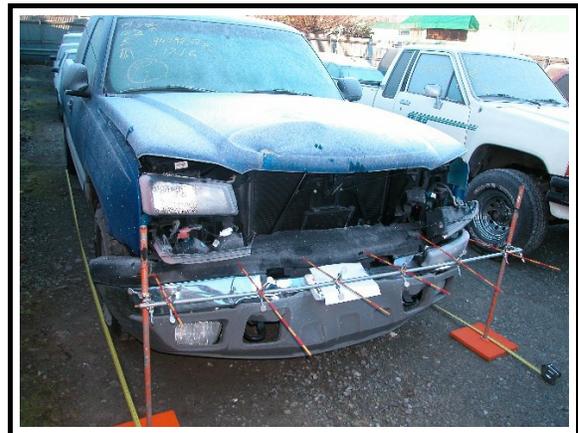
Figure 2. Exterior damage—case vehicle

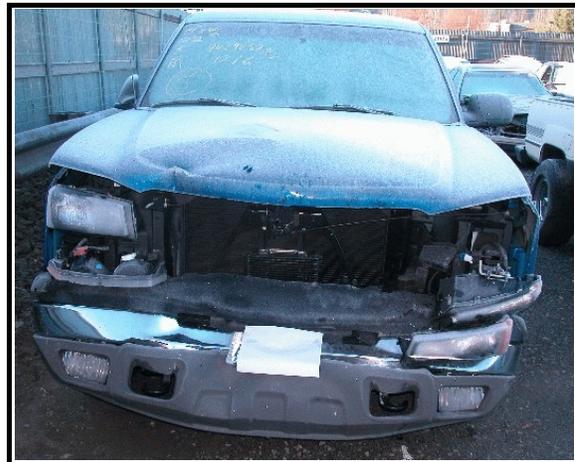
Damage Description:	Minor to moderate frontal damage to bumper and grille. The police report indicated that the vehicle had been towed due to damage. Vehicle declared a total loss by insurance company.	
CDC:	12FDEW1	
Delta V:	Total	24.0 km/h (14.9 mph)
	Longitudinal	-24.0 km/h (-14.9 mph)
	Latitudinal	0 km/h (0 mph)
	Energy	25,771 joules (19,008 ft lbs)

During the initial impact, the case vehicle sustained 170 cm (67 in) of direct and induced contact damage that extended across the entire frontal end width of the vehicle. The impact energy was managed by the forward structures of the vehicle. The damaged components included the bumper fascia and reinforcement bar, upper and lower radiator supports, the grille area, and the hood. Six crush measurements were documented at the bumper level: C1= 4 cm (2 in), C2=10 cm (4 in), C3= 19 cm (7 in), C4=19 cm (7 in), C5=11 cm (4 in), C6= 7 cm (3 in). A Collision Deformation Classification of 12FDEW1 was assigned to the damage. The principal direction of force was within the 12 o'clock sector and was an estimated 0 degrees. There was no reduction of either wheelbase. All doors remained closed and operational, and there was no glazing damage.

Figure 3. Front, case vehicle

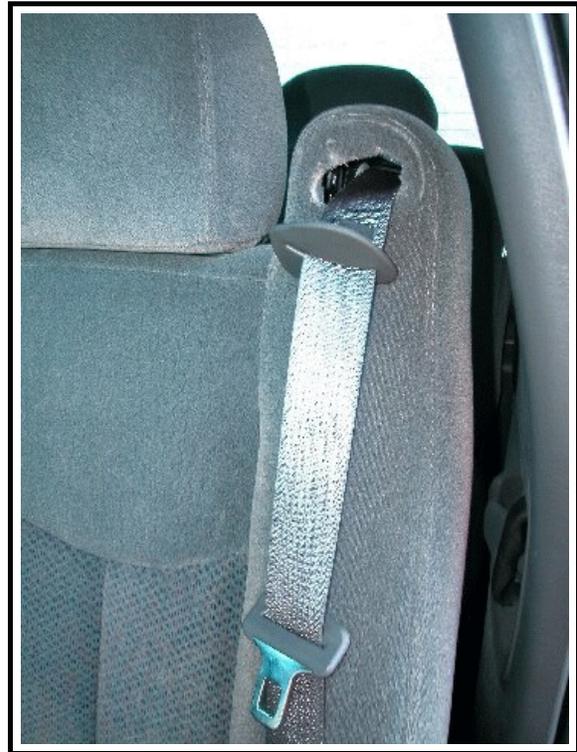
There was no interior damage beyond the deployed driver's air bag and the displaced plastic cover for the driver's shoulder harness. There was no intrusion and there were no occupant contacts.

Figure 4. Driver's displaced plastic cover

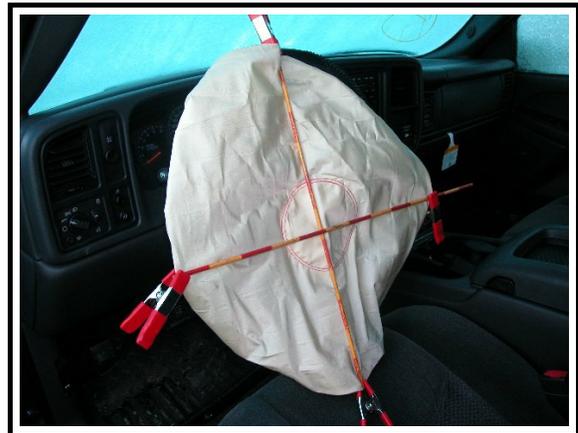
The case vehicle was equipped with advanced, dual stage driver and front right passenger air bags. The driver's air bag was mounted in the steering wheel hub. The driver's air bag was circular and measured 65 cm (26 in.) in diameter. The air bag had a maximum deflated excursion of 23 cm (9 in). It was equipped with two internal tether straps and two vent ports. The vent ports were 2.5 cm (1 in) in diameter and were located at the 11 and 1 o'clock positions. The dual module cover flaps opened in an "I" type configuration. The left and right flaps each measured 12 cm (5 in) high by 7 cm (3 in) wide. There were no indications of any damage to driver's air bag or the module cover flaps. On the face of the air bag there were vinyl transfers to the membrane from expansion within the module. The face of the air bag exhibited 12 horizontal and 10 vertical folds. The front right passenger air bag was a mid instrument panel mount and did not deploy. The passenger air bag switch was set to AUTO and the front right seat was unoccupied. The front right seat weight sensor sensed that no occupant was in the front right seat, and the SDM suppressed the front right passenger's air bag.

Figure 5. Driver's advanced air bag

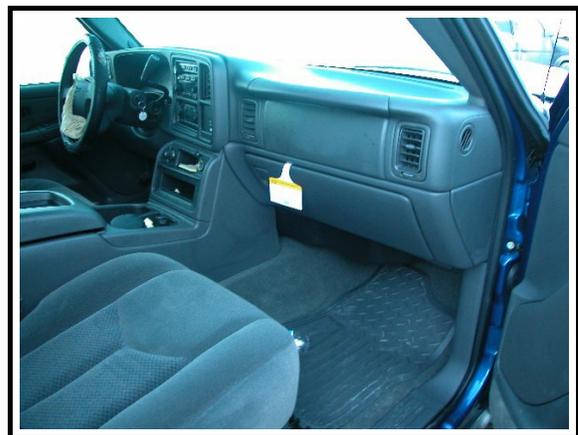
Figure 6. Non-deployed front right advanced air bag

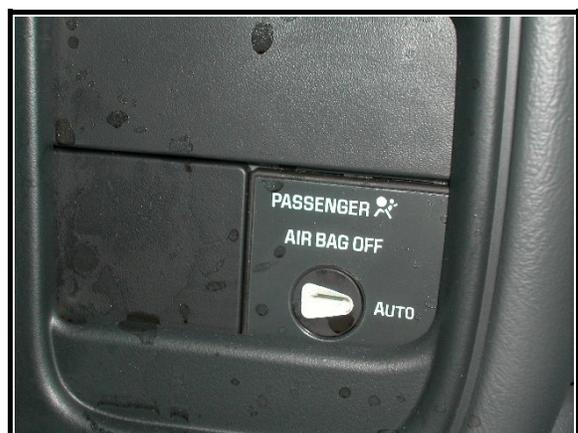
Figure 7. Front right passenger air bag cut off switch

³The air bag suppression switch was set to AUTOMATIC.
