**GENERAL DYNAMICS ON-SITE ADVANCED OCCUPANT PROTECTION SYSTEM
CRASH INVESTIGATION
SCI TECHNICAL SUMMARY REPORT**

CASE NO. CA02-039

VEHICLE – 2002 CADILLAC DEVILLE

CRASH DATE – AUGUST 2002

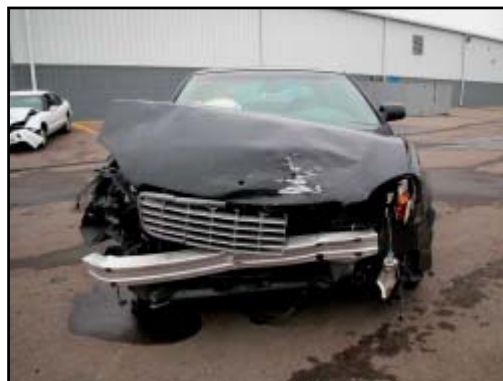
Figure 1. View of damaged 2002 Cadillac Deville

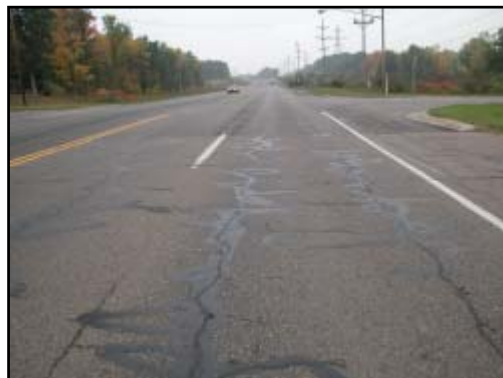
The 49-year-old female driver was operating the 2002 Cadillac Deville in a southbound direction in the outboard lane of the four-lane roadway (**Figure 2**). The data summary from the Event Data Recorder (EDR) indicated the Cadillac was traveling at a speed of 97 km/h (60 mph) five seconds prior Algorithm Enable. The 39-year-old driver of the 1998 Saturn was operating the vehicle in a westbound direction on the two-lane roadway on approach to the four-leg intersection (**Figure 3**). The driver of the Saturn disregarded the stop sign and proceeded into the intersection across the path of the Cadillac Deville. There was no evidence of attempted avoidance maneuvers by the driver of the Saturn. The driver of the Cadillac stated that she applied the brakes, but this avoidance was not supported by the EDR or physical evidence at the scene.

Figure 2. Southbound approach for the Cadillac

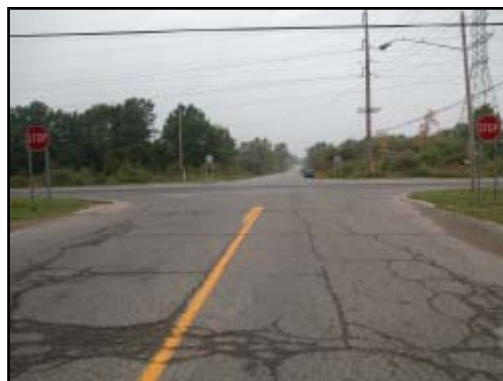
Figure 3. Westbound approach for the Saturn

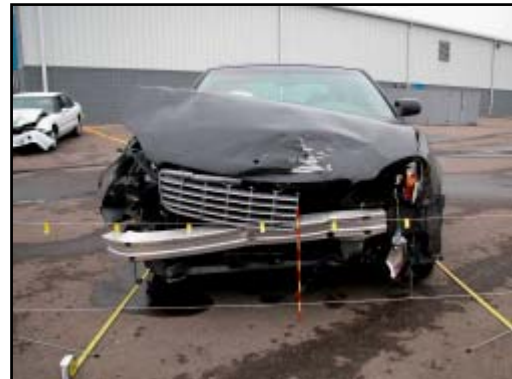
The 2002 Cadillac Deville sustained moderate damage as a result of the frontal impact with the 1998 Saturn (Figure 4). The direct contact damage along the leading edge of the hood began 14.0 cm (5.5") inboard of the left front corner of the hood and extended 118.1 cm (46.5") laterally along the hood. The lateral abrasions and contact deformation measured 26.7 cm (10.5") in depth from the leading edge of the hood rearward. The combined direct and induced damage involved the entire frontal width of the vehicle. The Field L measured 143.5 cm (56.5") across the width of the front bumper beam. The bumper fascia was separated and was not located with the vehicle at the time of the inspection. The grille was fractured and partially separated on the left side. The hood was buckled rearward. The left front fender was displaced inward at the forward aspect and outward at the rear aspect. The right front fender was displaced outward at the forward aspect as a result of the end shift (Figure 5). Both head lamp assemblies were separated. The bumper beam was crushed rearward and the maximum crush was located on the front left corner of the beam. Abrasions 24.9 cm (9.8") to the left of the hood's centerline were present on the hood from direct contact with the spring and suspension components of the right rear wheel of the Saturn. The right front wheel was displaced rearward which resulted in the shortening of the right wheelbase by 5.5 cm (2.2"). The left front wheel sustained minor abrasions from probable post-impact contact with the curbed roadside corner. The Collision Deformation Classification (CDC) for the impact with the Saturn was 71-FDEW-2. The CDC was incremented by 60 to reflect the lateral end shift to the right. Six crush measurements were documented along the front bumper beam and were as follows: C1 = 4.4 cm (1.8"), C2 = 21.1 cm (8.3"), C3 = 27.3 cm (10.8"), C4 = 27.3 cm (10.8"), C5 = 34.5 cm (13.6"), C6 = 32.4 cm (12.8").

Figure 4. Frontal view of damage to the 2002 Cadillac Deville

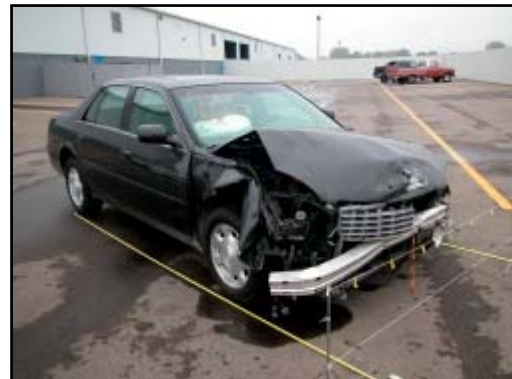
Figure 5. 45 degree view of the 2002 Cadillac Deville

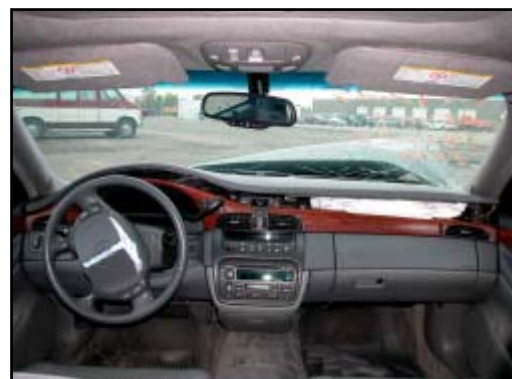
Interior damage to the 2002 Cadillac Deville was minor (Figure 6) and attributed to passenger compartment intrusion. All doors were operational. The windshield laminate was fractured on the right aspect from contact with the deployed front right passenger's air bag. The remaining glazing was undamaged. There were no

Figure 6. Interior view of 2002 Cadillac Deville

intrusions into the passenger compartment. The tilt steering column was found in the fourth position from the top (6 total positions) and was undamaged. The knee bolster was undamaged and did not exhibit contact evidence.

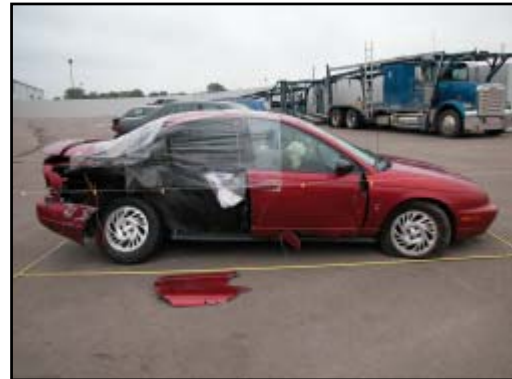
The 1998 Saturn sustained moderate right side damage as a result of the impact with the Cadillac Deville. The direct contact damage began at the leading edge of the right rear door and extended 182.9 cm (72.0”) rearward along the right side plane (**Figures 7 and 8**). The combined direct and induced damage began at the leading edge of the right front door and extended 295.9 cm (116.5”) rearward along the right side plane to the right rear bumper corner. The maximum crush measured 22.9 cm (9.0”) and was located 96.5 cm (38.0”) aft of the leading edge of the right rear door on the right rear quarter panel. The composite exterior surface of the right rear door had fractured and was

completely separated. The composite right rear quarter panel was also fractured in multiple locations and partially separated. The right aspect of the rear bumper fascia was abraded and displaced. The lower aspect of the right front door was fractured in multiple locations, and a large diagonal fracture that extended vertically from the bottom aspect to the door handle was present on the rear aspect of the door. The roof was buckled slightly and the sunroof was displaced but not fractured. The right rear wheel was displaced laterally against the suspension components. The right rear wheel was abraded and minor scuff marks were present on the sidewall of the tire. Both rear tires remained inflated and both front tires were deflated. The left rear wheel was displaced outward, and the rear track width was reduced by 13.7 cm (5.4”). The front bumper fascia exhibited abrasions consistent with an impact to a narrow object. Although delineator posts were present near the Saturn’s post-crash trajectory, the crash dynamics suggest that there was no contact with the delineator posts in this crash. The CDC for the impact

with the Cadillac Deville was 02-RZEW-2. Six crush measurements were documented along the right side at the mid-door level and were as follows: C1 = 0.0 cm, C2 = 0.0 cm, C3 = 8.3 cm (3.3”), C4 = 12.7 cm (5.0”), C5 = 14.0 cm (5.5”), C6 = 3.8 cm (1.5”). Based on the composite body panels, this crush profile was not an accurate representation of the resultant damage. A second crush profile was documented at the right sill which was used for the WinSMASH reconstruction model. These measurements and were as follows: C1 = 2.5 cm (1.0”), C2 = 6.4 cm (2.5”), C3 = 11.4 cm (4.5”), C4 = 15.2 cm (6.0”), C5 = 17.8 cm (7.0”), C6 = 3.8 cm (1.5”).

Figure 7. View of right side damage to the 1998 Saturn

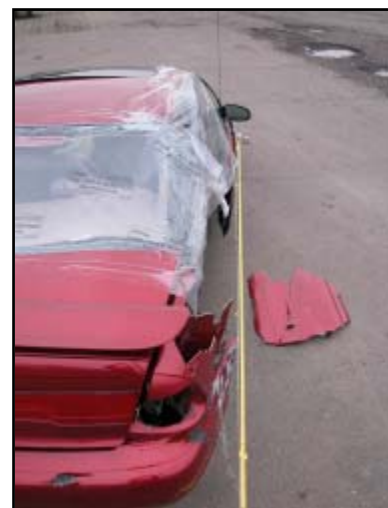
Figure 8. Longitudinal view of right side damage

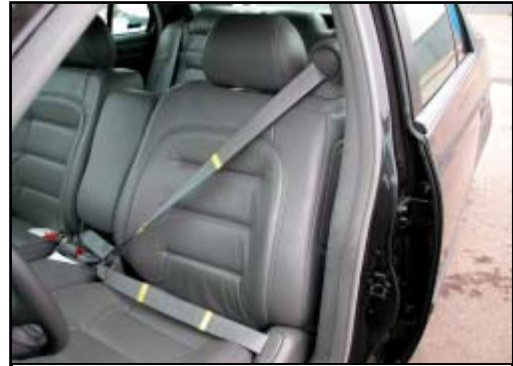
The 2002 Cadillac Deville was equipped with integrated manual 3-point lap and shoulder belts for the driver (Figure 9) and front right passenger positions and a lap belt for the front center position. The outboard seat belts were configured with sewn-on latch plates and electric shoulder belt height adjusters that were located on the outboard aspects of the front seat backs. The driver's restraint was configured with emergency locking retractors (ELR's) for the shoulder belt and lap belt. The front right restraint was configured with an ELR in the shoulder belt and a switchable/automatic locking retractor (ALR) for the lap belt. A label was present on the front right lap belt which stated, "With Active Air Bag: Move seat fully rearward. Pull belt out completely, then secure child seat." The shoulder belt height adjusters were electronically controlled by vertical motion of the seat back recline switch that was located on the outboard aspects of the front seat cushions. The height adjuster measured 11.4 cm (4.5") in depth and the front aspect consisted of a circular cover that measured 7.0 cm (2.8") in diameter with a diagonal opening through which the shoulder belt webbing passed. The top aspect of the driver's shoulder belt height adjuster was positioned 9.5 cm (3.8") above the seat back and the shoulder belt webbing was positioned 5.7 cm (2.3") above the seat back (Figure 10). The front right shoulder belt height adjuster appeared to be in the full-down position and the top aspect measured 7.6 cm (3.0") above the front right seat back.

Figure 9. View of driver's integrated 3-point lap and shoulder belt

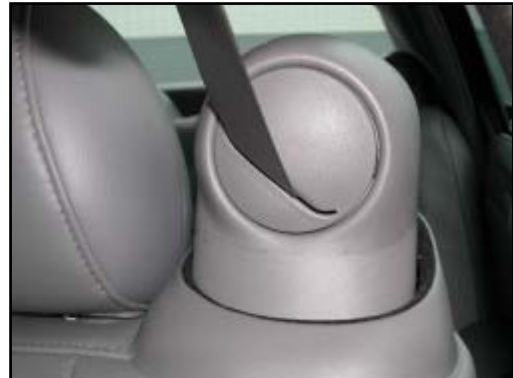
Figure 10. Close-up of the driver's shoulder belt height adjuster

full-down position and the top aspect

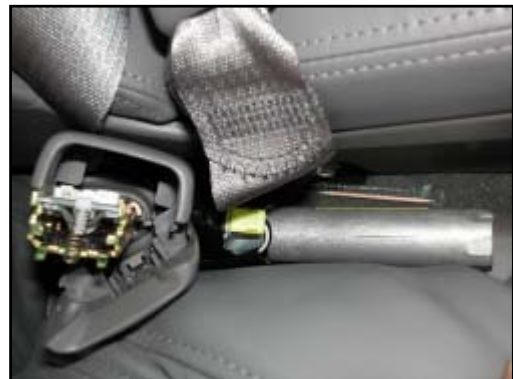
The driver and front right passenger's positions were equipped with seat belt buckle pretensioners that fired in conjunction with the frontal air bag system as a result of the frontal impact with the Saturn. The post-crash distance from the forward aspect of the piston to the forward edge of the barrel for the driver's and front right passenger's buckle pretensioners were 2.4 cm (0.9") and 2.1 cm (0.8"), respectively. Plastic trim covers prohibited exemplar measurements of the pretensioners. The front right seat belt buckle housing was fractured as a result of the front right pretensioner firing without an occupant restrained in the seat (Figure 11).

Figure 11. View of front right passenger's buckle pretensioner and fractured buckle housing

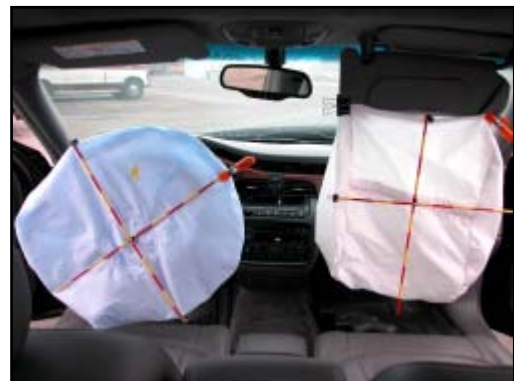
The 2002 Cadillac Deville was equipped with an AOPS that consisted of dual-stage frontal air bags, seat belt buckle pretensioners, and an Event Data Recorder (EDR). The dual-stage frontal air bags deployed as a result of the frontal impact with the Saturn (**Figure 12**). The driver's air bag was housed in the center of the steering wheel with symmetrical I-configuration cover flaps. Each flap measured 8.3 cm (3.3") in width and 11.4 cm (4.5") in height. The driver's air bag was circular in shape and measured 66.0 cm (26.0") in diameter in its deflated state. The air bag was tethered by four internal straps that measured 8.3 cm (3.3") in width and were located at the 12, 3, 6, and 9 o'clock positions. The air bag was vented by two circular ports that measured 3.2 cm (1.3") in diameter that were located at the 11 and 1 o'clock aspects on the rear aspect of the air bag 7.0 cm (2.8") aft of the peripheral seam. A small linear transfer that measured 1.3 cm (0.5") in length was located on the upper left quadrant of the face of the air bag 18.4 cm (7.3") from the center of the air bag.

Figure 12. View of deployed frontal air bags in the Cadillac Deville

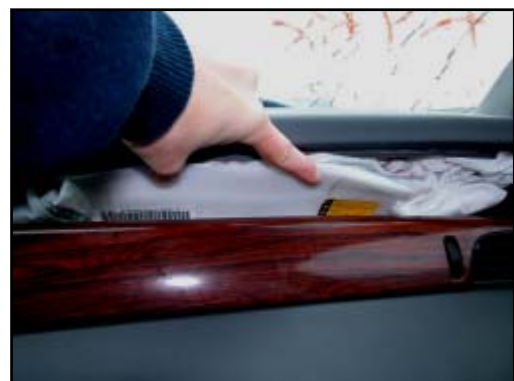
The front right passenger's air bag deployed from the mid-instrument panel area. There were no cover flaps, as the air bag deployed from separation of the right upper and mid-instrument panels. The post-deployment separation of the instrument panel measured 5.7 cm (2.3") in height. An internal plastic contoured flap that was adjacent to the mid-instrument panel aspect measured 26.7 cm (10.5") in width and 6.4 cm (2.5") in height. This flap was positioned over the lower aspect of the separated instrument panel and centered in relation to the air bag, which prevented the air bag from snagging edge of the instrument panel as it deployed (**Figure 13**). The front right passenger's air bag measured 35.6 cm (14.0") in width and 55.9 cm (22.0") in height in its deflated state. The air bag was vented by two circular ports that measured 6.4 cm (2.5") in diameter. The vent ports were located 35.6 cm (14.0") aft of the forward seams at the 3

Figure 13. View of internal plastic flap for the front right passenger's air bag

and 9 o'clock positions on side aspects of the air bag. There was no contact evidence on the air bag.

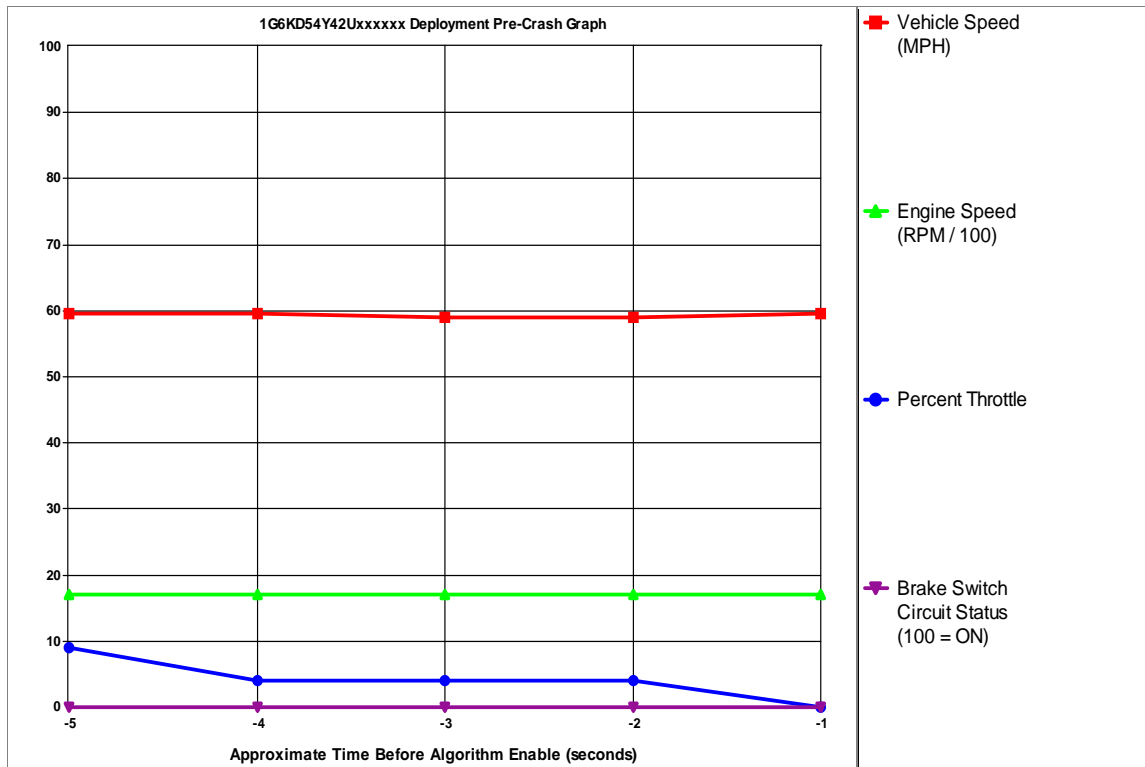
Seconds Before AE	Vehicle Speed (MPH)	Engine Speed (RPM)	Percent Throttle	Brake Switch Circuit Status
-5	60	1664	9	OFF
-4	60	1664	4	OFF
-3	59	1664	4	OFF
-2	59	1664	4	OFF
-1	60	1664	0	OFF

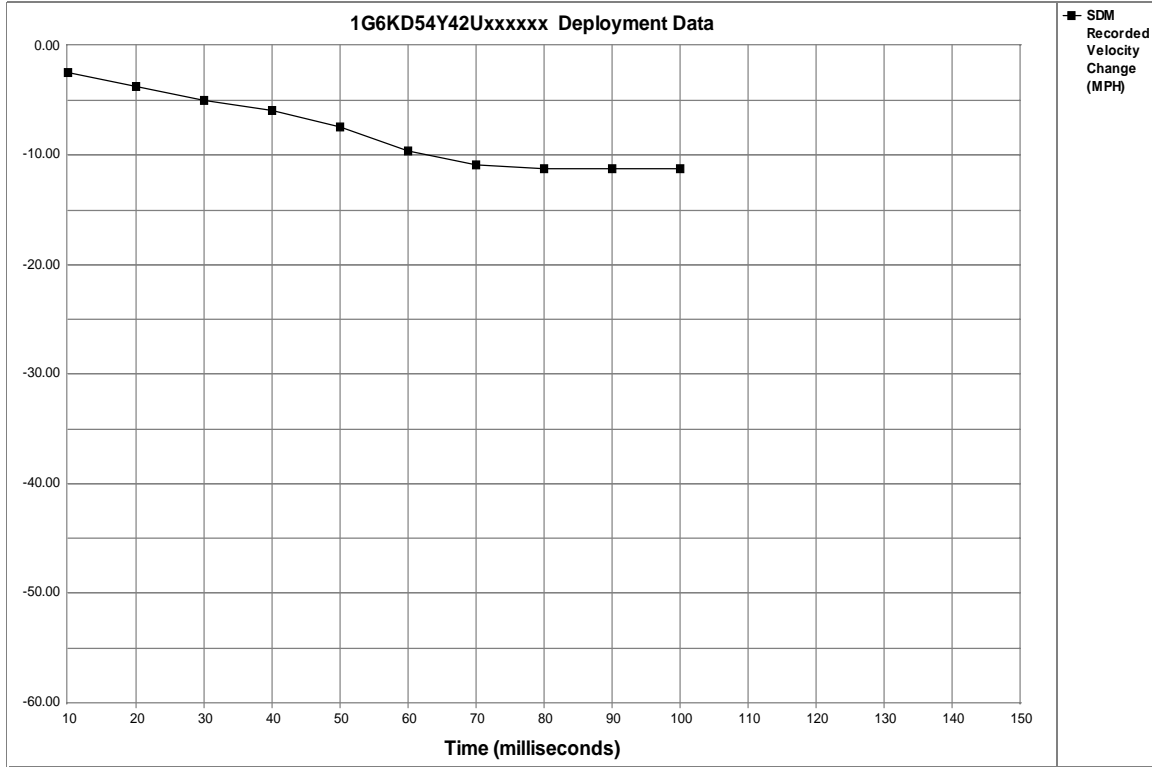
Time (milliseconds)	10	20	30	40	50	60	70	80	90	100	110	120	130	140	150
Recorded Velocity Change (MPH)	-2.48	-3.72	-4.96	-5.89	-7.44	-9.61	-10.85	-11.16	-11.16	-11.16	N/A	N/A	N/A	N/A	N/A

The EDR summary indicated that both the first and second stages of the frontal air bag system deployed in the crash. The first stage was commanded 5 milliseconds after the algorithm was enabled, and the second stage was commanded 7.5 milliseconds after the algorithm was enabled.

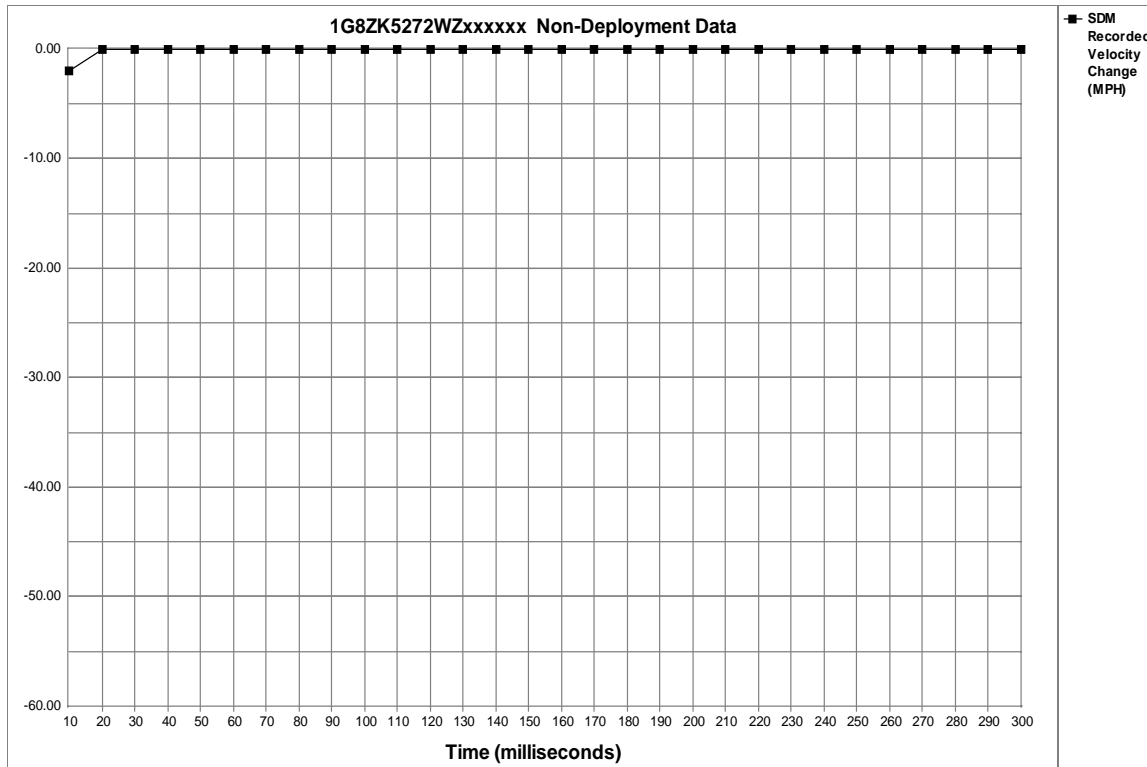
Time (milliseconds)	10	20	30	40	50	60	70	80	90	100	110	120	130	140	150
Recorded Velocity Change (MPH)	-1.97	0.00	0.00	0.00	0.00	0.00	0.00	0.00	0.00	0.00	0.00	0.00	0.00	0.00	0.00
Time (milliseconds)	160	170	180	190	200	210	220	230	240	250	260	270	280	290	300
Recorded Velocity Change (MPH)	0.00	0.00	0.00	0.00	0.00	0.00	0.00	0.00	0.00	0.00	0.00	0.00	0.00	0.00	0.00
