**CALSPAN REMOTE ADULT AIR BAG RELATED SERIOUS INJURY
INVESTIGATION**

SCI TECHNICAL SUMMARY REPORT

NASS/SCI COMBO CASE NO. 04-45-214K

VEHICLE – 1996 HONDA CIVIC

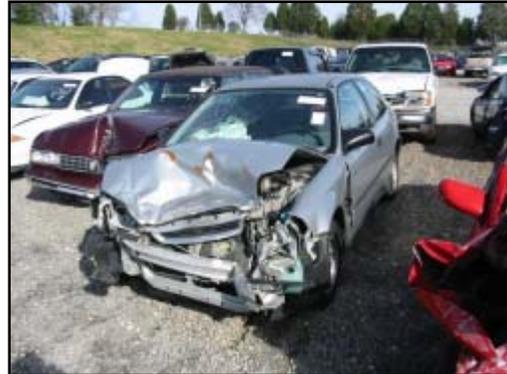
Figure 1. Subject 1996 Honda Civic.

This on-site investigation focused on the severity of the crash and the air bag related serious injuries to a restrained 83-year-old female front right passenger of a 1996 Honda Civic (**Figure 1**). The Honda was equipped with a frontal air bag system for the driver and front right passenger positions that deployed as result of an intersection crash with a 2000 Pontiac Bonneville. The Honda was occupied by a restrained 46-year-old male driver and a restrained 83-year-old female front right passenger. The Pontiac was occupied by a 15-year-old female driver and two occupants. The

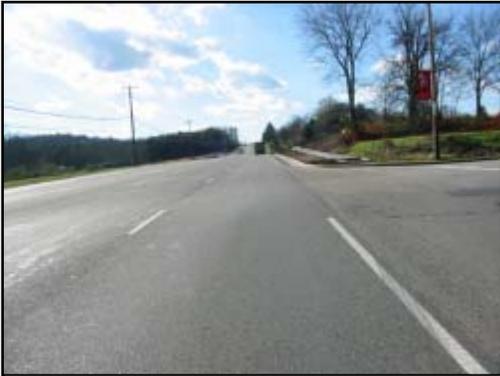
Figure 2. Honda's westbound approach to the intersection.

The restrained 46-year-old male driver of the Honda was operating the vehicle westbound approaching the intersection (**Figure 2**). The 15-year-old female driver of the Pontiac was traveling southbound approaching the intersection (**Figure 3**) where the driver turned left across the path of the Honda. No pre-impact evidence [i.e. skid marks] was present at the crash site. However, a level of pre-impact braking was applied by the driver of the Honda, which was supported by the air bag interaction by the front right passenger. This interaction is discussed in the ***Front Right Passenger Kinematics*** section of this report. The NASS scene schematic is included as **Figure 9** of this report.

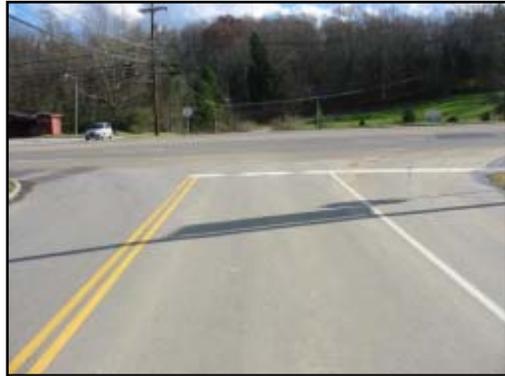
Figure 3. Pontiac's southbound approach to the intersection.

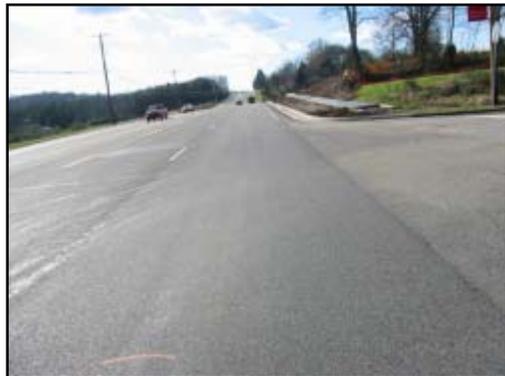
The full frontal aspect of the Honda impacted the front left aspect of the Pontiac in the northeast quadrant of the intersection (**Figure 4**). The impact resulted in moderate frontal damage to the Honda and unknown severity damage to the Pontiac. The resultant directions of forces were 1 o'clock for the Honda and 11 o'clock for the Pontiac. The missing vehicle algorithm of the WINSMASH program was used to calculate a delta V for this impact. The total calculated delta V for the Honda was 45 km/h (27.9 mph). The longitudinal and lateral components were -39 km/h (-24 mph) and -23 km/h (-14.3), respectively. The total calculated delta V for the Pontiac was 28 km/h (17.3 mph). The longitudinal component was -18 km/h (-11.2 mph) and the lateral component was 21 km/h (13.0 mph). The missing vehicle algorithm of the WINSMASH program typically overestimates the delta V due the limitations of the algorithm in a side impact configuration. Based on SCI experience, it appears the delta V was in the range of 24.0-32.0 km/h (15.0-20.0 mph) for the Honda. As a result of this intersection crash, the frontal air bags deployed in the Honda. Both vehicles came to rest within the intersection.

Figure 4. Approximate area of impact.

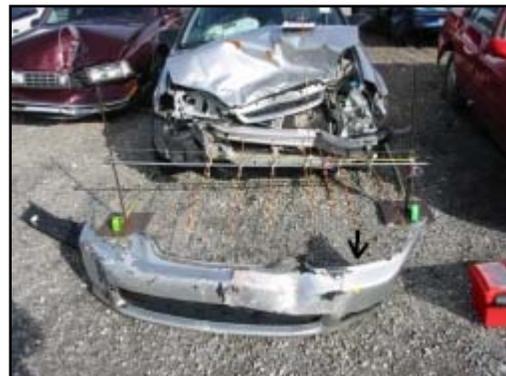
The 1996 Honda Civic sustained moderate severity frontal damage as a result of the intersection crash with the Pontiac (**Figure 5**). The damage involved the frontal structure, which was displaced longitudinally and laterally left. Additionally, the front bumper fascia was separated from the vehicle at impact. The NASS researcher measured the direct contact damage on the bumper fascia, which was 139.0 cm (54.7”) and began 64.0 cm (25.2”) left of the centerline and extended to the front right bumper corner. The maximum crush on the bumper reinforcement beam measured 42.0 cm (16.5”), which was located approximately 40.0 cm (16.0”) inboard of the left bumper reinforcement beam edge. Due to the separated bumper fascia, the NASS researcher documented the frontal crush along the bumper reinforcement beam using a combined direct and induced damage width of 95.0 cm (37.4”) and were as follows: C1 = 0.0 cm, C2 = 19.0 cm (7.5”), C3 = 38.0 cm (14.9”), C4 = 34.0 cm (13.4”), C5 = 29.0 cm (11.4”), C6 = 25.0 cm (9.8”). The CDC for this impact was 01-FDEW-2. The left and right side doors remained closed and operational post-crash. The windshield was fractured as result of the front right air bag deployment and the side and rear glazing remained intact.

Figure 5. Resultant frontal damage from the impact with the Pontiac.

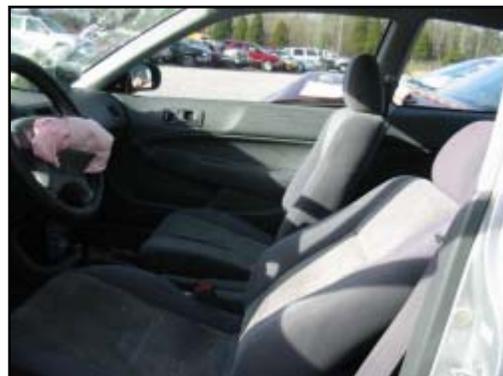
The 1996 Honda Civic sustained minor interior damage as result of occupant contacts. There was no intrusion of the passenger compartment. Occupant contacts were noted to the front left air bag from contact with the driver’s left hand, left wrist, and face. These contacts were evidenced by scuffmarks. Also noted was an occupant contact to the front right air bag from the front right passenger’s face, which was evidenced by body fluid.

Figure 6. Overall view of the interior first row.

Additionally, the NASS researcher noted a scuffmark to the right knee bolster from contact with the front right passenger's right knee. **Figure 6** is an overall of the front passenger compartment.

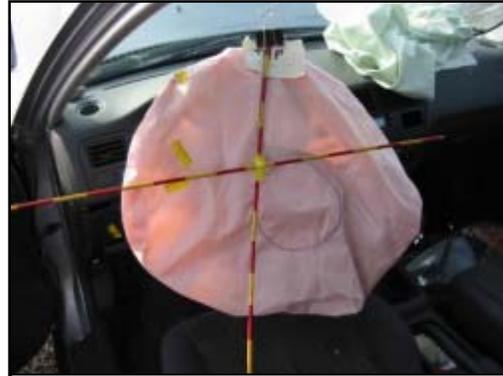
The 1996 Honda Civic was equipped with a frontal air bag system that deployed as result of the crash. The driver's air bag was conventionally located in the steering hub (**Figure 7**). The air bag membrane measured 62.0 cm (24.4") in diameter in its deflated state. Two vent ports at the 10 and 2 o'clock positions on the rear panel vented the air bag. The air bag contained two tether straps, which controlled the deployment pattern of the air bag. The air bag module consisted of two H-configuration asymmetrical cover flaps. The top cover flap measured 12.0 cm (4.7") in width and 7.0 cm (2.7") in height. The lower cover flap measured 14.0 cm (5.5") in width at the top and 11.0 cm (4.3") in width at the bottom and 5.0 cm (2.0") in height.

Figure 7. Deployed driver's frontal air bag. The area of occupant contacts was to the upper left quadrant.

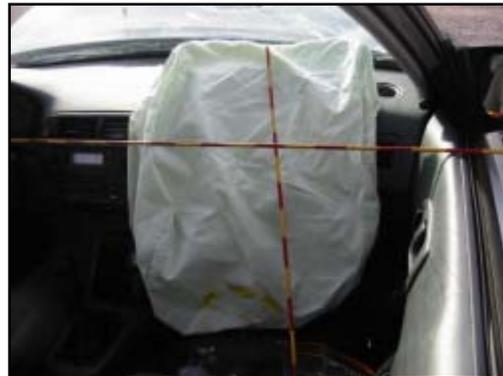
The front right air bag was a top mount design in the front right instrument panel (**Figure 8**). The air bag membrane measured 50.0 cm (19.7") in width and 60.0 cm (23.6") in height in its deflated state. The air bag was not tethered and was vented by two vent ports at the 10 and 2 o'clock positions on the side panels the air bag. The front right air bag consisted of two symmetrical cover flaps that measured 23.0 cm (9.0") in width and 5.0 cm (2.0") in height. No damage or failures were noted to the frontal air bags.

Figure 8. Deployed front right air bag.

The loading of the shoulder belt restricted the movement of her torso, which allowed her to continue to flex forward over the shoulder belt. As a result of the head flexion, the passenger's face moved into the path of the deploying front right air bag, which resulted in the left upper and lower lip laceration 2.0 cm (0.8"). The expanding non-tethered air bag displaced the passenger's eyeglasses, which resulted in the 2.5 cm (1.0") left eyebrow laceration. The continued expansion of the air bag against her head/face resulted in the bilateral subarachnoid hemorrhages. The air bag induced a rearward motion (hyperextension) of her head, thus resulting in the fracture of C1.
