Side Air Bag Investigation / Vehicle to Vehicle
Dynamic Science, Inc. / Case Number: 2004-074-059F
2000 Chevrolet Impala
Nebraska
March, 2004

1. Report No. 2004-074-059F	2. Government Accession No.		3. Recipient Catalog No.	
4. Title and Subtitle Side Air Bag Investigation		5. Report Date June 28, 2004

Dynamic Science, Inc.
Crash Investigation
Case Number: 2004-074-059F

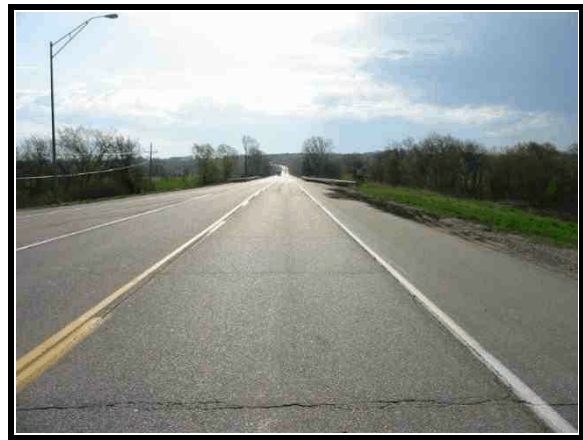
Figure 1. Approach to area of impact (west)

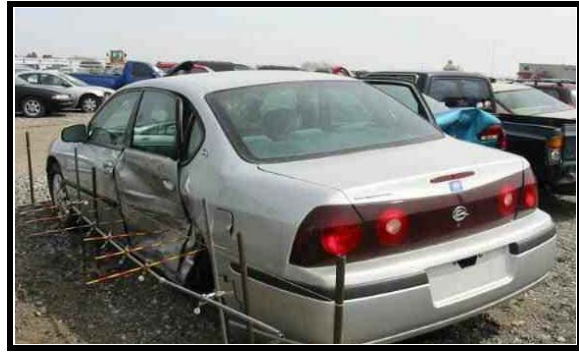
Figure 2. Left side, oblique view, Chevrolet Impala (case vehicle)

The side impact with the Chevrolet Beretta resulted in moderate damage to the left door and left rear quadrant of the Impala. The direct damage began 147.0 cm (57.8 in) forward of the left rear axle and extended 197.0 cm (77.5 in) rearward along the left side. Six crush measurements were documented at the mid door level: C1=1.0 (0.4 in), C2=13.0 cm (5.1 in), C3=18.0 cm (7.0 in), C4=15.0 cm (5.9 in), C5=8.0 cm (3.1 in), C6=2.0 cm (0.8 in). The maximum crush was located at C3 and measured 18.0 cm (7.0 in). The left axle was deformed rearward 9.0 cm (3.5 in).

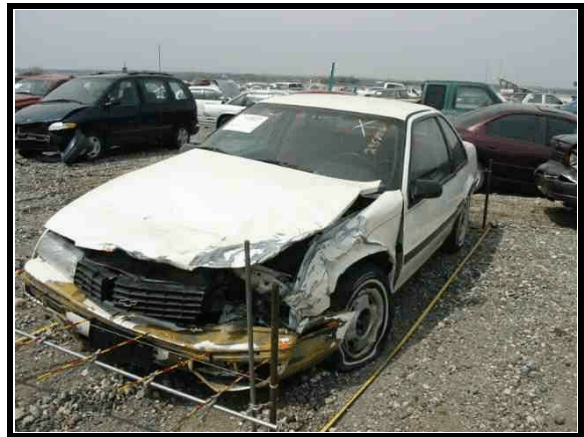
Figure 3. Front left, Chevrolet Beretta (other vehicle)

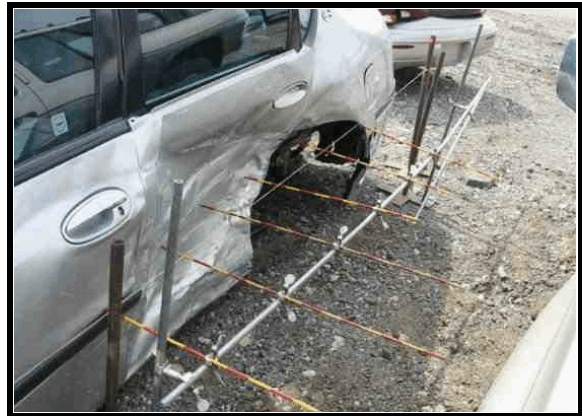
Figure 4. Close up of left side damage to Impala

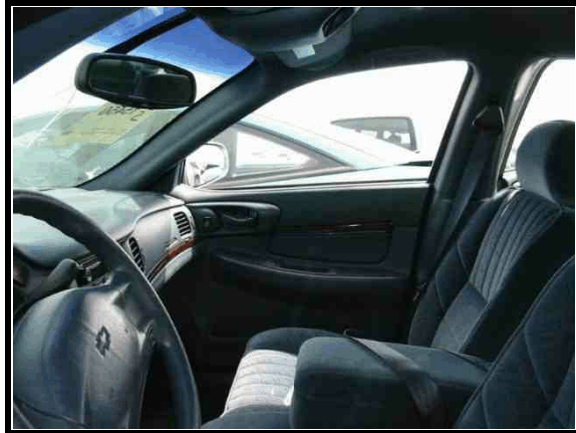
This 2000 Chevrolet Impala was equipped with an advanced occupant protection system. The system consists of the Sensing Diagnostic Module (SDM), a driver's front air bag, a front right passenger air bag, seat belt pretensioners for both front seats, driver's seat belt latch usage detector, and seat back mounted side air bags for the two front outboard seats. The driver's air bag module was mounted in a typical mode within the two-spoke steering wheel rim. The front right passenger's air bag module was a mid mount configuration within the upper right instrument panel. The system is controlled by the SDM. The SDM is located beneath the driver's seat.

Figure 5. Non deployed front air bags in case vehicle

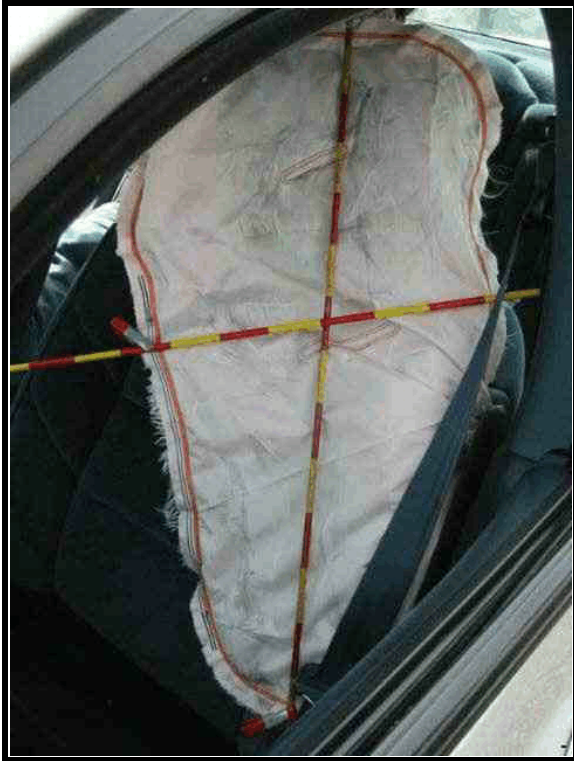
As a result of the impact with the Chevrolet Beretta, the driver's seat back mounted air bag deployed. The side air bag measured 69.0 cm (27.2 in) high by 42.0 cm (16.5 in) wide at the top and 22.0 cm (8.7 in) wide at the bottom. There was one tether and the air bag was internally vented. There were no indications of damage or contact to the air bag.

Figure 6. Driver's seat back mounted side air bag, exterior view

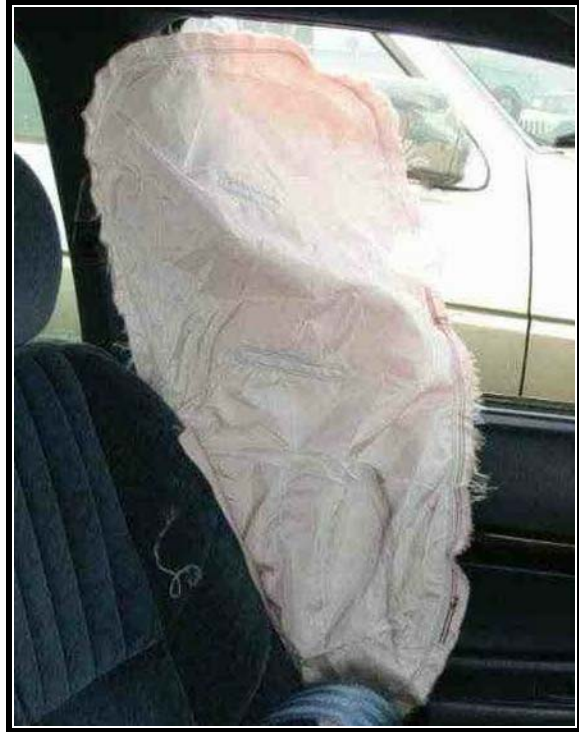
Figure 7. Driver's seat back mounted side air bag, interior view

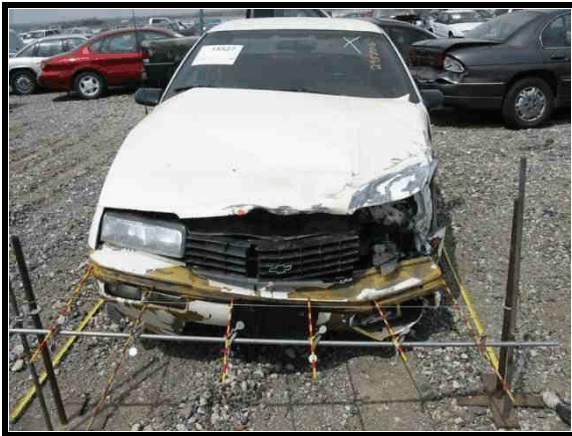
Description:	1990 Chevrolet Beretta two-door coupe	
VIN:	1G1LV14G6LExxxxxx	
Odometer:	259,055 km (160,974 miles)	
Engine:	2.2 L, 4 cylinder	
Reported Defects:	None	
Cargo:	None, per vehicle inspection	
Damage Description:	Moderate front end damage. Left front tire restricted. Vehicle towed from the scene due to damage.	
CDC:	12FYEW1	
Delta V:	Total	20.0 km/h (12.4 mph)
	Longitudinal	-20.0 km/h (-12.4 mph)
	Latitudinal	4.0 km/h (2.5 mph)
	Energy	26,974 joules (19,895 ft lbs)

Figure 8. Front, Chevrolet Beretta (other vehicle)

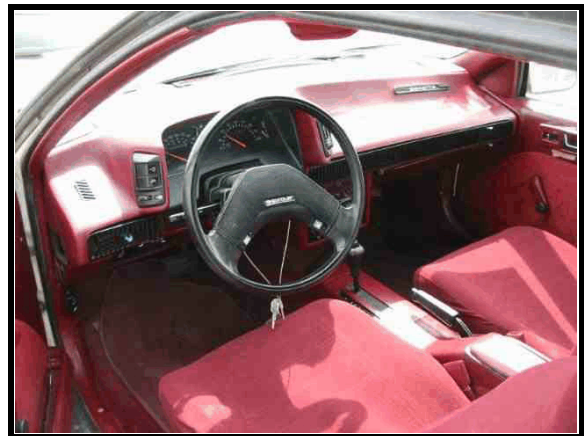
Figure 9. Interior, Chevrolet Beretta (other vehicle)

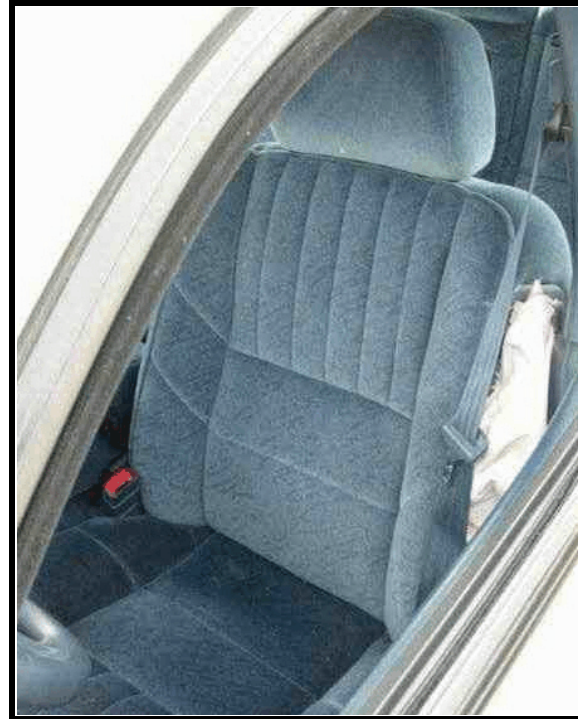
Prior to impact, the Chevrolet Impala was in a moderate clockwise yaw. This motion would have shifted the driver to left—possibly pressing against the door side panel. Both hands were on the steering wheel and actively turning to the right. At impact, the driver's seat mounted side air bag deployed—striking and causing the contusion and abrasion to the left upper arm. The driver's left leg pitched to the left and engaged the lower kick panel—causing a left ankle abrasion.

Figure 10. Driver's seated position. Side air bag visible.

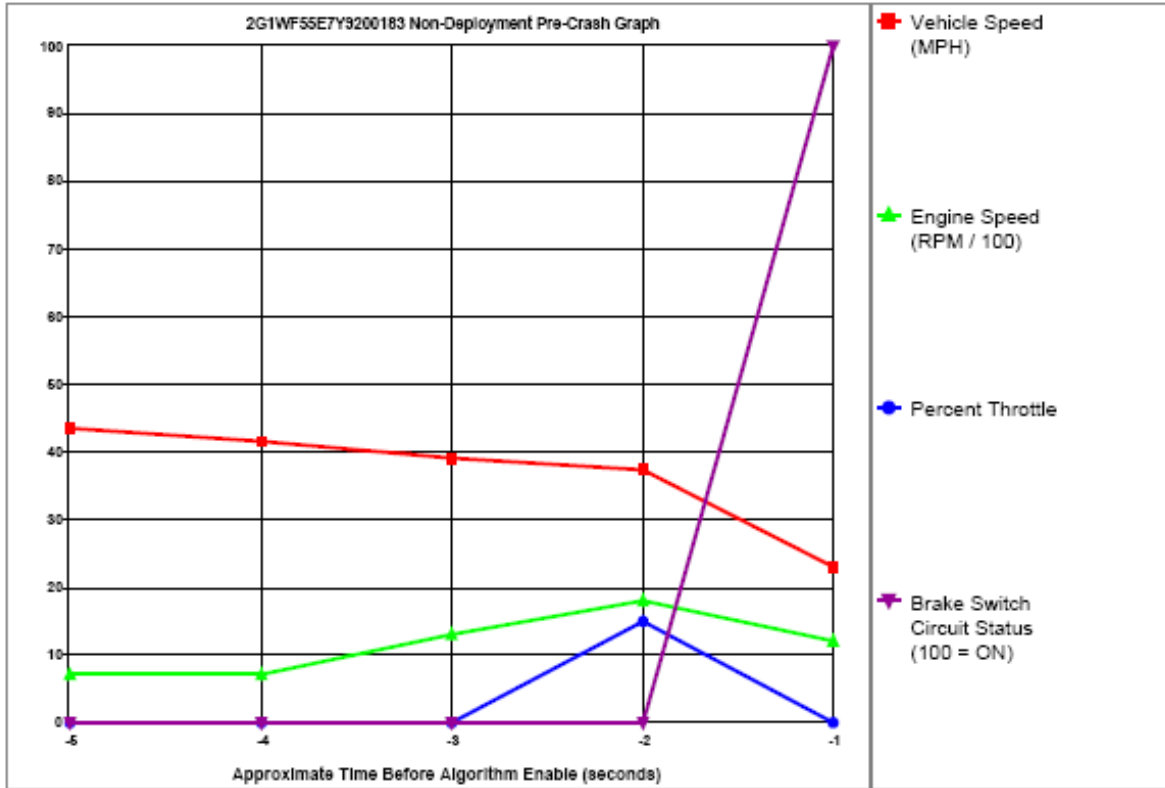
Seconds Before AE	Vehicle Speed (MPH)	Engine Speed (RPM)	Percent Throttle	Brake Switch Circuit Status
-5	44	704	0	OFF
-4	42	704	0	OFF
-3	39	1280	0	OFF
-2	37	1792	15	OFF
-1	23	1152	0	ON
