Advanced Occupant Protection System (AOPS) Investigation / Vehicle to Object
Dynamic Science, Inc. / Case Number: 2005-79-139B
2000 Honda Accord
California
November, 2005

1. Report No. 2005-79-139B	2. Government Accession No.	3. Recipient Catalog No.	
4. Title and Subtitle Advanced Occupant Protection System (AOPS) Investigation		5. Report Date April 28, 2006

This Remote/Combination Investigation focused on the Advanced Occupant Protection Investigation System (AOPS) that was present in a 2000 Honda Accord. (**Figure 1**). The AOPS consisted of dual-stage frontal air bags. This single vehicle crash occurred in November 2005 at 1220 hours. The subject vehicle was being driven by a 74-year-old female. The driver was wearing the manual 3-point lap and shoulder belt. The crash occurred in the southwest corner of a three leg intersection. The speed limit was 56 km/h (35 mph). The Honda was traveling southbound in the first lane from the right. The driver failed to negotiate the right hand curve and the vehicle went to the right. As the vehicle approached the concrete curb at the southwest corner of the intersection, the driver began braking. The Honda struck the curb and mounted it. T

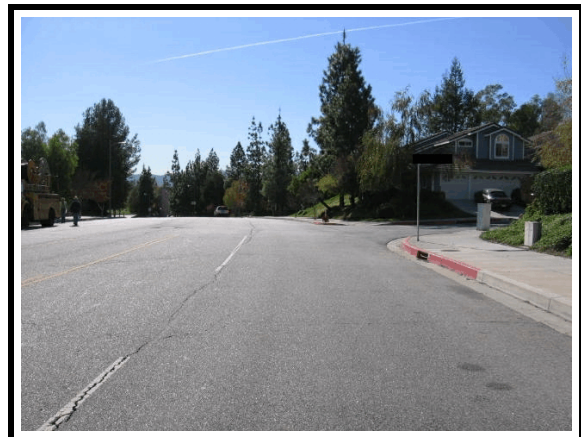
Figure 2. Approach to area of impact, south

The crash occurred in the southwest corner of a three leg intersection (**Figure 2**). The southern leg of the intersection is comprised of two southbound travel lanes, a two way turn lane, and two northbound travel lanes. The intersecting eastbound roadway was private. There was a 1.5% downhill grade for southbound travel. There were no adverse driving conditions and the roadway was dry. The speed limit was 56 km/h (35 mph).

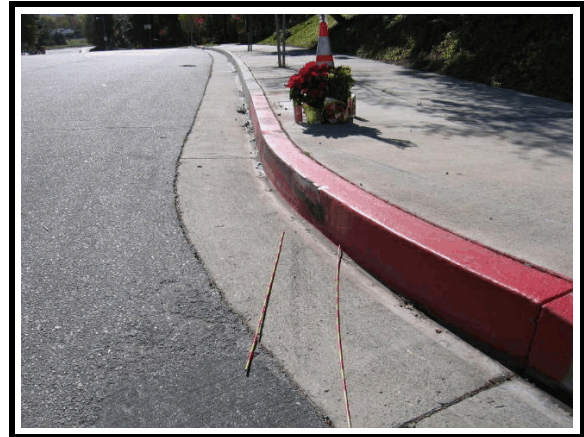
Figure 3. Area of impact with pole, pre-impact skidmarks

The driver failed to negotiate the right hand curve and the vehicle went to the right. As the Honda approached the concrete curb at the southwest corner of the intersection, the driver began braking and deposited a 4.3 m (14.0 ft) left wheel skid. The Honda struck the curb and mounted it (**Figure 3**). The Honda continued in a southerly direction and struck a metal light pole with its front end. The pole was sheared off at its base. The barrier routine of the WinSmash program computed a delta V of 31 km/h (19.3 mph), based on the Honda's front crush profile. This collision is beyond the WinSmash program due to the yielding object; the barrier equivalent speed is for reference only. The driver's air bag deployed at this time. The Honda came to rest off road, facing south.

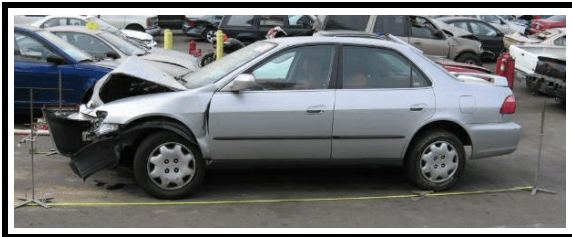
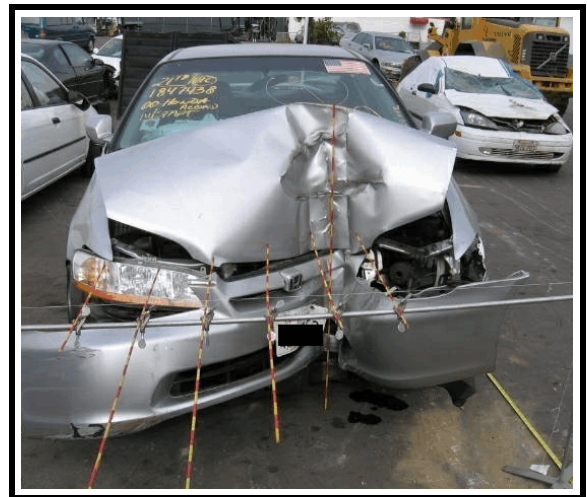
Damage Description: The 2000 Honda Accord sustained moderate front end damage as a result of the impact with the pole (**Figures 4-5**). The direct damage began 80 cm (31.4 in) left of the right front bumper corner and extended 40 cm (15.7 in) along the front plane. The combined direct and induced damage included the entire front end. The left front tire was restricted.

CDC: 12FYEN3

Six crush measurements were documented at the bumper level as follows: C1 = 3 cm (1.1 in), C2 = 45 cm (17.7 in), C3 = 31 cm (12.2 in), C4 = 18 cm (7.0 in), C5 = 5 cm (1.9 in), C6 = 0 cm.

Figure 4. 2000 Honda Accord, left side

Figure 5. 2000 Honda Accord, front end damage

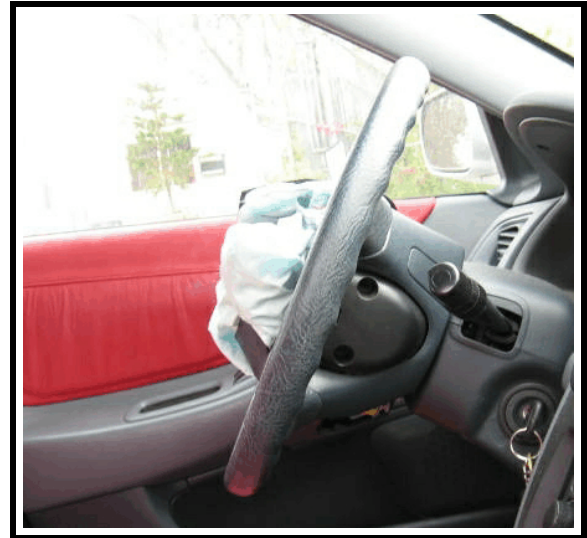
Figure 6. Deformed steering wheel rim

The Honda sustained moderate interior damage as a result of passenger compartment intrusion and occupant contacts. The left instrument panel and left floor pan sustained longitudinal intrusion. The top of the steering wheel was slightly deformed forward (**Figure 6**). The left knee bolster was deformed from occupant contact (**Figure 7**).

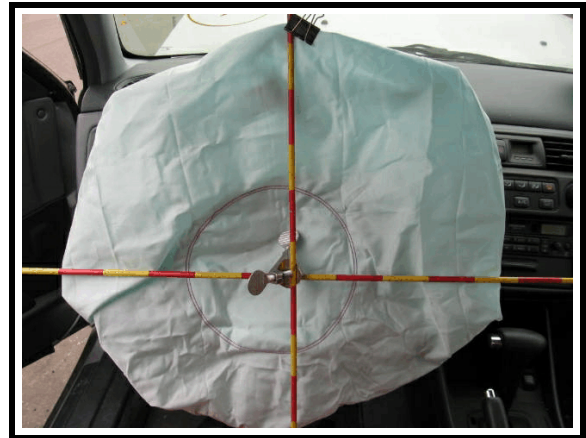
Figure 8. Deployed driver's air bag

The driver's air bag deployed from the center of the steering wheel hub through H-configuration module cover flaps (**Figure 8**). The deployed driver's air bag measured 55 cm (21.6 in) in its deflated state. The air bag was circular in shape and was equipped with two internal tethers and two vent ports. Neither the air bag nor the cover flaps were damaged. There was a scuff located in the center of the deployed air bag that may have been due to occupant contact.

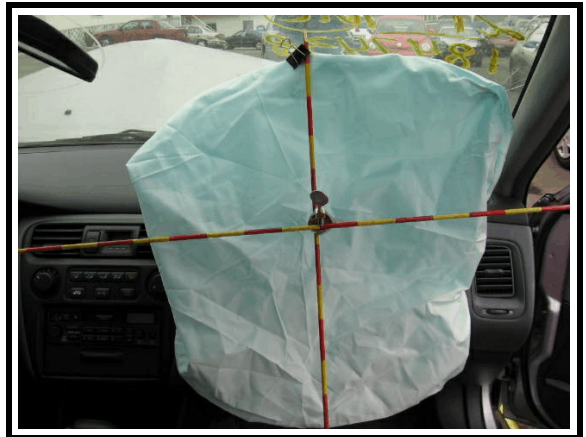
Figure 9. Deployed front right passenger's air bag

The front right passenger air bag deployed from a top-mounted module (**Figure 9**). The air bag was rectangular in shape and was equipped with two internal tethers. The air bag had no vent ports. There was no damage or occupant contact noted to either the module cover or the deployed passenger air bag.
