Child Safety Seat Investigation / Vehicle to Vehicle
Dynamic Science, Inc. / Case Number: DS05012
2002 Honda Civic
California
July 2005

Dynamic Science, Inc.
Crash Investigation
Case Number: DS05012

TABLE OF CONTENTS

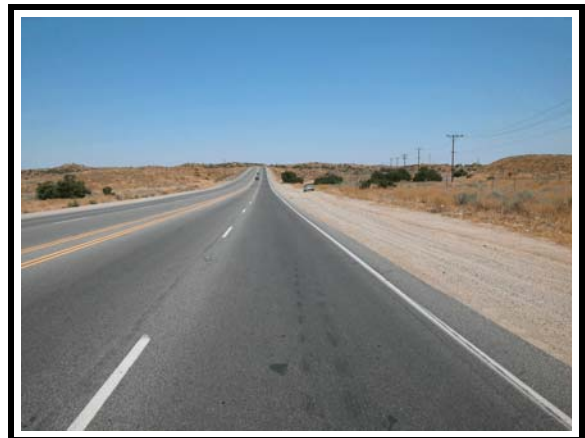
Figure 2. Overview of vehicle approach (north)

This crash occurred in an unincorporated area of southern California. The surrounding area is rural. The crash occurred on a four lane, undivided east/west asphalt roadway. There are two traffic lanes for eastbound traffic, separated by broken white lines. There are two lanes for westbound traffic, separated by broken white lines. The eastbound and westbound lanes are separated by a solid double yellow lines. The roadway was straight and had a positive grade for eastbound travel. The posted speed limit is 97 km/h (60 mph). The weather was clear, the temperature 51 degrees C (91 degrees F), and there was a light wind coming from the southwest. Sunset occurred

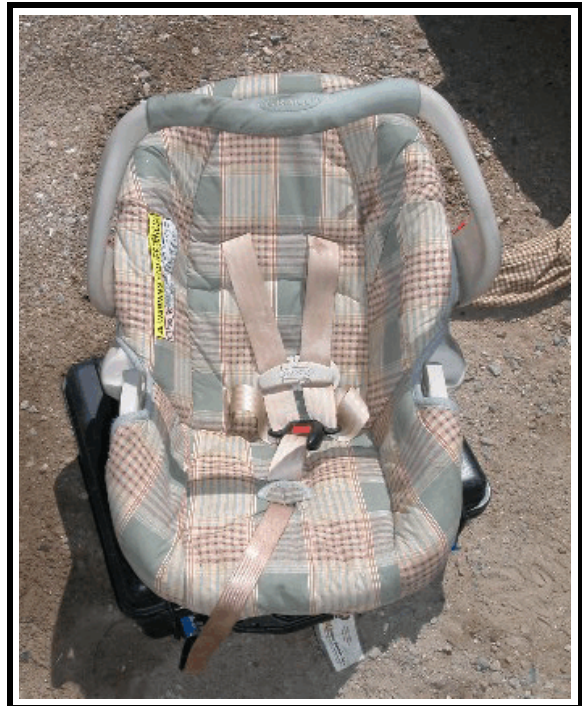
Figure 4. Graco SnugRide Infant Safety Set

A Graco SnugRide infant safety seat was positioned in the rear right of the Honda Accord. The model number was 7425 CLE and the date of manufacture was October 6, 2004. The seat was designed to be in the rear-facing position and was equipped with a 5-point internal harness. The seat can be used with or without the stay-in-vehicle base. The base was not being used at the time of the crash. The seat handle was in the up position at the time of inspection. A locking clip was available but was not used. The seat was anchored to the vehicle using the 3-point lap and shoulder belt. The seat belt has a switchable retractor, but the retracting mode is not known.

There was blood found on the left portion of the handle, on the left harness, on the left seat back above the left harness slot, and on the left side of the seat. There was a loading/flexion mark on the left side of the seat (right side if facing toward front of vehicle) at the top harness slot level. There were black smudges along the top of the carrying handle.

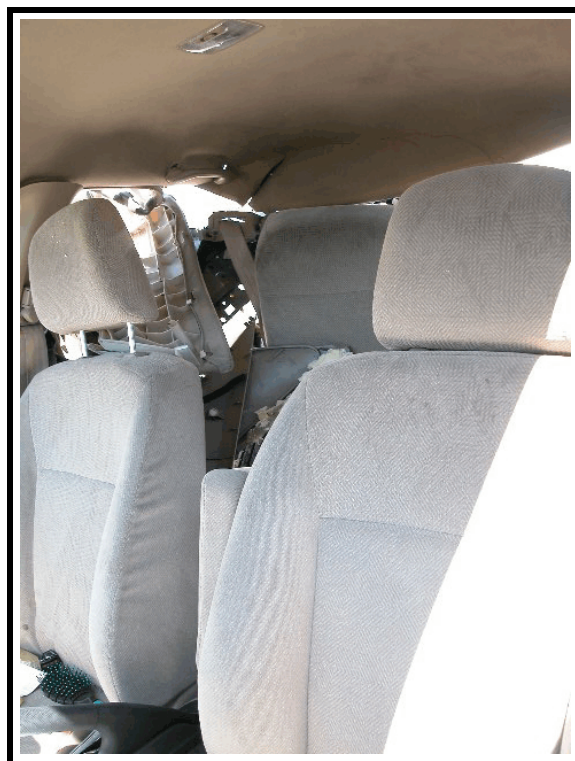
Figure 6. Driver's seat back

The 22-year-old male driver was seated in an upright posture and restrained by the 3-point manual lap and shoulder belt. The seat track was adjusted to the mid position. At impact, the driver initiated a rearward trajectory and loaded the driver's seat back. He rebounded forward and came to rest in his initial seat position. He was able to exit the vehicle under his own power. There were no reported injuries.

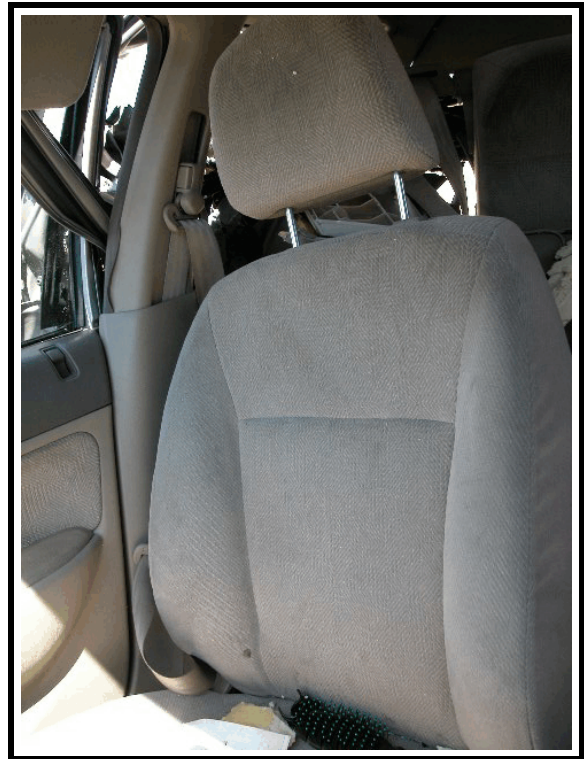
Figure 7. Front right seat back

The 21-year-old female front right occupant was seated in an upright posture and restrained by the 3-point manual lap and shoulder belt. The seat track was adjusted to between the mid and rear most track position. At impact, the front right occupant initiated a rearward trajectory and loaded the front right seat back. She rebounded forward and came to rest in his initial seat position. She was able to exit the vehicle under her own power. There were no reported injuries.

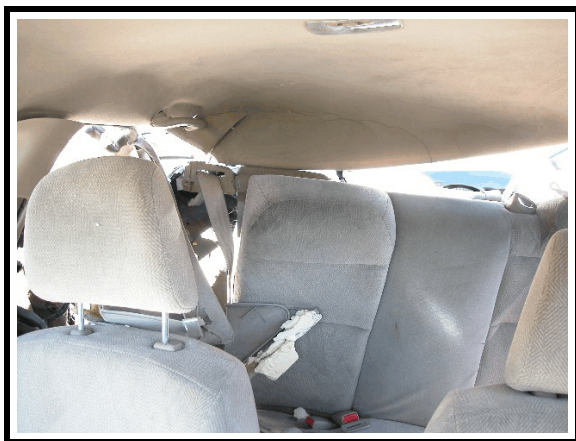
Figure 8. Second row right seat position

The 2002 Honda Civic sustained heavy damage as a result of passenger compartment intrusion. The bottom hinge for the second row right seat separated from its attachment. The rear seat and right C pillar sustained longitudinal intrusion. The movement of door and the tearing of the sheet metal essentially formed a hole in the right side that measured 46.0 cm (18.1 in) by 38.0 cm (14.9 in).

Position	Intruded Component	Magnitude of Intrusion	Direction
Second row left	Seat back	10.0 cm (3.9 in)	Longitudinal
Second row middle	Seat back	24.0 cm (9.5 in)	Longitudinal
Second row right	Seat back	43.0 cm (16.9 in)	Longitudinal
Second row right	C pillar	Unknown	Longitudinal

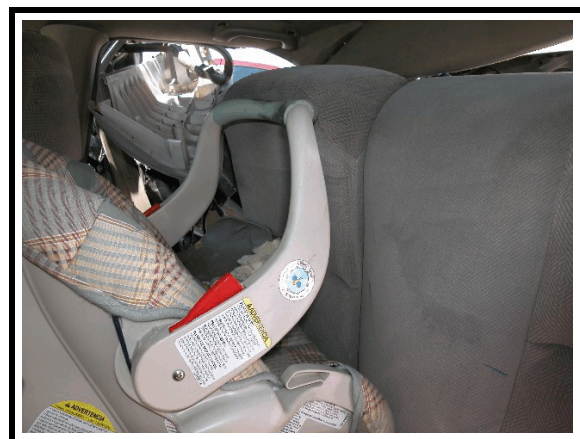
Figure 9. Child safety seat in second row right seat position

The 7-month-old female child was restrained in the rear-facing infant safety seat by the five-point harness. The seat was installed in the rear right position of the Honda Civic with the vehicle's 3-point safety belt. It appears more likely than not that the carrying handle was in the up position at the time of the crash. There were black smudges found on both the handle and on the right rear seat back. At impact, the child and child seat initiated a rearward trajectory. The intruding rear seat back forced the infant seat forward. The child appears to have struck the handle at the eyebrow level, causing the skull fractures and facial abrasions. The back of the infant seat was pressed against the back of the front right seat. The plastic seat back on the right side of the infant seat was deformed rearward. Portions of the plastic fascia on the right side of the vehicle interior were fractured by the intrusion. The child occupant died of head injuries.
