Child Safety Seat Fatality Investigation / Vehicle to Vehicle
Dynamic Science, Inc. / Case Number: DS05013
2002 Ford Expedition
1993 Dodge Caravan
Nevada
August 2005

Dynamic Science, Inc.
Crash Investigation
Case Number: DS05013

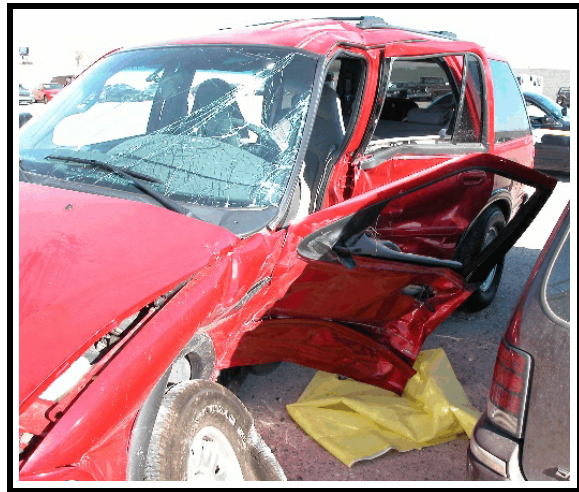
Figure 1. Left side, 2002 Ford Expedition

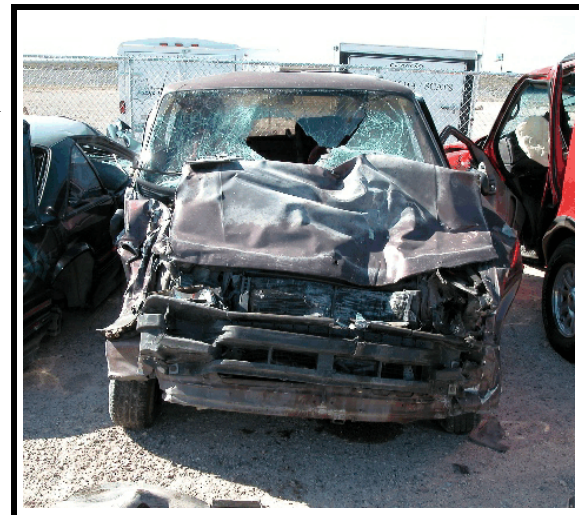
Figure 2. Front, 1993 Dodge Caravan

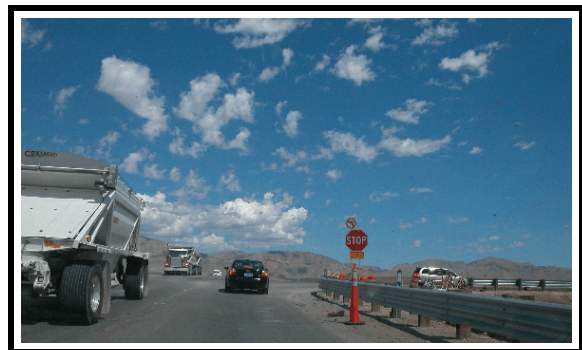
Figure 3. Approach for Ford Expedition (north)

There is an uphill grade and the road surface is asphalt. The speed limit for this leg of the intersection is 56 km/h (35 mph). The northbound approach is controlled by a stop sign. There is also a “Traffic from Left Does Not Stop” warning sign. The westbound leg of the intersection is comprised of a left turn lane, two eastbound travel lanes, and a right hand turn lane. The roadway is curved to the left. There is an uphill grade and the road surface is asphalt. The speed limit for the interstate off-ramp was 89 km/h (55 mph).

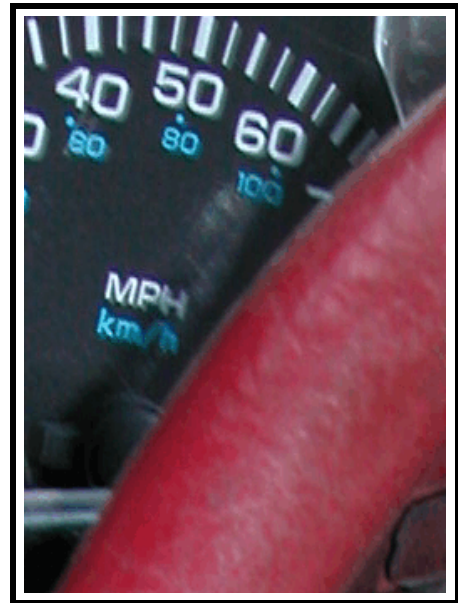
Figure 4. Speedometer needle “slap” marking

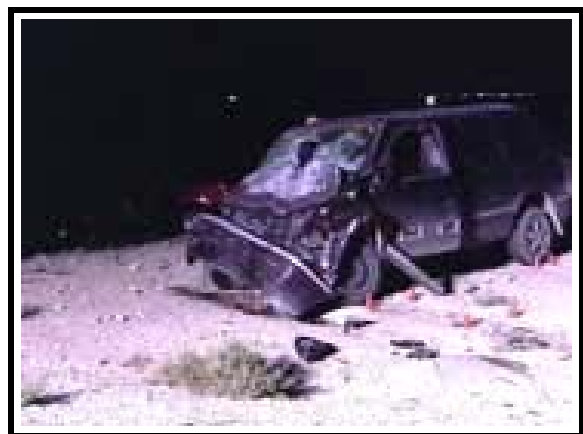
Figure 5. Front, Dodge Caravan

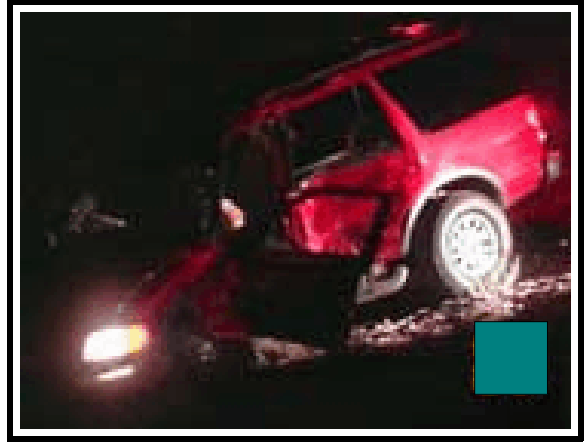
Figure 6. Left side, Ford Expedition

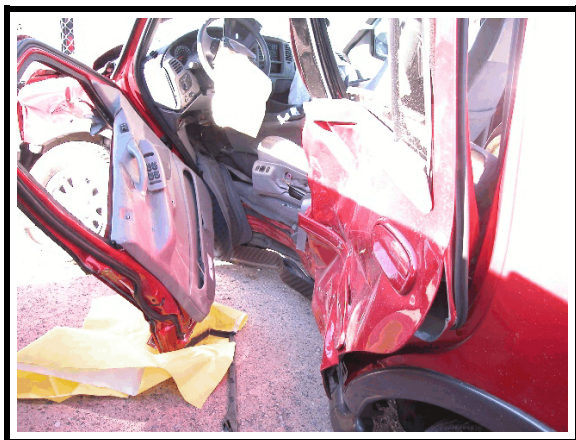
The 2002 Ford Expedition sustained major left side damage as a result of the first impact with the Dodge Caravan. The direct damage began at the left front tire and extended 222.0 cm (87.4 in) rearward along the left side plane. The combined direct and induced damage began 50.0 cm (19.7 in) forward of the front axle and extended 280.0 cm (110.2 in) rearward along the left side plane. The maximum lateral crush was located at C3 and measured 60.0 cm (23.6 in) at the sill level. Both left side doors were deformed and initially jammed shut. The driver's door was pried open by emergency personnel. The wheelbase on the left side was shortened by 26.0 cm (10.2 in). Six crush measurements were documented at the sill level as follows: C1= 0.0 cm (0.0 in), C2= 28.0 cm (11.0 in), C3= 60.0 cm (23.6 in), C4= 55.0 cm (21.6 in), C5= 20.0 cm (7.9 in), C6= 3.0 cm (1.2 in). There was a second, side-slap type impact between the left corner of the Expedition and the right rear door area of the Caravan. The direct damage began at the left rear bumper corner and extended 18.0 cm (7.0 in) forward along the left side.

CDC:	Impact 1: 09LPAW3	
	Impact 2: 09LBEE1	
Delta V (Impact 1):	Total	28.8 km/h (17.9 mph)
	Longitudinal	-5.0 km/h (-3.1 mph)
	Latitudinal	28.4 km/h (17.6 mph)
	Energy	98,358 joules (72,677 ft lbs)

Figure 7. Ford Expedition, left side impact

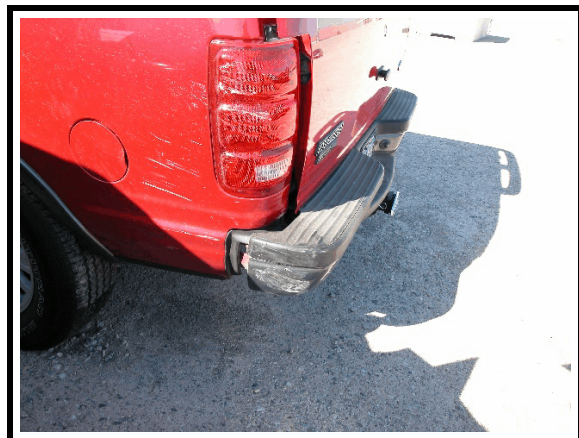
Figure 8. Ford Expedition, second impact

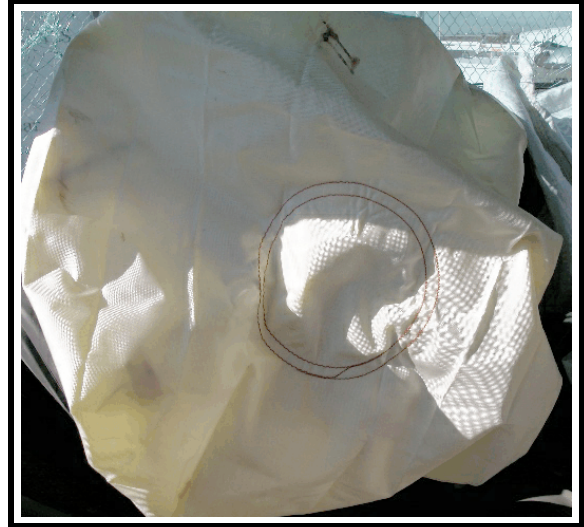
The driver's air bag deployed from the center of the steering wheel hub through H-configuration module cover flaps. The top flap measured 13.0 cm (5.1 in) in height and 18.0 cm (7.0 in) in width. The bottom flap measured 4.0 cm (1.6 in) in height and 18.0 cm (7.0 in) in width. The deployed driver's air bag measured 59.0 cm (23.2 in) in diameter in its deflated state. The air bag was tethered by a single internal strap. Two circular vent ports were located at the 11 and 1 o'clock aspects on the rear of the air bag. There were no contacts or damage to the air bag or module cover.

Figure 9. Deployed driver's air bag

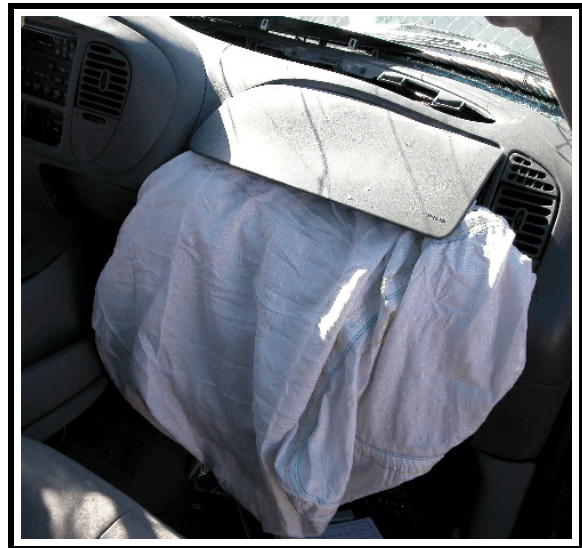
The front right passenger's air bag deployed from a mid-mount module with a rectangular cover flap that was hinged at the forward aspect. The module cover flap measured 35.0 cm (13.8 in) along the top, 16.0 cm (6.3 in) in width, and 38.0 cm (15.0 in) along the bottom. The deployed front right passenger's air bag measured 52.0 cm (20.5 in) laterally from seam to seam. There were no vent ports or tethers. There were no contacts or damage to the air bag or module cover.

Figure 10. Deployed front right passenger's air bag

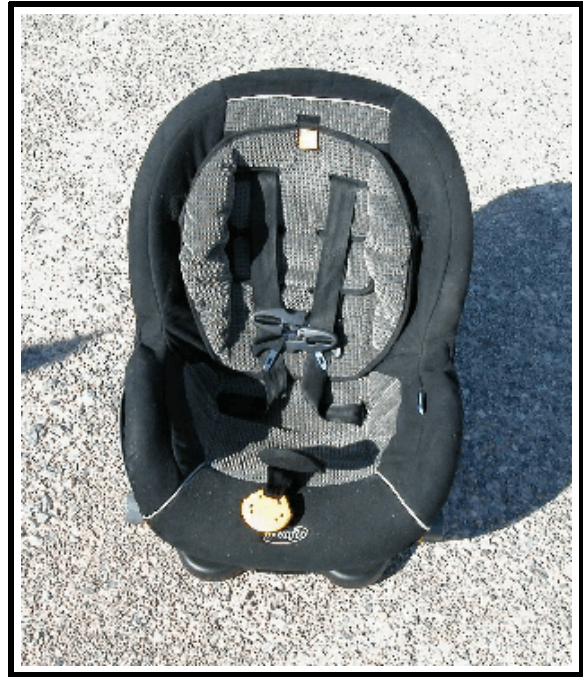
Both child safety seats had been installed in a forward facing fashion. Both seats were anchored to the vehicle using the manual 3-point lap and shoulder belts in their respective seating positions. The seat belts at these locations were configured with sliding latch plates and switchable ELR/Automatic Locking Retractors (ALR). It is not known if the belts had been switched at the time of the crash.

There were no indications of damage or loading to either child safety seat.

Figure 11. Evenflo Triumph 5 CSS (second row, left)

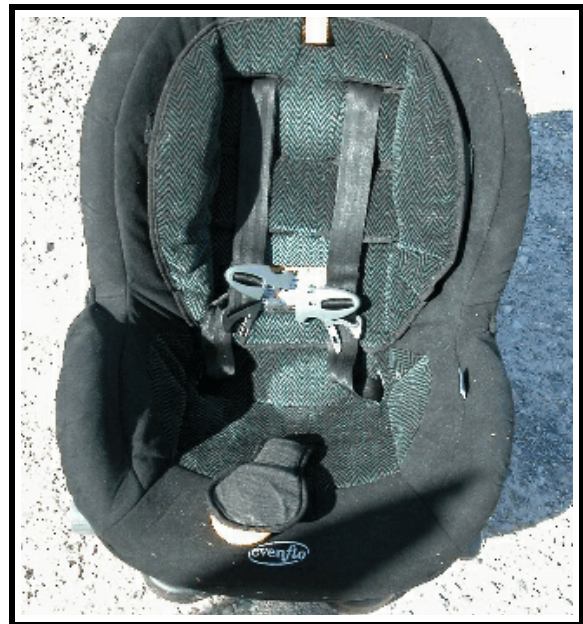
Figure 12. Evenflo Triumph 5 CSS (second row, right)

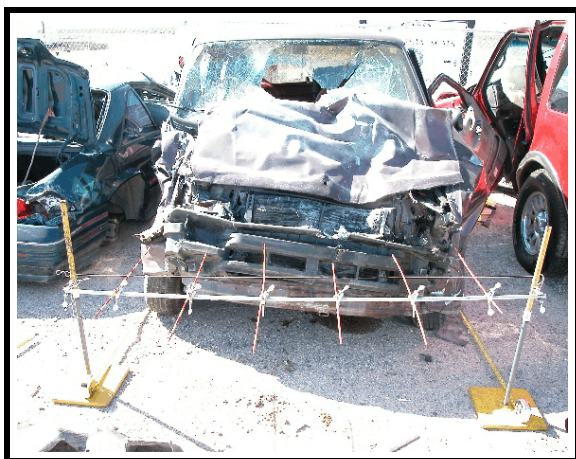
The 1993 Dodge Caravan sustained major front end damage as a result of the first impact with the Ford Expedition. The direct damage began at the front right bumper corner and extended across the entire front end. Six crush measurements were documented at the bumper level as follows: C1 = 35.0 cm (13.8 in), C2 = 26.0 cm (10.2 in), C3 = 28.0 cm (11.0 in), C4 = 29.0 cm (11.4 in), C5 = 28.0 cm (11.0 in), C6 = 36.0 cm (14.2 in). The right side wheelbase was shortened by 8.0 cm (3.1 in). The left side wheelbase was shortened by 12.0 cm (4.7 in). There was a second, side-slap type impact between the right rear door of the Caravan and the left bumper corner of the Expedition. The direct damage began 87.0 cm (34.3 in) forward of the rear axle and extended 33.0 cm (13.0 in) forward along the right side.

Figure 13. 1993 Dodge Caravan, front impact

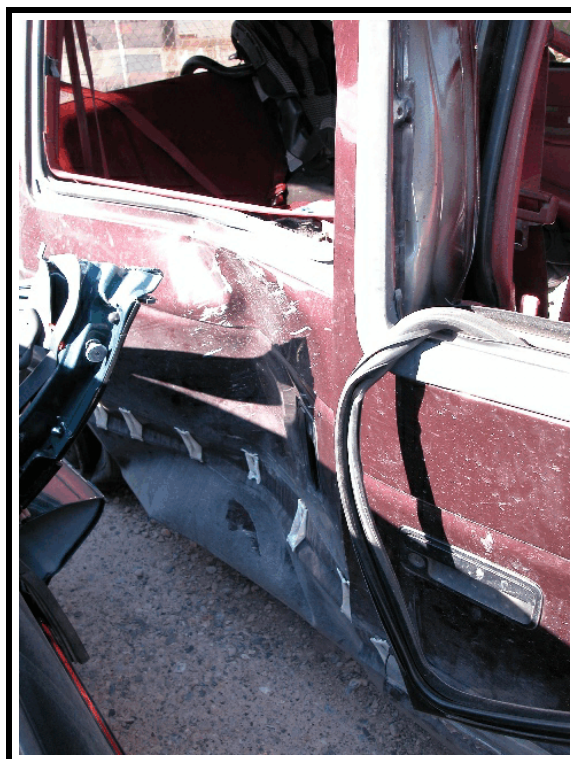
Figure 14. Dodge Caravan, secondary impact

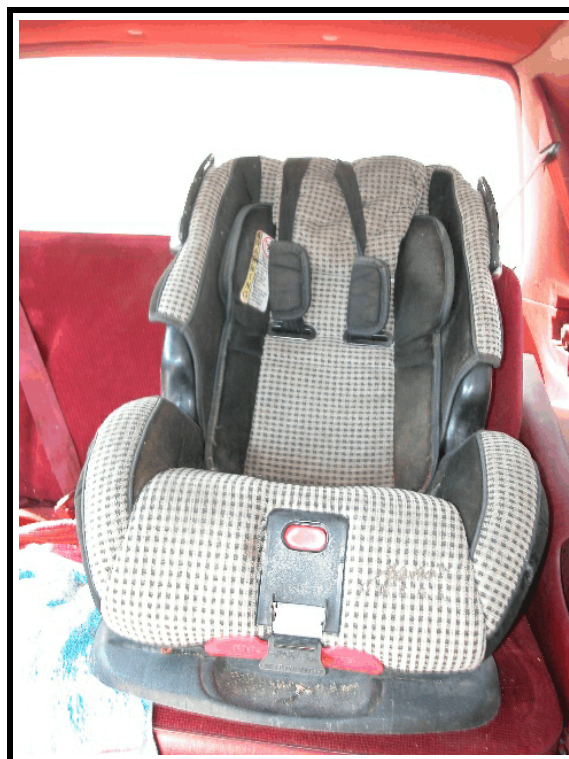
The 3-year-11-month old female third row left occupant was seated in a Cosco Alpha Omega convertible child safety seat. The child seat model number was 02-332. The seat was configured with a tray shield. The manufacturer recommends that the child safety seat only be used for children weighing between 2.3-18.1 kg (5.0-40.0 lbs) and whose height is between 7.5-15.7 cm (19.0-40.0 in). The seat is intended to be used in the rear facing mode for children weighing less than 10.0 kg (22.0 lbs). The seat was installed in the forward facing mode. The internal harness was routed through the single set of harness slots. The 3-year-old child using this seat met the recommendations for weight but exceeded the maximum height by 5.0 cm (2.0 in).

Figure 15. Cosco Alpha Omega convertible child safety seat (used by 3-year-11-month old child in third row left seat)

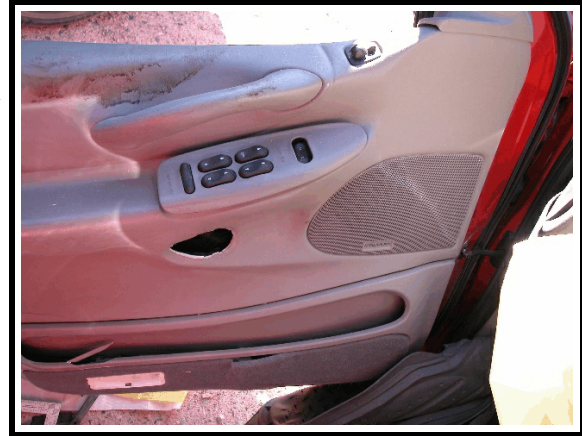
The 37-year-old male driver was seated in an upright posture and restrained by the 3-point manual lap and shoulder belt. The seat track was in the middle position. At the time of the vehicle inspection, the seat back was found at a 63 degree angle and the seat bottom at a 6 degree angle. At impact, the frontal air bags deployed and the safety belt pretensioners actuated. The male driver initiated a lateral and slightly forward trajectory. The left door intruded into the passenger compartment. The driver contacted the door with his left side. He sustained a left-sided diaphragm rupture, a left lung laceration, as well as left-sided pneumothorax. He required extrication from the vehicle. He was then transported to a local hospital and arrived with a Glasgow Coma Scale (GCS) score of 15. He was admitted to the ICU postoperatively for further observation. The following day he developed ventricular tachycardia. He remained in the hospital for a total of nine days.

Figure 16. Contact/puncture to driver's door panel

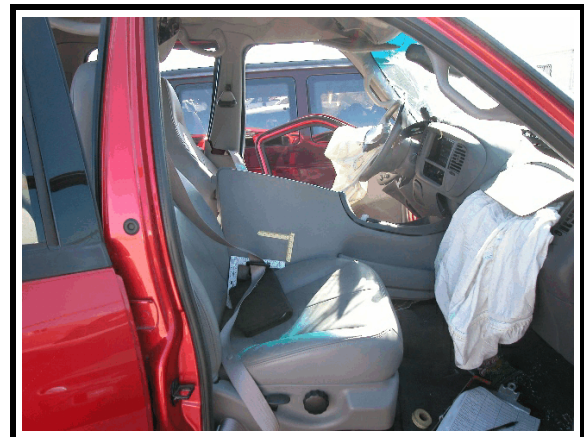
The 36-year-old female front right seat occupant was seated in an upright posture and restrained by the 3-point lap and shoulder belt. At the time of the vehicle inspection, the seat back was found at a 68 degree angle and the seat bottom at a 16 degree angle. At impact, the frontal air bags deployed and the safety belt pretensioners actuated. This occupant initiated a lateral and slightly forward trajectory. Her left side heavily engaged the center console—shifting it to the left. This contact caused an abrasion to the left triceps and the movement likely caused a cervical strain and a fracture to the front right incisor tooth. This occupant also complained of pain to her head and chest. She was able to exit the vehicle on her own and did not report any loss of consciousness. She was transported by ground ambulance to a local trauma center. A CT scan later ruled out any mediastinal injury or pneumothorax with the complaint of chest pain. She was released later in the evening.

Figure 17. Contact to center console

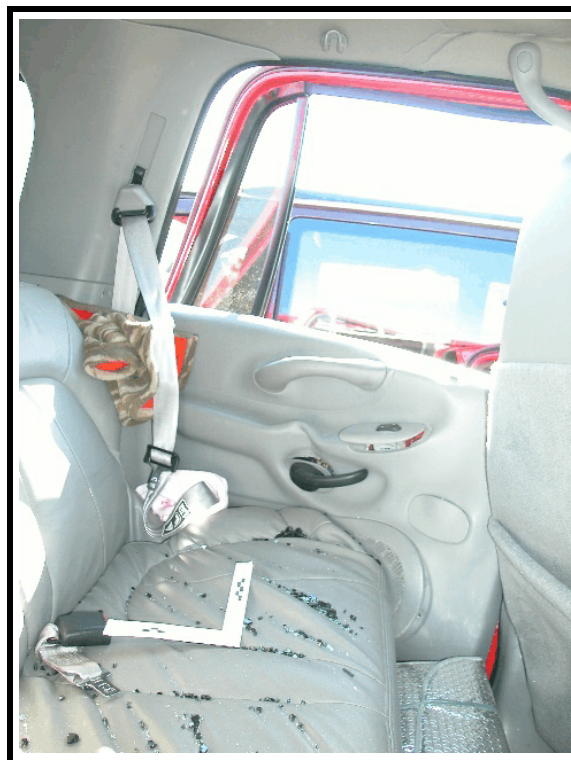
The 21-month-old male child was restrained in a forward facing convertible child safety seat by the 5-point harness. The child seat was anchored in the second row left seat position with the 3-point manual lap and shoulder belt. The leather covered split bench seat with a folding back had a seat back angle of 63 degrees and a seat bottom angle of 11 degrees. At impact, the child and child seat initiated a lateral and slightly forward trajectories to the left. The child seat engaged and cracked the door side panel. The child likely engaged the left interior of the child seat shell, but there were no resultant injuries. He sustained several small abrasions to his right arm due to glass fragments. He was transported by ground ambulance to a local trauma center. He was examined and observed for one hour before being released.

Figure 18. Second row, left seating area

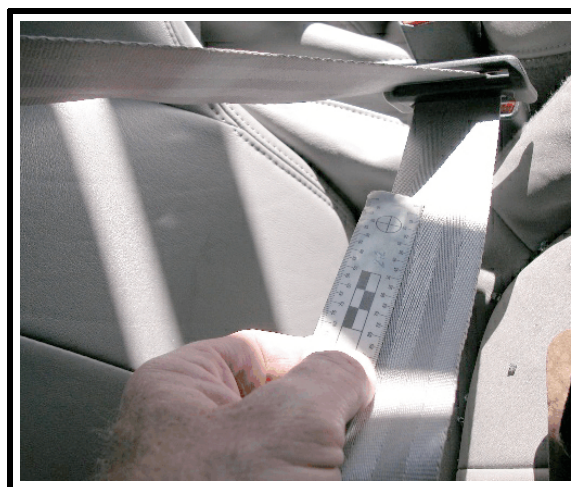
The 21-month-old female child was restrained in a forward facing convertible child safety seat by the 5-point harness. The child seat was anchored in the second row right seat position with the 3-point manual lap and shoulder belt. The leather covered split bench seat with a folding back had a seat back angle of 71 degrees and a seat bottom angle of 11 degrees. At impact, the child and child seat initiated a lateral and slightly forward trajectories to the left. The webbing on the lap portion of the lap and shoulder belt exhibited signs of loading. The child likely contacted the left interior shell of the child seat, but there were no resultant injuries. There were no indications of any injuries. The child's mother wanted to have the child checked. The child was transported by ground ambulance to a local trauma center. She was examined and observed for one hour before being released.

Figure 19. Loading to second row right seat belt webbing

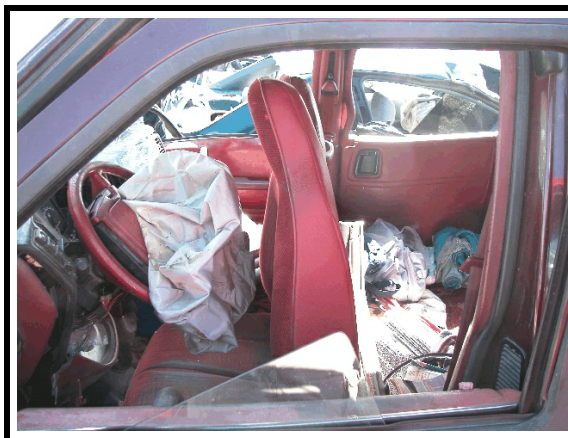
The 43-year-old male driver of the Dodge Caravan was seated in a forward facing fashion. He was wearing the manual 3-point lap and shoulder belt. At impact, the frontal air bag deployed. The male driver initiated a forward trajectory. He loaded the safety belt and both knees engaged the lower instrument panel/knee bolster. The seat back was deformed forward by impact forces and possibly some unknown object. During the second impact there would have been some small amount of lateral motion to the right. The driver sustained “moderate” injuries according to the police report. He was transported to a local trauma center for treatment. The extent of his injuries are not known. The medical facility could not locate any records for this person.

Figure 20. Driver's seated position

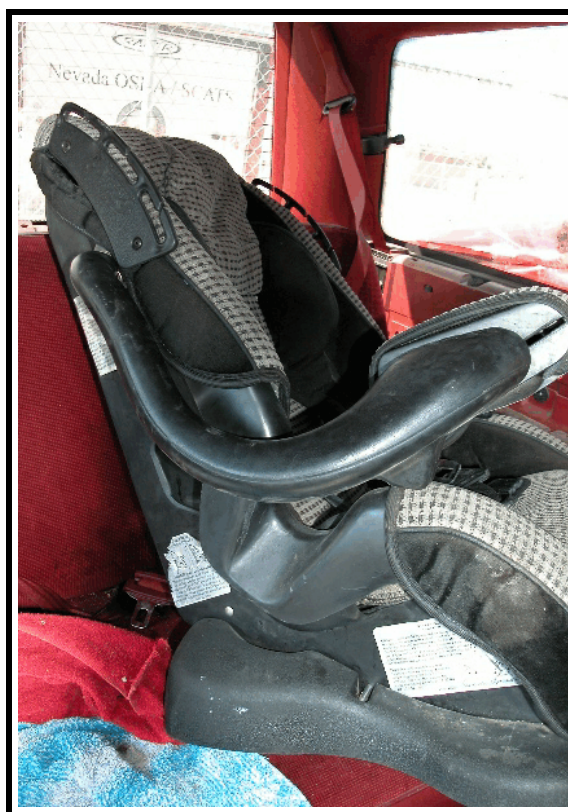
The 3-year-11-month-old female child was restrained in a forward facing child safety seat by the tray shield. According to the coroner investigations, the child seat was anchored to the vehicle using the manual lap and shoulder belt. At the time of the vehicle inspection, the bench seat back was found at a 68 degree angle and the seat bottom at a 9 degree angle. At impact, this occupant initiated a forward trajectory and engaged the child seat shield. There was a dark track-like impression over the lower aspect of the child's abdomen that was situated approximately 6.3 cm (2.5 in) below the level of the umbilicus and extended into the flank. Associated with the impression were abrasions on the left aspect of the lower abdomen and flank. X-rays were negative for any skull fractures, maxillary fractures, cervical spine fractures, and clavicle fractures. The cause of death was given as “due to deceleration injury due to motor vehicle collision.”

Figure 21. Cosco Alpha Omega child safety seat

Based on the injury pattern it would appear that the full impact was loaded through the shield.

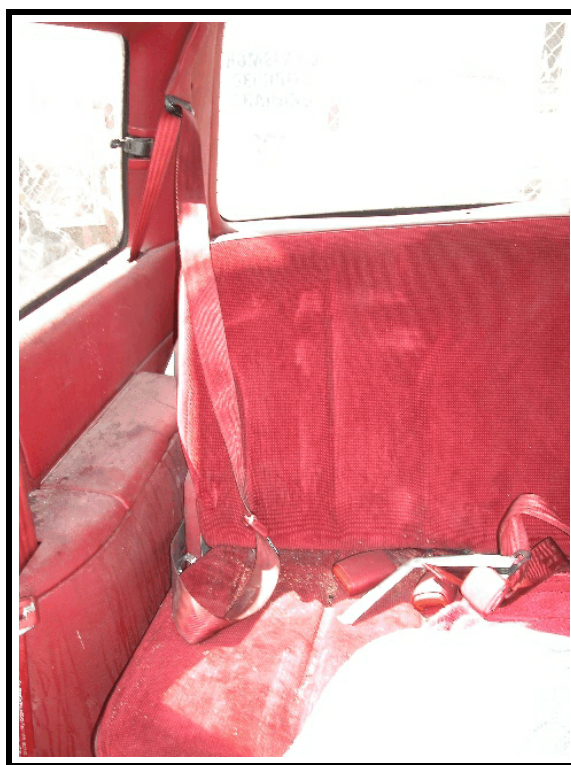
The 3-year-old male child was restrained in a forward facing child safety seat. The child seat was anchored to the vehicle using the 3-point manual lap and shoulder belt. Based on the child's injury pattern it is believed that the child was wearing the internal child seat harness. At the time of the vehicle inspection, the vehicle seat back was found at a 68 degree angle and the seat bottom at a 9 degree angle. At impact, this occupant initiated a forward trajectory and loaded the internal child seat harness, causing the internal abdominal injuries and the external abdominal abrasion/contusion. He was transported from the scene by ground ambulance. He was transported in the child seat and arrived at the hospital with a GCS of 15. EMS personnel indicated that he did lose consciousness and had vomited 2-3 times. This occupant was admitted and hospitalized for an unknown number of days.

Figure 22. Seat area for third row, right occupant
