Remote Redesigned Air Bag Investigation
Dynamic Science, Inc. (DSI), Case Number DS05025
2004 Kia Optima
Arizona
July 2005

1. Report No. DS05025	2. Government Accession No.	3. Recipient Catalog No.	
4. Title and Subtitle Remote Redesigned Air Bag Investigation		5. Report Date April 27, 2006

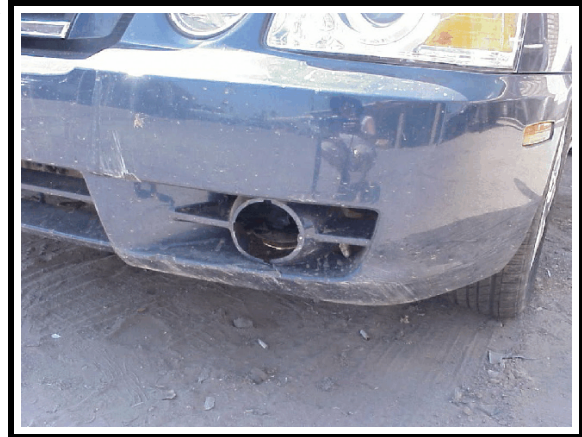
Figure 1. Front left bumper, 2004 Kia Optima

The photos show that there was a single vertical scuff to the bumper fascia just inboard of the left headlights. There was also scuffing to the bottom edge of the fascia on the left side. There was abraded metal down the left side along the frame rail. This damage appeared to be the result of the vehicle bouncing along through the rocky depression which separated the east and westbound travel lanes. The plastic skirt on the bottom radiator support was pulled away on the left side. There were likely multiple impacts in this crash. The Collision Deformation Classification (CDC) for this crash based on the final appearance of the damage was 12FYLS2. There was a puncture visible along the outer sidewall, which was also visible in the picture. The police report indicated that this tire had been flattened, but it had been filled with air prior to the body shop photos being taken.

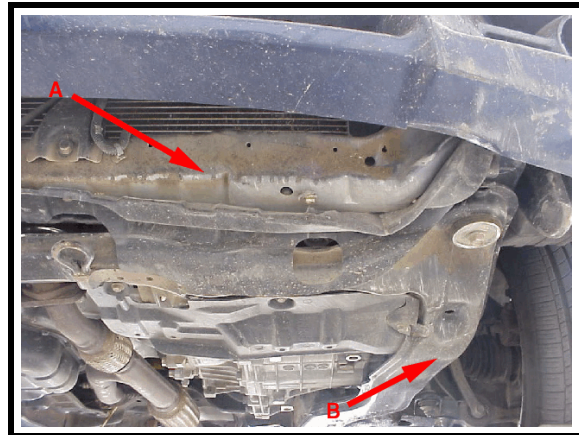
Figure 2. Undercarriage damage: (A) shows contact to radiator support, (B) shows the length of visible contact

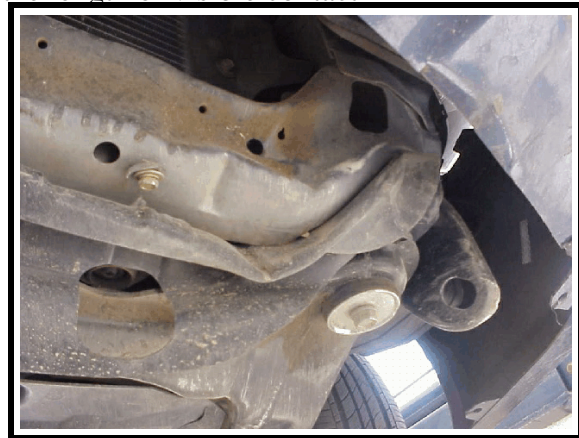
Figure 3. Close up of contact to radiator support

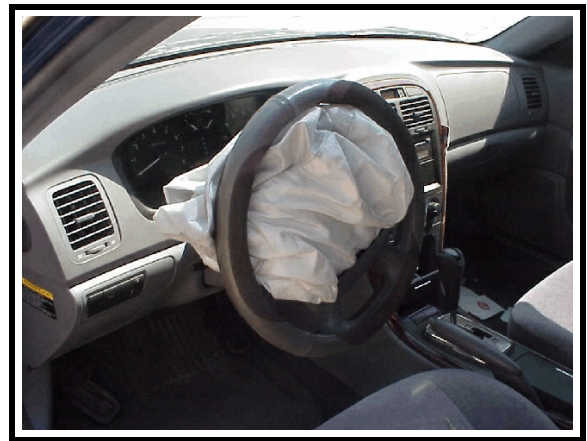
The photograph showed the deployed steering wheel mounted air bag, but it had been folded and tucked underneath the steering wheel rim. Therefore, the fabric could not be inspected for signs of failures and occupant contact points.

Figure 4. Driver's air bag

The driver also was seated in very close proximity to the steering wheel and consequently, the air bag module. As the vehicle sustained impact forces to the undercarriage area, with resulting damage, the deceleration of the car caused the air bag to deploy. The rapidly expanding fabric struck the driver's face, resulting in fractures to her nose and left eye orbit. It also caused a laceration to her left eyelid region, and contusions to both of her eyes.
