**CALSPAN ON-SITE CERTIFIED ADVANCED 208-COMPLIANT VEHICLE  
CRASH INVESTIGATION**

**CALSPAN CASE NO: CA05-036**

**VEHICLE: 2005 TOYOTA COROLLA**

**CRASH DATE: MAY 2005**

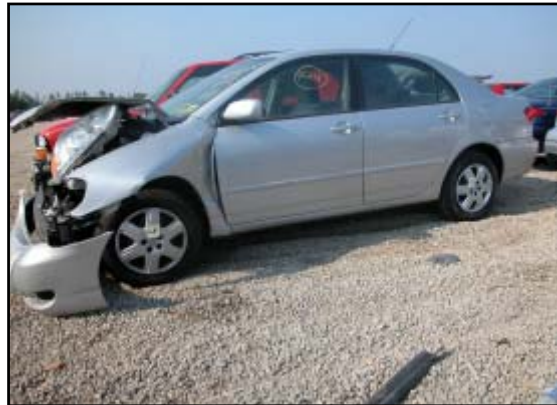
**Figure 1. 2005 Toyota Corolla subject vehicle.**

This on-site investigation focused on the performance of the Certified Advanced 208-Compliant (CAC) safety system in a 2005 Toyota Corolla (**Figure 1**). The manufacturer of this vehicle has certified that this 2005 Toyota Corolla meets the advanced air bag requirements of the Federal Motor Vehicle Safety Standard (FMVSS) No. 208. The safety system included dual stage frontal air bags, safety belt buckle switch sensors, safety belt retractor pretensioners, and an occupant detection sensor for the front right seat. The Toyota also utilized an Air bag Control

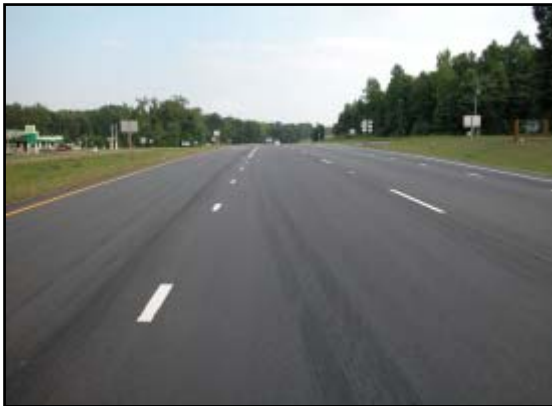
**Figure 2. Toyota's southbound approach to the intersection.**

The restrained 39-year-old female driver of the 2005 Toyota Corolla was operating the vehicle southbound on the four-lane roadway approaching the four-leg intersection (**Figure 2**). A 17-year-old female driver was operating the 1996 Saturn SL2 eastbound on an intersecting roadway (**Figure 3**). The 17-year-old female driver of the Saturn was approaching the intersection that was controlled by a stop sign where she intended to turn left. She failed to detect the southbound Toyota and proceeded into the intersection.

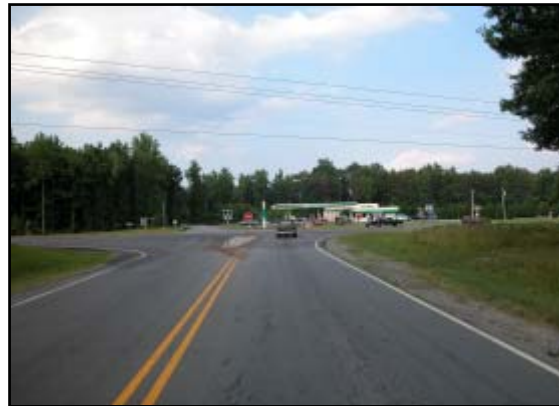
**Figure 3. Saturn's eastbound travel.**

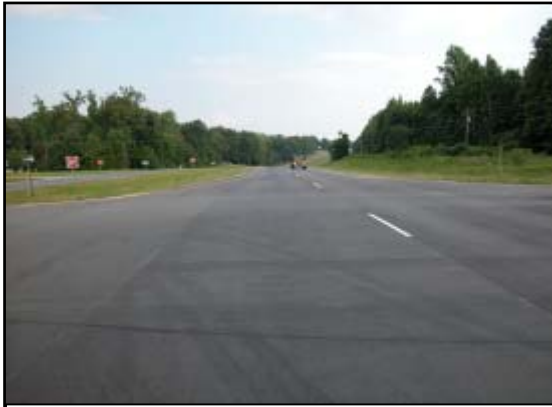
The front of the Toyota impacted the left side of the Saturn in the northeast quadrant of the intersection (**Figure 4**). The resultant directions of force were within the 1 o'clock sector for the Toyota and the 10 o'clock sector for the Saturn. The WINSMASH program was used to calculate the delta-V's for this impact. The total delta-V for the Toyota was 26.0 km/h (16.2 mph). The longitudinal and lateral components were -22.5 (-14.0 mph) and -13.0 (-8.1 mph), respectively. The total delta-V for the Saturn was 29.0 km/h (18.0 mph). The longitudinal and lateral components were -18.6 km/h (-11.6) and 22.2 km/h (13.8 mph), respectively. The Toyota's ACM recorded a delta-V of 17.7 km/h (11.0 mph) at 150 ms from AE. The Toyota's driver's frontal air bag deployed and the

**Figure 4. Area of impact with the southbound travel lanes.**

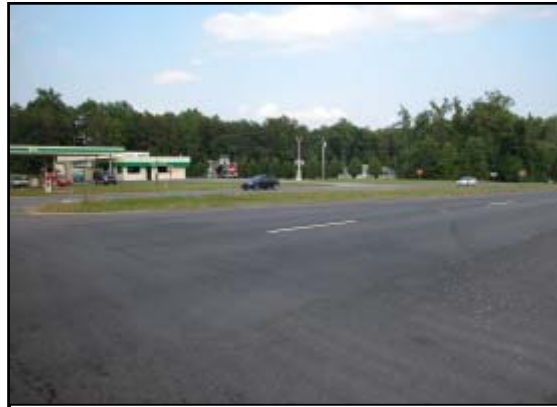
safety belt pretensioner fired due to the severity of deceleration sustained during the impact. The Toyota traveled approximately 10 meters (33 feet) in a southwesterly direction from the point of impact to final rest. The Toyota came to rest at the southeast quadrant of the intersection, facing a westerly direction. The Saturn began to rotate counterclockwise due to the lateral crash force applied aft of the vehicles center of gravity. The Saturn traveled approximately 13 meters (43 feet) while rotating counterclockwise and came to rest in the median facing in a northwest attitude. **Figure 5** is an overall view of the final rest locations for both vehicles.

**Figure 5. Final rest area for both vehicles.**

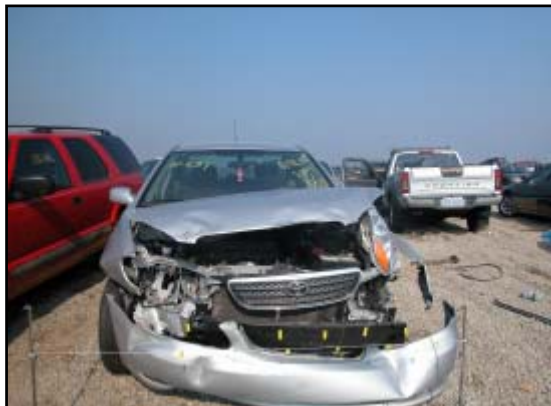
The 2005 Toyota Corolla sustained moderate severity frontal damage as a result of the impact with the Saturn (**Figure 6**). The damage consisted of longitudinal and lateral deformation to the frontal structure. The direct contact damage extended across the 116 cm (45.5”) width of the front bumper fascia. The maximum crush measured 23 cm (9.1”) and was located 11 cm (4.3”) left of the centerline. The crush was documented utilizing six equidistant points along the 112 cm (44.0’) width of

**Figure 6. Resultant damage to the frontal plane of the Toyota.**

the front bumper beam and were as follows: C1 = 16 cm (6.3”), C2 = 21 cm (8.3”), C3 = 23 cm (9.1”), C4 = 23 cm (9.1”), C5 = 23 cm (9.1”), C6 = 13 cm (5.1”).

The lateral deformation was captured by measuring the deflection of the front frame rails. The left frame rail was deflected 24 cm (9.5”) left and the right frame rail was 19 cm (7.5”) left. The Collision Deformation Classification (CDC) for this impact was 81-FDEW-2 with an incremented shift value of 80 added to the 1 o’clock direction of force.

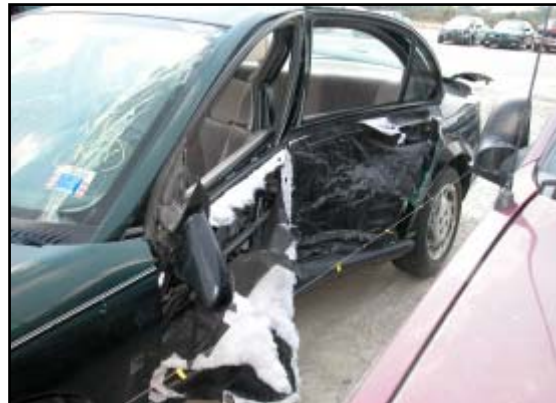
The 1996 Saturn SL2 sustained moderate severity damage to its left side as a result of the impact with the Toyota (**Figure 7**). The direct contact damage began 54 cm (21.3”) aft of the left front axle and extended 175 cm (68.9”) rearward. The maximum crush measured 36 cm (14.1”) and was located on the leading edge of the left rear door. The exterior door panels of the Saturn were constructed of a composite material that fractured and separated from the vehicle’s space frame. As a result of the separated door panels, the crush profile was documented at the side impact door beams using a combined direct and induced damage length of 191 cm (75.2”). The crush profile was as follows: C1 = 0, C2 = 0.5 cm (0.2”), C3 = 5.5 cm (2.2”), C4 = 12.5 cm (4.9”), C5 = 14.5 cm (5.7”), C6 = 40.5 cm (15.9”). The CDC for this impact was 10-LPEW-3.

**Figure 7. Left side damage to the 1996 Saturn SL2.**

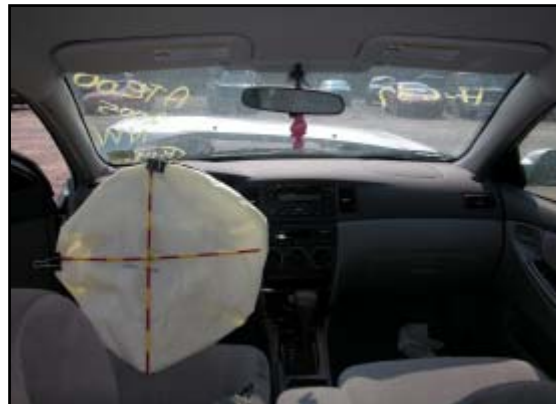
There was no intrusion or occupant contact points to the interior of the vehicle. The only damage associated with this crash was the deployment of the driver’s frontal air bag and firing of the safety belt retractor pretensioner. **Figure 8** is an overall view of the first row of the passenger compartment.

**Figure 8. Overall view of the interior first row.**

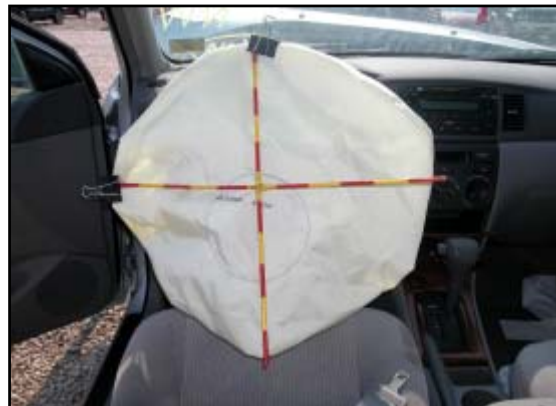
The driver's air bag was conventionally located in the center of the steering wheel hub (**Figure 9**). Three T-shaped cover flaps were used to conceal the air bag. The top cover flap measured 15 cm (6.0") in width and 8 cm (3.3") in height. The lower cover flaps measured 8 cm (3.0) in width and 6 cm (2.5) in height. The air bag membrane measured 58 cm (23.0") in diameter in its deflated state. The driver's air bag was tethered by two wide band tethers sewn to the face of the air bag with a stitched pattern that was 17 cm (6.8") in diameter. Two 11 cm (4.3") wide band tethers were attached to the circular stitching. Two vent ports vented the airbag at the 11 and 1 o'clock positions on the rear panel. The maximum excursion of the air bag membrane at the tethers measured 33 cm (13.0"). No occupant contacts were present on the air bag membrane. The following identifiers were printed on the face of the air bag:

**Figure 9. Driver's frontal air bag.**

312266 420d

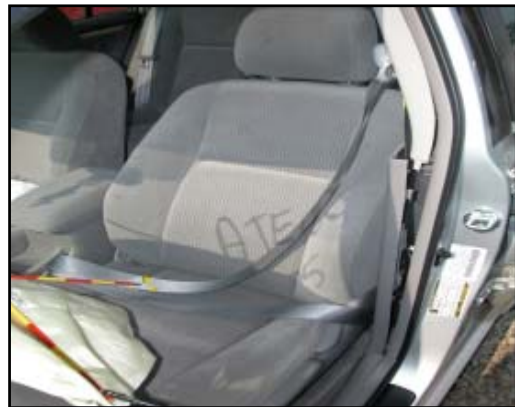
The 2005 Toyota Corolla was equipped with manual continuous loop 3-point lap and shoulder safety belts for the five seating positions. The driver safety belt was configured with a sliding latch plate, Emergency Locking Retractor (ELR), height adjustable D-ring that was in the full-down position, and a retractor pretensioner. The driver utilized her safety belt in the crash, which was supported by the frictional abrasions on the latch plate and safety belt webbing. The abrasion pattern on the webbing measured 3 cm (1.0") in length and was located 121-123 cm (47.5-48.5") above the latch plate stop button. Furthermore, the retractor pretensioner fired during the crash, which locked the safety belt in the used position (**Figure 10**).

**Figure 10. Driver's safety belt restricted in the used position.**
