REMOTE NOT-IN-TRAFFIC SURVEILLANCE BACKOVER INVESTIGATION

CASE NUMBER - IN-07-004

VEHICLE - 2003 FORD F150 4x4 LARIAT SUPER CAB

CRASH DATE - October 2006

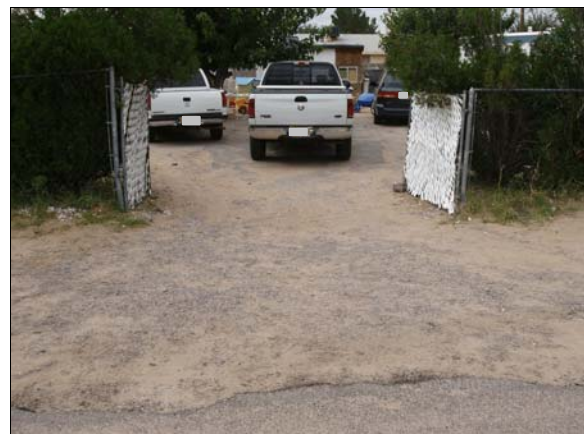
Figure 1: On-scene sheriff's department photo showing overview of case vehicle from street after incident in relation to parked pickup on its left and parked minivan on its right

Crash Environment: The case vehicle was parked in a somewhat large, level driveway area adjacent to a residence. The case vehicle was parked between a late model pickup truck on its left and what appeared to be a minivan on its right (**Figure 1**). It is not known if the case vehicle

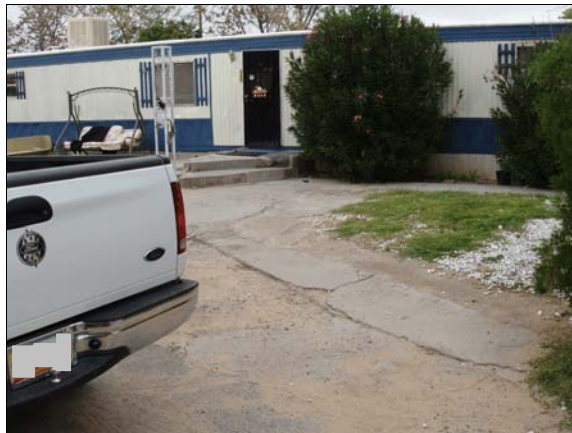
Figure 2: Sheriff's department photo showing view of back of case vehicle at final rest in relation to the door of the residence

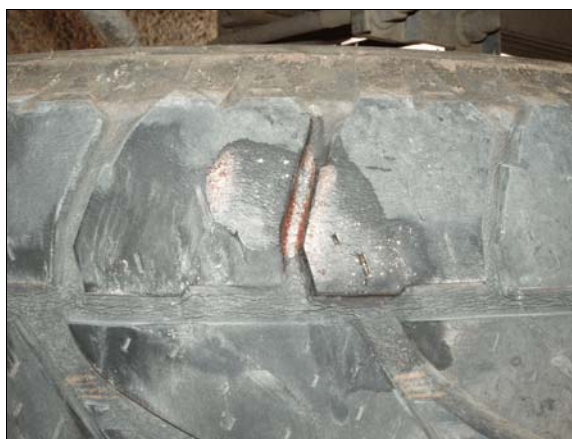
Figure 3: Sheriff's department photo showing blood spot and contact mark on inside portion of case vehicle's left rear tire tread

Crash: The evidence in the sheriff's department on-scene photos indicated that as the case vehicle backed up, the child was most likely impacted by the left portion of the back bumper and knocked to the ground. The inside of the case vehicle's left rear tire then rolled over him. **Figure 3** shows a blood stain on the inside tread face of the left rear tire. This evidence and the injuries and tire mark evidence on the child's body visible in the sheriff's department on-scene photos indicated that the child was facing up with his feet toward the vehicle when he was contacted by the left rear tire and backed over. What appear to be tire marks were visible on the inside of his left leg. The tire marks extended onto the left portion of his abdomen, chest and face indicating he was laying on

his back or knocked to his back as the backover progressed. The evidence indicated that the case vehicle's left rear tire passed completely over the child's body. Based on the length of the case vehicle's rear overhang, blood stain evidence on the pavement below the case vehicle and measurements made by scaling off of one of the on-scene photos (**Figure 4**), it was determined that the case vehicle traveled backward approximately 2.9 to 3.2 meters (9.6 to 10.6 feet) from the point of bumper contact with the child to the case vehicle's rest position depicted in the sheriff's department on-scene photos. The distance the case vehicle backed to impact is not known. However, an outer bound distance can be estimated based on the sheriff's department on-scene photos and knowledge of the case vehicle's overall length. If the case vehicle had been parked as far forward as the children's play area (**Figure 5**), then given the case vehicle's rest position relative to the parked pickup truck (**Figure 6**) indicates the outer bound distance backed to impact would likely have been no more than the length of the case vehicle [5.7 meters (18.7 feet)]. Given this distance and backup acceleration data determined from exemplar vehicle acceleration tests (conducted assuming "normal" acceleration), the outer bound speed at impact and time to impact could have been respectively 8.5 km.p.h (5.3 m.p.h) and 4.82 seconds.

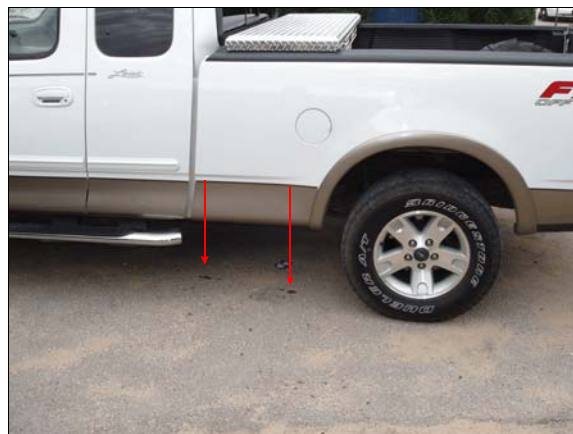
Figure 4: Sheriff's department photo showing left side view of case vehicle at its final rest position, arrows show blood spots on pavement

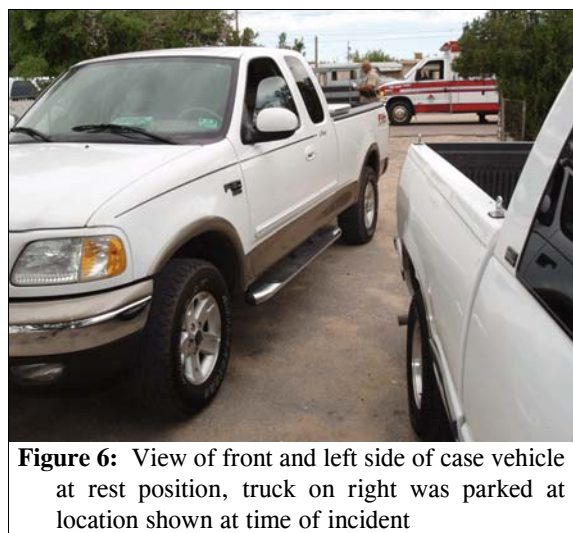
Figure 6: View of front and left side of case vehicle at rest position, truck on right was parked at location shown at time of incident

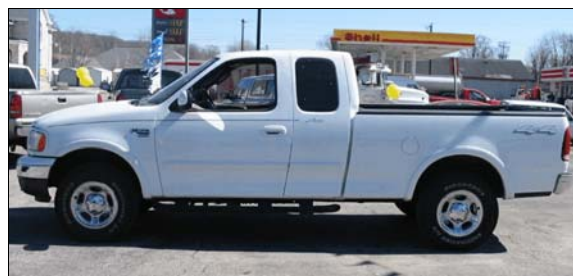
Figure 7: Left side view of exemplar 2003 Ford F150 4x4 super cab

An exemplar 2003 Ford F150 Lariat 4x4 super cab pickup truck (**Figure 7**) was located and a nominal visibility study was undertaken to determine the size of the blind zone behind the back of the pickup truck. The measurements were made assuming the driver was looking over his right shoulder through the backlite as he backed up. The surrogate driver for this study was 180 centimeters (71 inches) tall and his eye height was 164 centimeters (64.6 inches) above the ground as he sat in the driver's seat. A target 71 centimeters (28 inches) tall was moved rearward from the

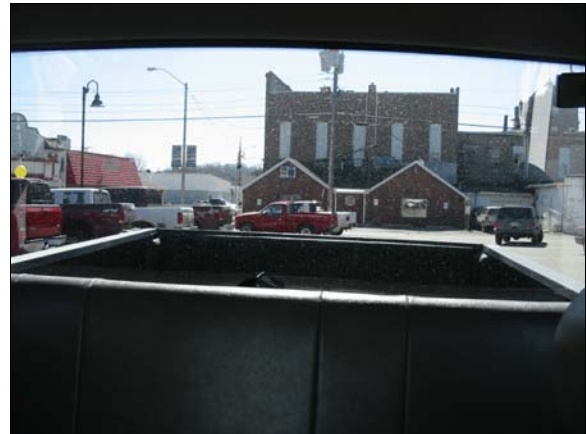
Figure 9: View out backlite of exemplar vehicle from driver's seat

back of the vehicle along the approximate centerline until the target came into view (**Figure 8** above and **Figure 9**). The target had to be moved rearward from the tailgate 10.4 meters (34.1 feet) before the top of the target began to come into the surrogate driver's view. The target was then moved forward slightly until it was out of view and then moved to the right from the approximate centerline until it came into view off the right rear corner of the truck bed. The distance from the truck's projected centerline to this point was 5.6 meters (18.4 feet). The target was then moved to the left from the approximate centerline until it came into view off the left rear corner of the truck bed. The distance from the projected centerline to this point was 2.7 meters (8.9 feet). For all practical purposes, a driver looking over his right shoulder while backing this vehicle would be unable to turn his head far enough to look much beyond the left rear corner of the truck bed. Nominal visibility observations were also taken to determine the blind zone off the right side of the truck bed and the right "C"-pillar. **Figure 10** shows a view from the driver's seat toward the right "C"-pillar and through the right side of the backlite. See the nominal visibility diagram at the end of this report for an illustration of the back and right side blind zones.
