Not In Traffic Surveillance Back Over Investigation / Vehicle v. Non-Motorist
Dynamic Science, Inc. / Case Number: DS07008
2006 Ford F250
Oregon
January 2007

1. Report No. DS07008	2. Government Accession No.		3. Recipient Catalog No.	
4. Title and Subtitle Not In Traffic Surveillance Investigation		5. Report Date June 4, 2007

Dynamic Science, Inc.
Crash Investigation
Case Number: DS07008

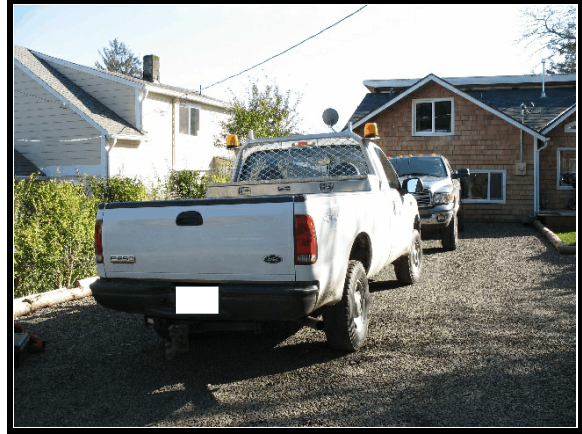
Figure 2. Position of case vehicle prior to backing (south)

The driver of the case vehicle arrived shortly after his wife got home. He pulled into the left side of the driveway. He went into the house and brought a piece of furniture that he then placed in the back of the pickup. The driver recalled seeing the child on the porch at some point prior to the incident. The driver indicated that he looked in his left mirror and then looked over this left shoulder just prior to backing up. He was intending to back onto the roadway in an easterly direction and then continue forward down the roadway to the west. When he looked in the mirror and over his shoulder, he indicated that he was looking for headlights. Prior to the vehicle backing, the child appears to have left the porch and approached

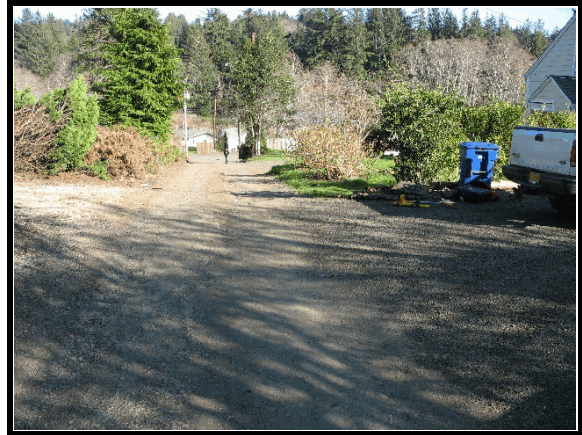
Figure 3. Adjacent roadway (east)

been cleaned up. At the time of the incident, there were a series three medium size tree stumps arranged in a row on the eastern side of the parking area. There was also a large tree stump that was in the process of being burned out located at the northern end of the parking area near the roadway. The stump was in a hole and there was a dirt/rock berm surrounding it. This tree, and a number of others in the area, had fallen down during a recent storm. There were three vehicles, including the case vehicle, that were in the parking area at the time of the incident. One vehicle had been backed into the parking area and was facing north with the rear end near the residence porch. A second vehicle was parked on the east side of parking area facing north. This vehicle was parked in front of the case vehicle. The case vehicle was parked facing south. It was dark at the time of the incident and there were no streetlights available. The parking area was generally level and was comprised of rocks and dirt. The parking area is adjacent to an east/west street. There was no posted speed limit for the parking area.

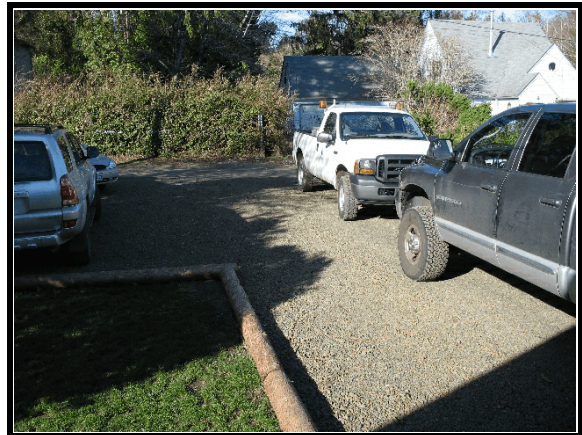
Figure 4. Path of non-motorist to impact area (north)

The case vehicle was being driven by a 31-year-old male. Prior to the incident, the mother of child in this case arrived home from the grocery store and parked on the right side of the driveway. She began bringing groceries into the house. She also brought in the 1-year-old in her child seat. The 1-year-old female child weighed 13 kg (29 lbs) and was 74 cm (29 in) tall. She was wearing a white shirt, pants and a pink hooded sweater.

the right side of the Ford.

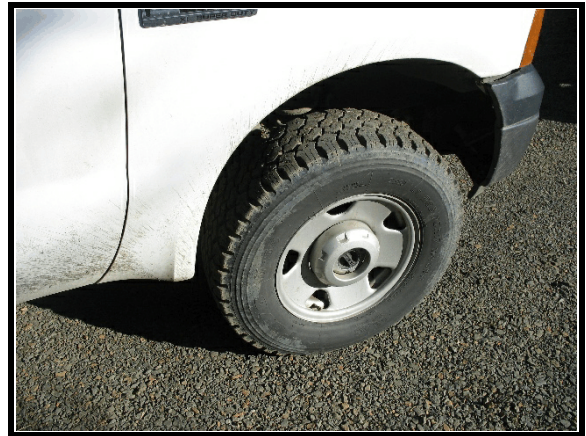
Figure 5. Front right tire

The driver then began backing his vehicle out of the driveway to move it to the back of their residence. As he began backing, he felt that he had run over something. He initially thought he had run over the berm to his right. It appears that the child had been moving towards the north. She was knocked down and then run over by the front right tire. The tire had traveled over her back.

The F250 was configured with stock Toyo LT265/70R17 tires. The specific tire information is as follows:

Position	Measured Pressure	Measured Tread Depth	Restricted	Damage
LF	Unknown ¹	10 mm (12/32 in)	No	None
RF	Unknown	9 mm (11/32 in)	No	None
LR	Unknown	9 mm (11/32 in)	No	None
RR	Unknown	9 mm (11/32 in)	No	None

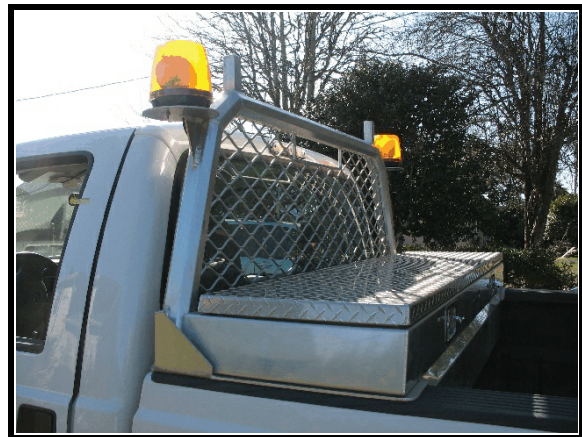
Figure 7. Tool box and cab protector

The 2006 Ford F250 Super Duty pickup was identified by the Vehicle Identification Number (VIN): 1FTNF21506Exxxxxx. The pickup was a company vehicle that was equipped with a 5.4 liter V8 engine, an automatic transmission, and four wheel drive. The pickup was carrying an aluminum tool box and there was a wire mesh cab protector attached to the forward portion of the bed.

Ground to belt line:	135.0 cm (53.1 in)
Ground to top of trunk/tailgate:	143.0 cm (56.3 in)
Ground to top of rear bumper:	78.0 cm (30.7 in)
Ground to bottom of rear bumper:	53.0 cm (20.9 in)
Driver's seated eye height:	171.0 cm (67.3 in) from ground 78.0 cm (30.7 in) from seat bottom
Eye position (seated forward facing):	41.0 cm (16.1 in) forward of back of B pillar
Overall vehicle height:	202.0 cm (79.5 in)
Overall vehicle width:	203.0 cm (79.9 in)
Overall vehicle length:	564.0 cm (222.0 in)
Rear overhang:	119.0 cm (46.9 in)
Track width:	174.0 cm (68.5 in)
Longitudinal distance between rear most projection and front door latch pillar:	264.0 cm (103.9 in)
Bed length:	255.0 cm (100.4 in)
Bumper width:	16.0 cm (6.3 in)
Height of tool box above bed:	17.0 cm (6.7 in)
Width of tool box:	52.0 cm (20.5 in)

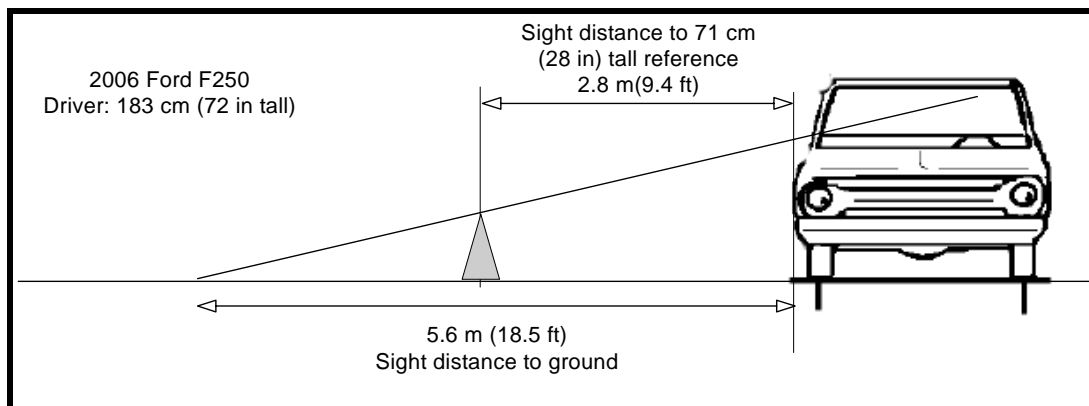
Figure 8. Nominal Visibility Diagram

A visibility study was conducted during the inspection of the Ford F250 pickup in order to determine the nominal blind zone for the right side of the vehicle. The Ford driver assisted the SCI investigator in making the visibility observations. The observations were conducted at the driver's residence. The driver's seated eye height was 171.0 cm (67.3 in) from the ground. The eye position was 41.0 cm (16.1 in) forward of the back of the B pillar. The target was aligned laterally along the right side of the Ford along a line established by the eye position. The target was moved laterally 2.8 m (9.4 ft) before the top of the target came into view. The area between the bottom window frame and the top of the target formed a blind spot for the driver.

It should be noted that while the child was in the blind spot, the driver was not looking in this direction while backing the Ford.
