**NOT-IN-TRAFFIC SURVEILLANCE
CALSPAN REMOTE BACKOVER INVESTIGATION**

SCI CASE NO: CA07-009

**VEHICLE: 1997 HONDA CIVIC
LOCATION: TENNESSEE
CRASH DATE: FEBRUARY 2007**

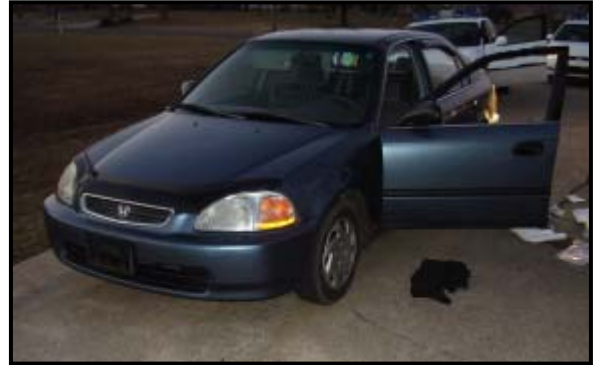
Figure 1: Front oblique view of the Honda.

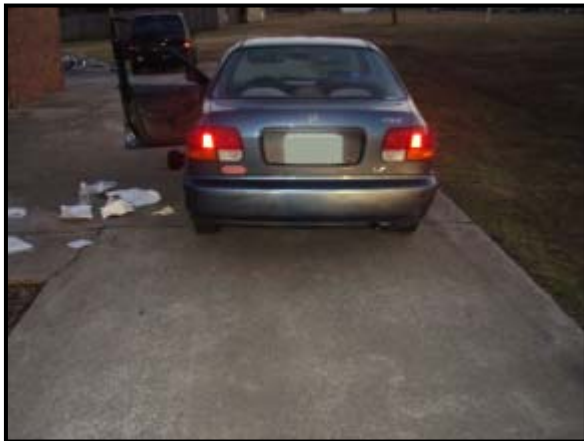
Figure 2 is a back view of the Honda at final rest in the driveway. A swipe mark (road film removed) was present on the left aspect of the rear bumper fascia. **Figure 3** is a close-up view of the left rear corner. The swipe mark was an indicator of probable contact with the child during the backing maneuver. The mark began 28 cm (11 in) left of center and extended 29 cm (11.5 in) left. The elevation of the rear bumper on the exemplar Honda Civic measured 39 cm to 58 cm (15.5 in to 22.8 in) above the ground. The center of the swipe mark was an estimated 51 cm (20 in) above the ground. The height of the rear deck lid measured 100 cm (39.5 in) above the ground.

Figure 2: Rear view of the Civic at final rest.

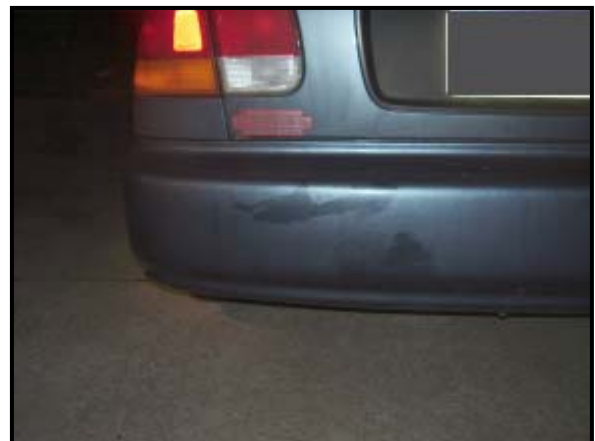
Figure 3: Close-up view of the left rear corner.

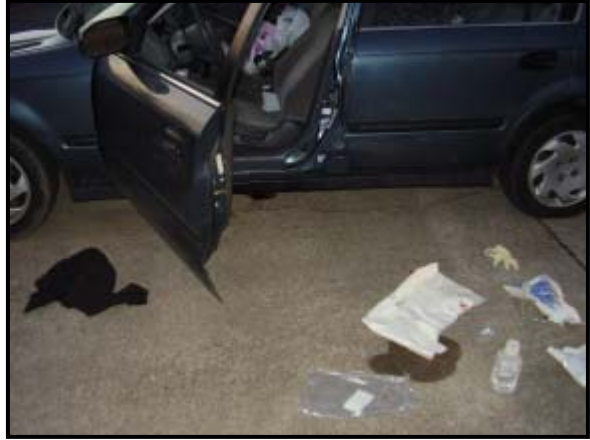
Figure 4: Final rest location of the child.

The driver called for help and a neighbor reportedly jacked up the vehicle and was able to slide the child to the left side of the Honda. A first responder to the crash indicated that the child was located approximately at the B-pillar location on the centerline of the vehicle. She apparently was contacted by the rear bumper, straddled by the rear tires and dragged a short distance. The child was transported to a trauma center as a precaution for a possible head injury. Reportedly, she sustained multiple soft tissue injuries to the face, trunk and arms. There were no skeletal fractures and no brain injury. The child was hospitalized overnight and released. The prognosis was for a full recovery.
