Remote Not In Traffic Surveillance Back Over Investigation
Dynamic Science, Inc. / Case Number: DS07023
1991 Chevrolet Suburban
California
January 2007

1. Report No. DS07023		2. Government Accession No.		3. Recipient Catalog No.	
4. Title and Subtitle Not In Traffic Surveillance Back Over Investigation				5. Report Date November 9, 2007

Dynamic Science, Inc.
Crash Investigation
Case Number: DS07023

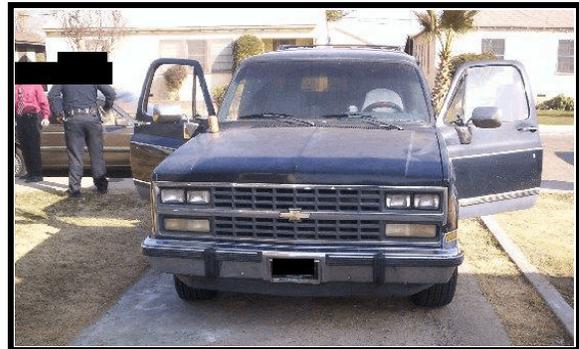
Figure 1. Case vehicle, 1991 Chevrolet Suburban

This single vehicle incident occurred in January 2007 at 1335 hours. The case vehicle is a 1991 Chevrolet Suburban (see Figure 1). The crash took place in the driveway of a private residence. The 25-year-old male driver of the case vehicle entered the vehicle from the left side. He was not aware that his son, a 21-month-old male, was outside of the house. A witness saw the driver begin backing his vehicle down the driveway. The witness saw the child was standing behind the vehicle and began yelling for the driver to stop. The driver was unable to see the child due to the blind zone behind his vehicle. The distance from the parked position to impact was smaller than the blind zone. The rear bumper of the Suburban struck the child and knocked him to the ground. The left rear tire struck the head of the child and he sustained a head injury.

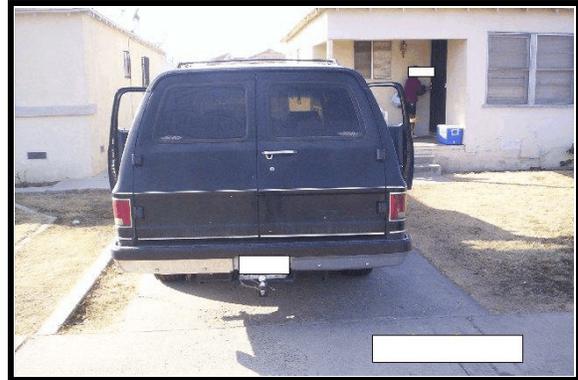
Figure 2. Rear of 1991 Chevrolet Suburban, crash scene (looking west)

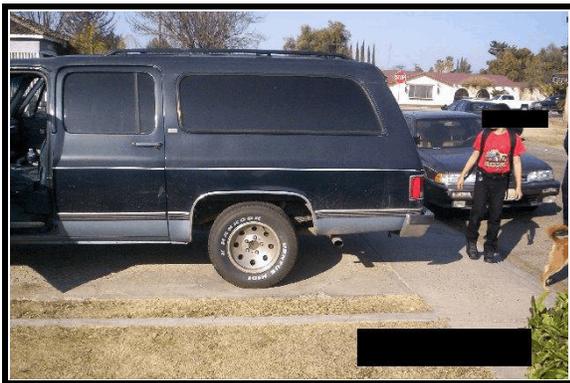
Figure 3. Chevrolet Suburban at final rest

The driver heard his neighbor yelling. The driver stopped the vehicle after traveling 2.9 m (9.7 ft) and opened the driver's door. The vehicle came to rest with the rear bumper just over the north/south sidewalk. As the driver exited the vehicle, he then saw the child on the ground next to the vehicle. EMS personnel responding to the scene indicated that the child sustained several contusions to the back of his head. The child was airlifted to an area trauma center in critical condition. He was later transferred to an area children's hospital. The police reported that the child sustained a "severe injury". He was hospitalized for two days and then released.

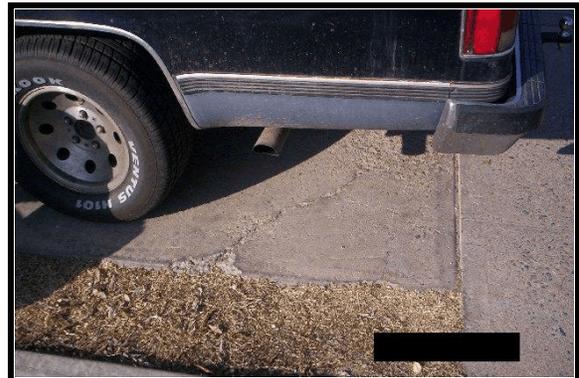
Figure 4. Left rear tire and bumper of Chevrolet Suburban at final rest

The left rear bumper of the Suburban struck the child and knocked him to the ground. The left rear tire struck the head of the child and he sustained a head injury. The witness described the contact as the tire pinching the child's head and his body forced out from underneath the vehicle to the side of the driveway.

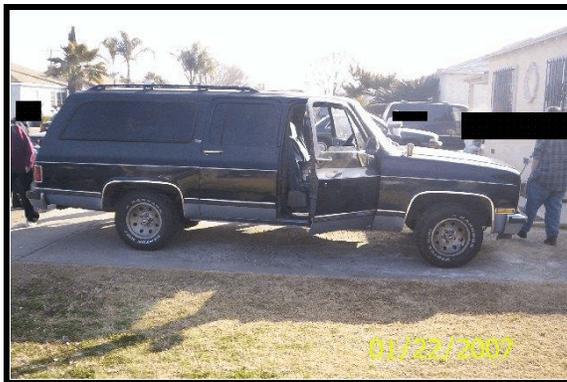
Figure 5. Right side, Chevrolet Suburban

There was no damage to the Chevrolet Suburban and no reports of any contact evidence. The Collision Deformation Classifications (CDC) for the impact with the non-motorist was 06B9LU1.

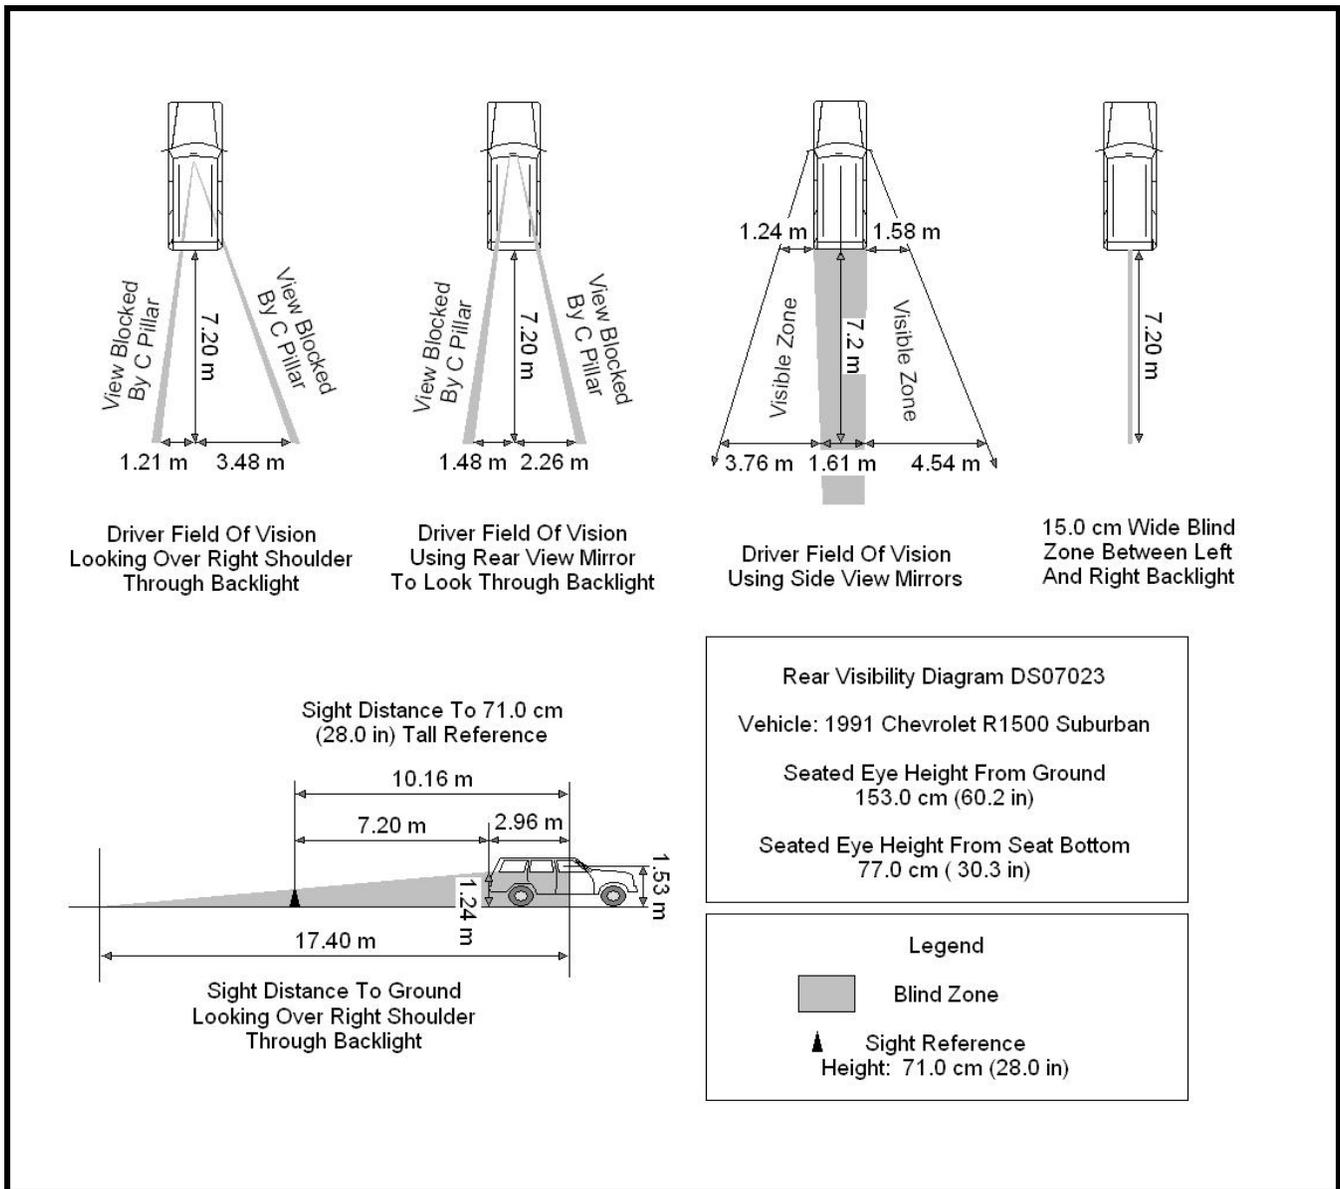
Figure 6. Nominal Sight Distances

A visibility study was conducted in order to determine the nominal blind zone behind the vehicle as well as the nominal blind zone of both side view mirrors. Measurements were taken using a 1995 GMC C1500 Suburban exemplary vehicle. The standard 71.0 cm (28.0 in) high target was used to obtain the measurements. The measurements were taken on a paved level surface.

The initial set of measurements were taken as if the driver were looking over his right shoulder through the backlight. The target was moved rearward from the back bumper along the Suburban's centerline until it became visible to the investigator. The point at which the target became visible to the investigator measured 7.20 m (23.62 ft) rearward of the back bumper. This measurement was used as the point of origin for a set of lateral measurements which were then taken. Measurements taken laterally to the left and right would result in a visibility zone that could be viewed through the backlight. The point at which the roadway surface became visible to the investigator measured 14.44 m (47.38 ft) rearward of the back bumper.

Another set of measurements were taken to simulate the driver using the rear view mirror to look through the backlight. The target was moved rearward from the back bumper along the Suburban's centerline until it became visible to the investigator. The point at which the target became visible to the investigator measured 7.20 m (23.62 ft) rearward of the back bumper. This measurement was used as the point of origin for a set of lateral measurements which were then taken. Measurements taken laterally to the left and right would result in a visibility zone that could be viewed through the backlight. The point at which the roadway surface became visible to the investigator measured 14.44 m (47.38 ft) rearward of the back bumper.

Since the SCI investigator was using an exemplar vehicle, he adjusted the side mirrors appropriately for the driver's seated eye height. With the SCI investigator seated, the side views were examined. The target was placed at the right side of the back bumper. The target was moved from the side of the vehicle laterally to the right until the target became visible through the right side view mirror. The target was then moved laterally to the right to the point where the target was no longer visible. These measurements resulted in a visibility zone which could be viewed through the side view mirror. This process was repeated on the left side of the vehicle. The area between the left and right visibility zones resulted in a blind zone. At 7.20 m (23.62 ft) rearward of the rear bumper, the blind zone was approximately 1.61 m (5.28 ft) in width. At 19.0 m (62.34 ft) rearward of the back bumper, the blind zone was approximately 100 cm (39.37 in) in width. There was insufficient working space to determine at what distance from the vehicle the right and left visibility zones would meet.

The Suburban was configured with double doors for the rear hatch. Each door was configured with one window. The doors met along the vehicle's longitudinal center. The left and right backlights were separated by 15.0 cm (5.9 in) of window frame material, which resulted in a blind zone of 15.0 cm (5.9 in) at the vehicle's rear bumper. The blind zone became progressively narrower as the target was moved further away from the rear bumper.
