TRANSPORTATION RESEARCH CENTER

ON-SITE NOT IN TRAFFIC SURVEILLANCE BACK OVER INVESTIGATION

CASE NUMBER - IN07027
LOCATION - MICHIGAN
VEHICLE - 1994 FORD ECONOLINE VAN
CRASH DATE - June 2007

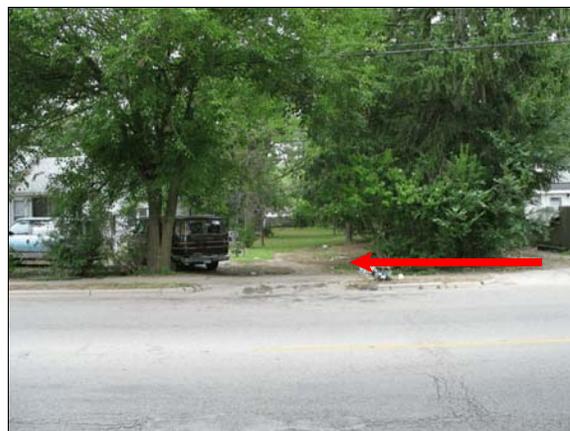
Figure 1: Overview of incident site, red arrow shows pedalcyclist's westbound travel path toward right side of backing case vehicle (Note: neither vehicle in driveway is the subject vehicle)

Pre-Crash: The pedalcyclist, multiple children, and adults were outside the residence. The driver and her fiancé (i.e., the front right passenger) were both inside the residence visiting. The driver and the front right passenger exited the south side of the residence and encountered the victim near the entrance. The driver stated she stopped for approximately 30 seconds to tie the victim's shoes. The victim then went on his way and subsequently got on his tricycle (**Figure 2**). The driver and passenger then walked approximately 12 meters (39.4 feet) to the Ford, both approaching from the left. The driver went straight to the driver's door and the passenger walked around the front of the Ford to the right front door. After entering, the driver stated she checked her rearview and side view mirrors. The driver stated she then asked the other adults, who were in the yard, whether the children playing about the yard were clear of the back of the Ford. When the driver received assurance that the area behind the Ford was clear, she began to back up. The driver estimated that the time between vehicle entry and the start of the backing maneuver was approximately 60 seconds. Her intention was to back counterclockwise (i.e., east) into the street, then proceed westbound. Meanwhile, the pedalcyclist was east of the driveway on the sidewalk, riding his tricycle westbound across the path of the backing Ford (**Figure 3**).

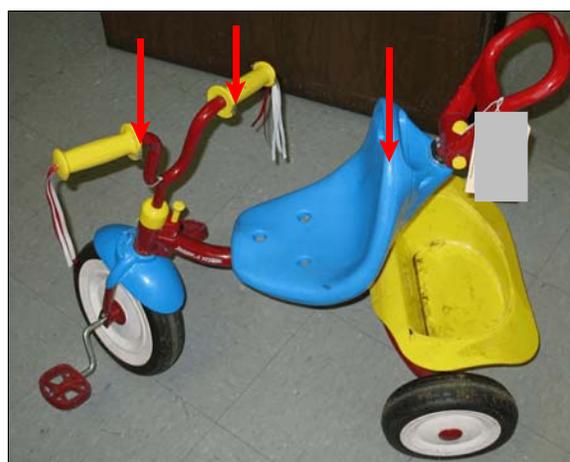
Figure 2: Left side of tricycle, arrows show pavement abrasions

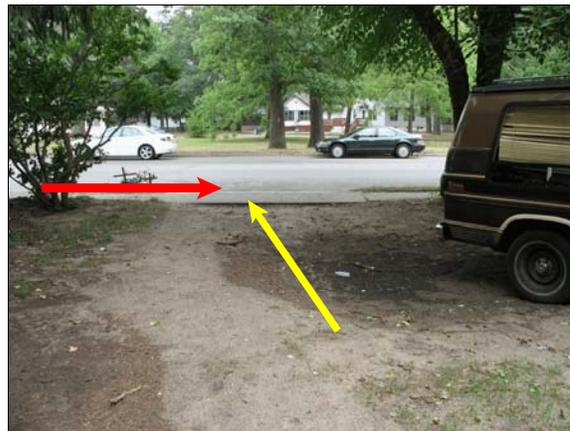
Figure 3: Yellow arrow shows backing travel path of case vehicle, red arrow shows pedalcyclist's travel path (Note: vehicle in driveway is not case vehicle)

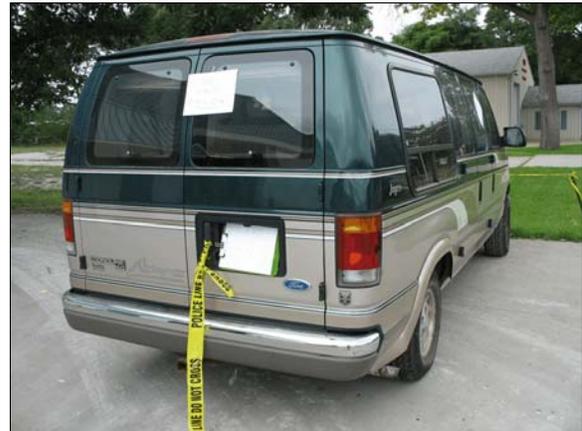
Figure 4: Overview of back of Ford, witness stated impact to pedalcyclist was to center portion of back bumper

Crash: The Ford's driver began to back the Ford southbound toward the street, but couldn't remember whether she was looking through the backlight or any of her mirrors as she backed up. The driver indicated she tapped the accelerator lightly as she backed to get over the lip of the sidewalk. She also turned the steering wheel slightly to the right. According to a witness, almost immediately after the Ford began to back up, the center area of the Ford's back bumper (**Figure 4**) impacted the pedalcyclist, who was behind the Ford after approaching from the right. The impact knocked the pedalcyclist and his tricycle over onto their left side. The adults in the yard immediately yelled at the driver to stop. By the time the driver stopped backing, the Ford had dragged the pedalcyclist and his tricycle from the sidewalk, past the mouth of the driveway, and into the street, a total distance of approximately 2.3 meters (7.5 feet). Based on an interview with a witness and the available information, as the pedalcyclist was dragged, he remained under the back of the Ford and no tire passed over him. The pedalcyclist sustained skull fractures, brain injuries and multiple contusions and abrasions. His head injuries most likely occurred after he was knocked over to the left by the Ford's back bumper. As the back of the Ford passed over him, the right side of his head most likely contacted the undercarriage, possibly the trailer hitch, and his head was pressed between the undercarriage and the pavement when the back of the van traveled down the slope of the driveway apron.

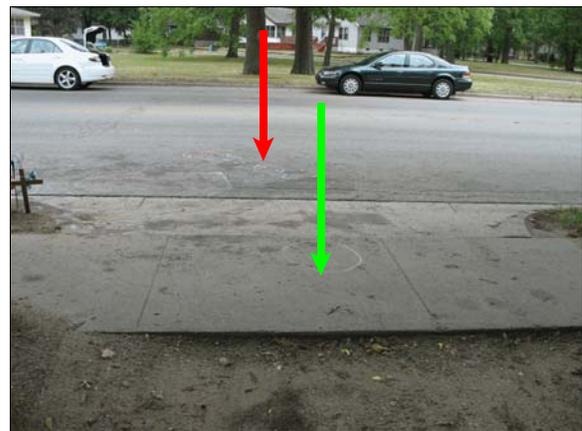
Figure 5: Overview of impact area in sidewalk indicated by green arrow, red arrow shows reported location of back of case vehicle at final rest

Based on the scene inspection, police crash report, and witness accounts, it was determined that the Ford traveled backward to impact approximately 0.8 meter (~3 feet) and traveled 2.8 meters (~9 feet) from impact to final rest (**Figure 5**). Based on the driver interview, the distance backed to impact, and reasonable acceleration values to calculate a range of speeds, the Ford's impact speed was estimated to be approximately 3 km.p.h. (~2 m.p.h.). The time to impact was calculated to be approximately 2.2 seconds.

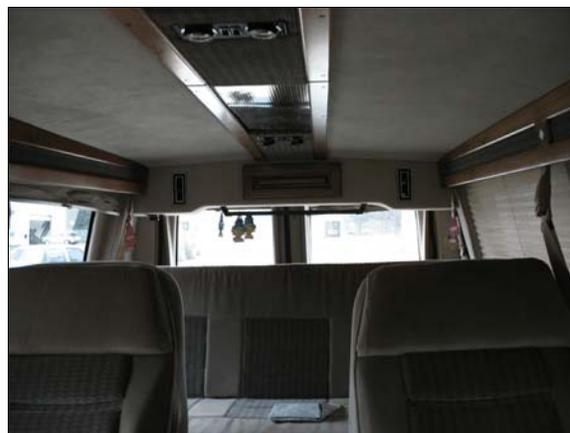
Figure 6: View out backlight from driver's seat; driver stated only the right rear window shade was down at time of the incident

For the assessment of the blind zone behind the Ford, the surrogate driver was asked to look over his right shoulder out of the backlight (Figure 6). The target was positioned behind the Ford and moved rearward until it came into the driver's view. It was necessary to move the target rearward from the back of the Ford 13.4 meters (44 feet) before the surrogate driver could see it over the top of the third row seat back (Figures 6 and 7). At this point, the target was moved to the right from the vehicle's approximate centerline 4.9 meters (16 feet) where it became obstructed by the right "D"-pillar. The target was then moved an additional 2.7 meters (8.9 feet) to the right where it became visible again through the right rear window. The target was then returned to the centerline and moved to the left. The target was moved 1.6 meters (5.2 feet) from the centerline where it became obstructed by the left "D"-pillar. The surrogate driver was not able to see the target if moved further to the left because it was unnatural to turn his head any further to the right.

The surrogate driver was then asked to view behind the Ford through the rearview mirror (Figure 8). It was necessary to move the target rearward from the back of the vehicle 17 meters (55.8 feet) before the driver could see it over the top of the third row seat back (Figure 6). When moved 2.9 meters (9.5 feet) to the right of the vehicle's approximate centerline, the target became obstructed by the second row right seat back. The target was then moved 2.3 meters (7.5 feet) to the left of the centerline where it became obstructed by the left "D"-pillar. It was not visible to the surrogate driver if moved further left. When viewing through the rearview mirror as well as through the backlight, an area of the surrogate driver's view was obstructed by the center frame of the double back doors (Figure 6). The width of this area was not determined.

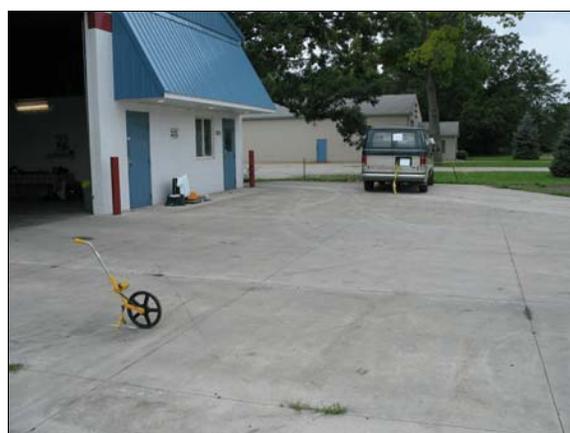
Figure 7: Measuring wheel shows location where target came into surrogate driver's view when looking over right shoulder through backlight

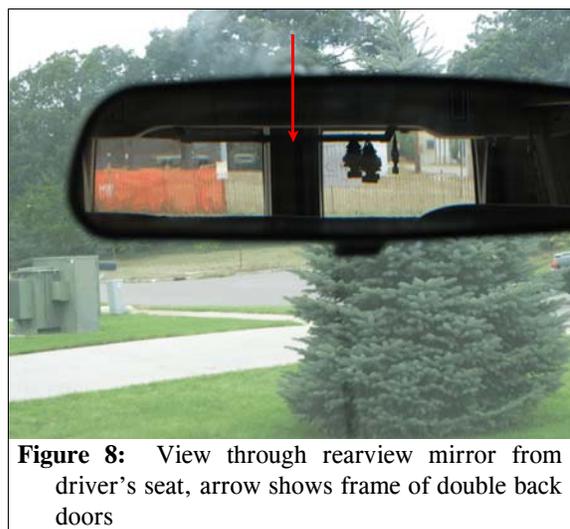
Figure 8: View through rearview mirror from driver's seat, arrow shows frame of double back doors

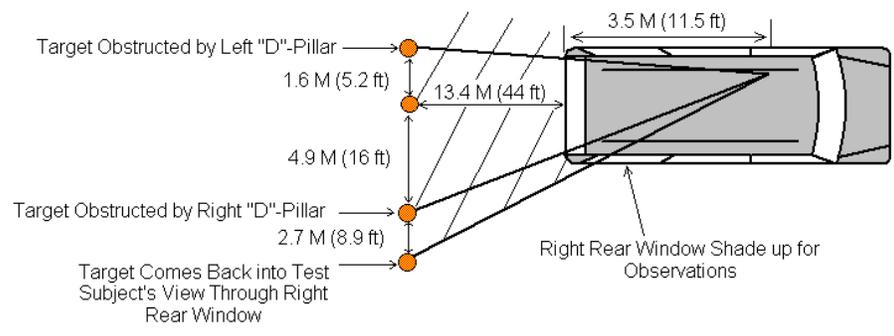
Nominal Visibility Diagram Case Vehicle = 1994 Ford E150 Econoline Van

Surrogate Driver's Eye Height From Ground = 162 cm (63.8 in)

1. Distance Back of Ford
To Point a 71 cm (28 in) High Reference Target
Comes Into Surrogate Driver's View as He Looks Over Right Shoulder Out of Backlight

A visibility study was conducted during the inspection of the Ford in order to determine the nominal blind zone behind the Ford as well as the right "D"pillar blind zone. In addition, the blind zone of the rearview and side view mirrors were also assessed. The Ford's driver was not available for the visibility study. Instead, a sheriff's deputy assisted this contractor in the study and acted as a surrogate driver. The deputy was approximately 175 centimeters (~69 inches) tall. The deputy's eye height as he sat in the driver's seat was measured as 162 centimeters (64 inches) above the ground. The surrogate driver adjusted the driver's seat to the approximate middle track position, which was his normal seat adjustment. The standard 71 centimeters (28 inches) high target was used for the visibility observations. Please refer to the Nominal Visibility Diagram at the end of this report when reading the following discussion.

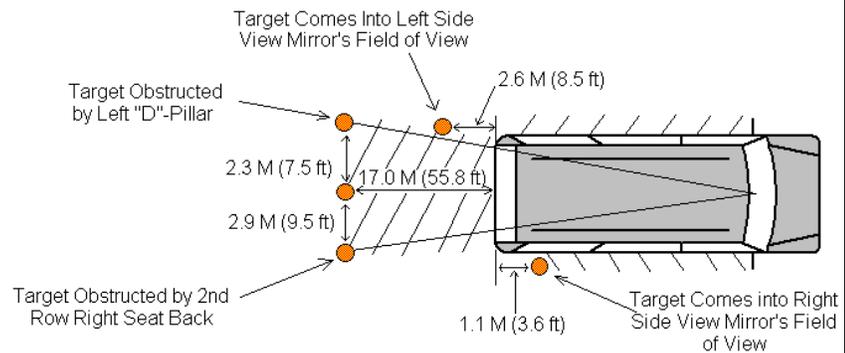
2. Rearview Mirror Blind Zone and Side View Mirrors' Blind Zone
Down Side of Vehicle

placed at the back left corner of the Ford and had to be moved rearward 2.6 meters (8.5 feet) before it came into left side view mirror’s field of view. The target was then moved to the Ford’s back right corner, where it was visible to the surrogate driver through the right side view mirror. The target was then moved 1.1 meters (3.6 feet) toward the front of the Ford where it passed out of the mirror’s field of view.

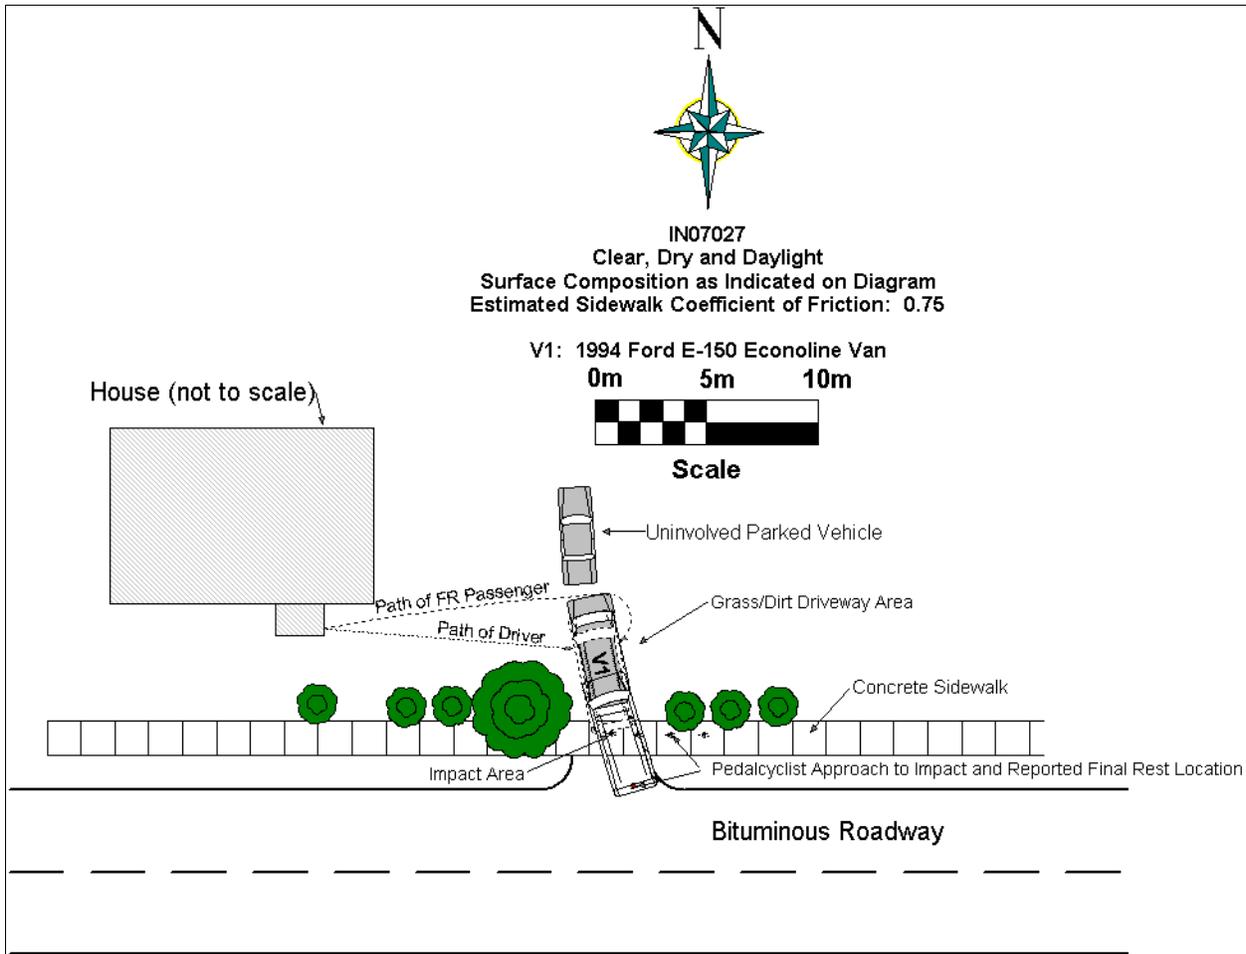
SCENE DIAGRAM 10

area of the back yard of the residence. The driveway was level and its surface was a combination of dry dirt and grass and there was significant vegetation on the east and west sides of the driveway entrance (**Figure 1**). In addition, the driveway was lower than the sidewalk, ranging from 5-10 centimeters (2-4 inches). However, the sidewalk was also level. There was one other vehicle in the driveway at the time of the incident, but it was in front of the Ford. At the time of the incident the light condition was daylight, the atmospheric condition was clear and the driveway, sidewalk and street surfaces were dry. See the Scene Diagram at the end of this report.
