Remote Not In Traffic Back Over Investigation
Dynamic Science, Inc. (DSI), Case Number DS07040
2000 Chevrolet Suburban
Nevada
July 2007

1. Report No. DS07040		2. Government Accession No.		3. Recipient Catalog No.	
4. Title and Subtitle Remote Not in Traffic Back Over Investigation				5. Report Date September 3, 2008

**Dynamic Science, Inc.
Crash Investigation
Case Number: DS07040**

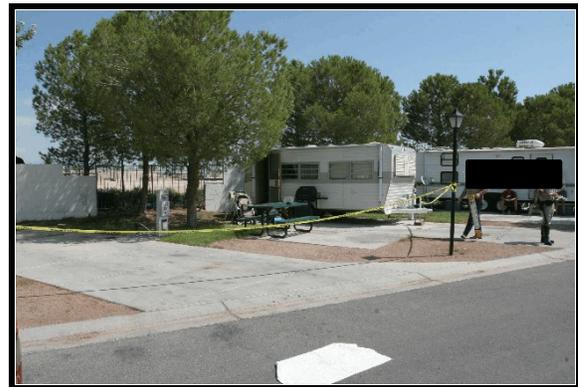
Figure 3. Approach to area of impact (northeast)

The driver's view rearward toward the door of the trailer was partially obscured by a power hook-up, a picnic table, and possibly a stroller (**Figure 3**).

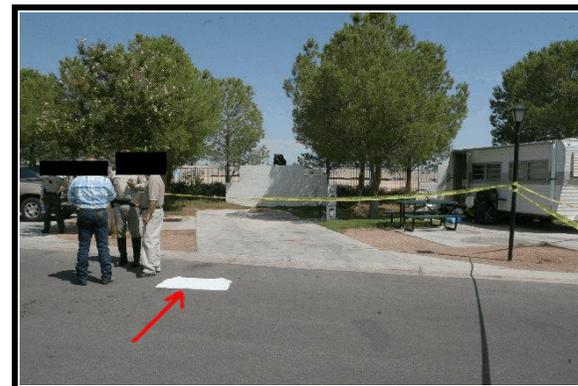
Figure 4. Arrow marks area of impact (looking north)

As the Suburban continued backing, the child was contacted and run over by the left rear tire (**Figure 4**). The Suburban came to rest on the street just beyond the point of impact.

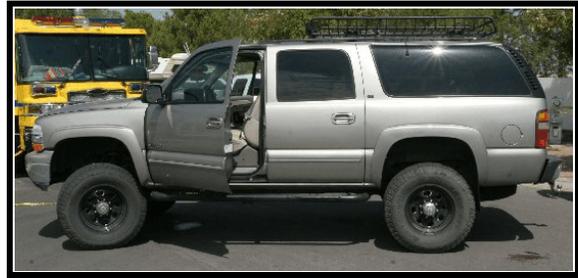
Figure 5. Left side, Chevrolet Suburban

The 2000 Chevrolet Suburban sport utility vehicle was identified from the police report by the Vehicle Identification Number (VIN): 3GNGK26U3YGxxxxxx (**Figure 5**). The Suburban was a K2500 series full-size utility vehicle that was equipped with a 6.0 liter, eight-cylinder engine, a 4-speed automatic transmission, 4-wheel drive, front/rear disc brakes with ABS, and power steering. The second and third row side windows, as well as the backlight, were tinted. There was a sports logo decal sticker affixed to the left backlight (**Figure 6**). The driver's sight line, with the driver looking over her right shoulder toward the left rear of the vehicle, would have been limited by the sticker. It was determined that the Suburban was configured with Toyo Open Country A/T LT315/75R16 tires on after-market American Racing rims. The tires had an overall diameter of 87.8 cm (34.6 in). LT245/75R16 tires are recommended by Toyo for this vehicle. The LT245/75R16 tires have an overall diameter of 77.5 cm (30.5 in). The Suburban had been modified with a lift¹ kit and a trailer package. The Suburban was also equipped with an after-market luggage rack.

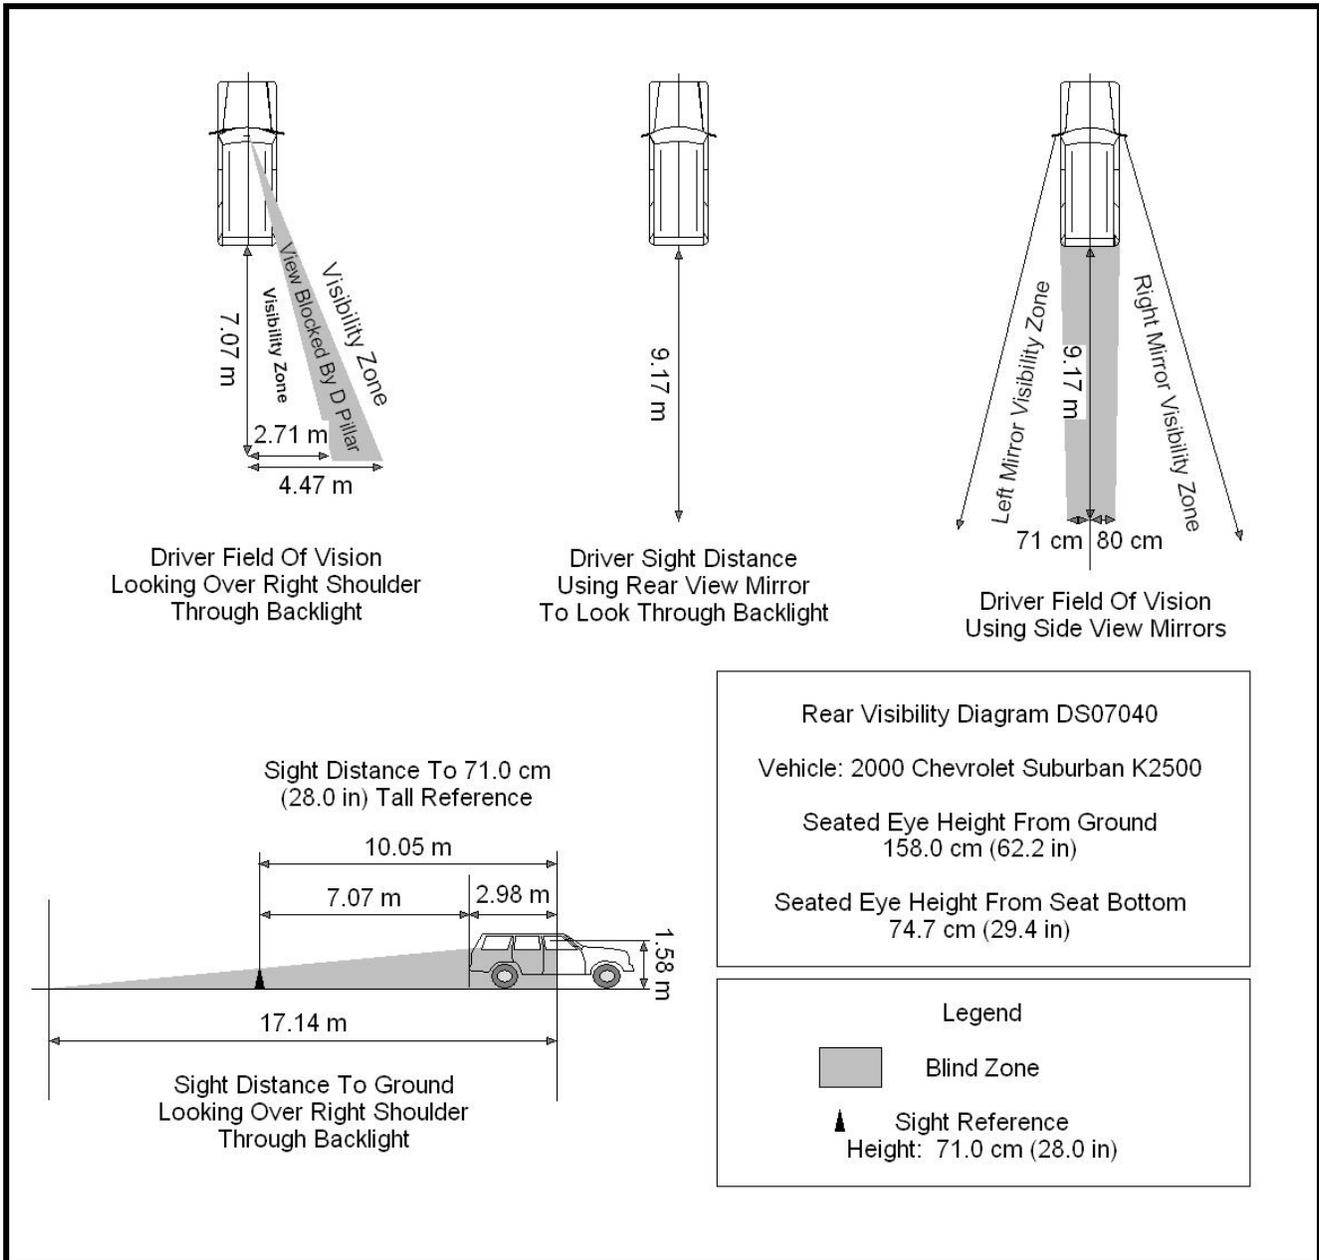
Figure 7. Nominal visibility diagram (stock vehicle)

The initial set of measurements were made with the surrogate driver looking over the right shoulder out of the backlight. The target was moved rearward from the back bumper along the Suburban's centerline until it came into the driver's view. The target had to be moved 7.07 m (23.2 ft) before the top of the target came into the driver's view (**Figure 7**). This target distance was later adjusted to compensate for the increased vehicle height due to the lift kit and larger tires (**Figure 8**).

A second set of measurements were made with the surrogate driver looking through the rear view mirror. The target was again moved rearward along the center line until it came into the driver view. The target was moved 9.17 m (30.1 ft) rearward from the rear bumper. This target distance was later adjusted to compensate for the increased vehicle height due to the lift kit and larger tires.

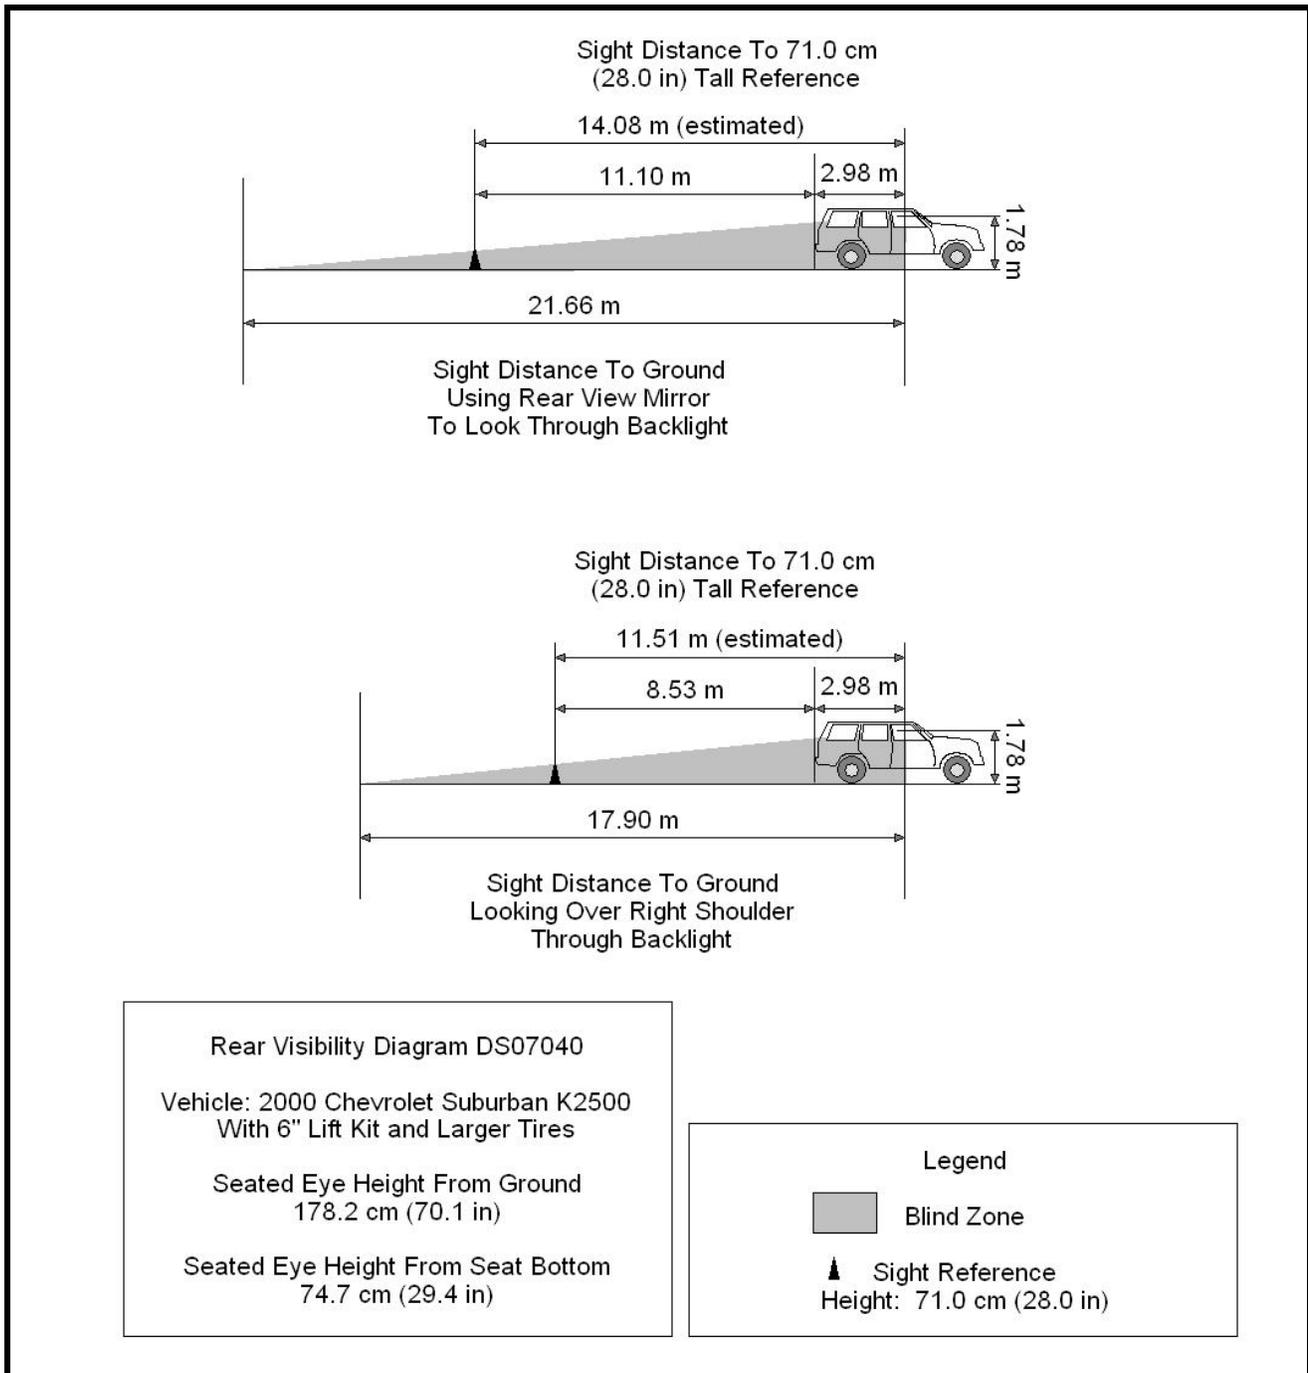
Figure 8. Nominal visibility diagram (with lift kit and larger tires)

With the driver looking over the shoulder, the driver's vision become blocked by the headrest and the B pillar at a point 2.71 m (8.9 ft) to the right of the centerline. The blind zone ends 4.47 m (14.7 in) to the right of the centerline.

A third set of measurements were made with the driver looking through the left and right side view mirrors. The target was placed at the center line 9.17 m (30.0 ft) rearward of the vehicle's back bumper. The target was moved laterally until it became visible to the driver. For the right, the target became visible 80.0 cm (31.4 in) from the center line. For the left, the target became visible 71 cm (27.9 in) from the center line. This resulted in a blind zone which measured 1.51 m (4.95 ft) in width at a distance of 9.17 m (30.0 ft) rearward of the vehicle's back bumper.

Based on the driver's view over her shoulder, the 86 cm (34 in) tall child would have been in the driver's blind zone for a distance of 6.3 m (20.7 ft).
