Remote Combination Child Seat Investigation
Dynamic Science, Inc. (DSI), Case Number 2008-81-043B
1998 Mercury Mystique
Washington
April 2008

1. Report No. 2008-81-043B	2. Government Accession No.		3. Recipient Catalog No.	
4. Title and Subtitle Remote Combination Child Seat Investigation			5. Report Date September 18, 2008

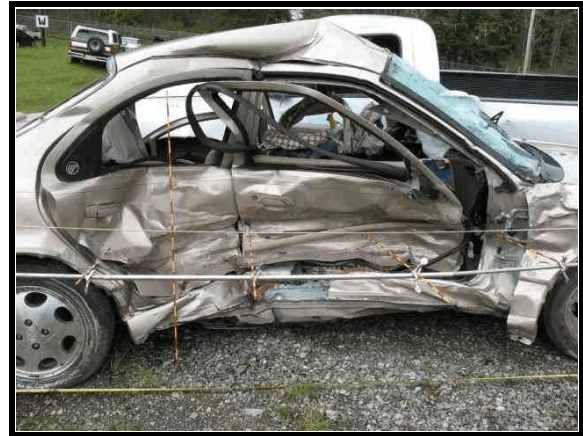
Figure 1. 1998 Mercury Mystique

This remote combination investigation focused on the injuries sustained by a second row occupant seated in a rear facing child seat while traveling in a 1998 Mercury Mystique (**Figure 1**). This two vehicle crash occurred in April 2008 at 1650 hours. The subject vehicle was being driven by a restrained 18-year-old female. The front right seat was occupied by a restrained 16-year-old female. The second row middle seat was occupied by a 5-month-old male who was restrained in a rear-facing Graco SnugRide Infant Safety Seat (ISS). The other vehicle was a 1997 Ford Ranger pickup that was being driven by a restrained 34-year-old male. The crash occurred within an interchange area.

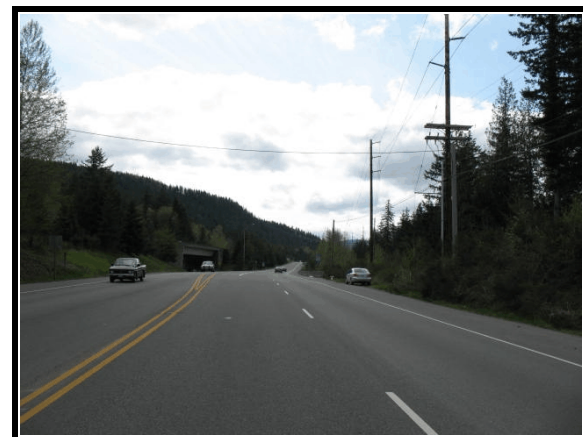
Figure 2. Westbound approach to area of impact

This crash occurred in April 2008 at 1650 hours within an interchange area. The eastbound lane of the roadway travels beneath an interstate roadway overpass. The eastbound lane curves to the right and merges with the westbound lanes to become a four-lane, undivided roadway (**Figure 2**). The eastbound lane was bounded on the right by a solid white line, an asphalt shoulder, and an ascending grass-covered embankment, and on the left by two sets of double yellow painted lines. The westbound lanes were separated from the

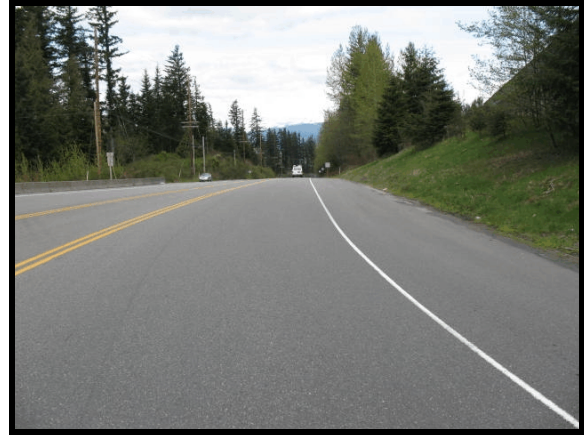
Figure 3. Eastbound approach to area of road departure and impact

eastbound lanes by a double yellow painted centerline east of the merging area (**Figure 3**). Two sets of double yellow lines comprised a painted divider as the two roadways began to merge. The westbound roadway was bordered on right by a solid white line, an asphalt shoulder, and a grass covered embankment. There was freezing rain at the time of the crash and the asphalt roadway was wet. The speed limit was 80 km/h (50 mph).

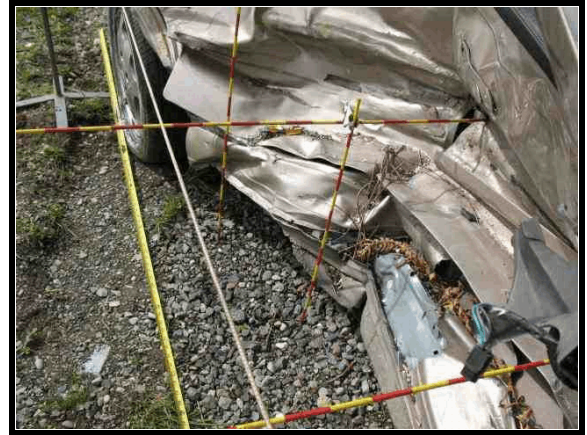
Figure 4. Right side damage, Mercury Mystique

The Mercury Mystique sustained severe right side damage as a result of the impact with the Ford Ranger (**Figure 4**). The direct damage began 13 cm (5.1 in) forward of the right rear axle and extended 220 cm (86.7 in) forward along the right side plane. The maximum lateral crush was located at C3 and measured 71 cm (27.9 in). Both right side doors were deformed and jammed shut. The damage to the front right door slightly overrode the right sill. The front door was forced rearward which formed a gap between the forward aspect of the door and the A-pillar. The gap extended upward to include the area between the A-pillar and the door/window frame. The direct damage extended vertically to include the entire height of the door panels. The right side view mirror was broken away. The right roof side rail sustained induced lateral crush as a result of the right side doors and B-pillar crush. The combined direct and induced damage began 26 cm (10.2 in) rearward of the right rear axle and extended 284 cm (111.8 in) forward along the right side plane. Six crush measurements were documented at the mid-door level as follows: C1 = 0 cm, C2 = 19 cm (7.5 in), C3 = 71 cm (27.9 in), C4 = 61 cm (24.0 in), C5 = 30 cm (11.8 in), C6 = 0 cm. The Collision Deformation Classification was 02RYEW5.

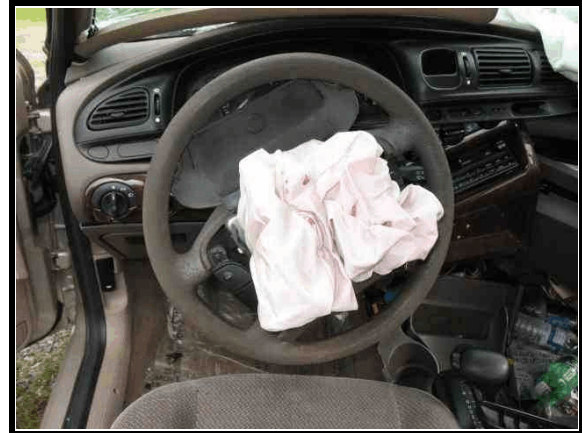
Figure 5. Driver's deployed air bag

The driver's air bag deployed from the center of the steering wheel hub through H-configuration module cover flaps (**Figure 5**). The deployed air bag had a circular stitching pattern in the front center that corresponded to an unknown number of internal tether straps. It also had two circular vent ports on the back of the bag at the 11 and 1 o'clock positions. There was blood located on the air bag face, primarily across the top quadrant. There were no other reported occupant contacts to the air bag.

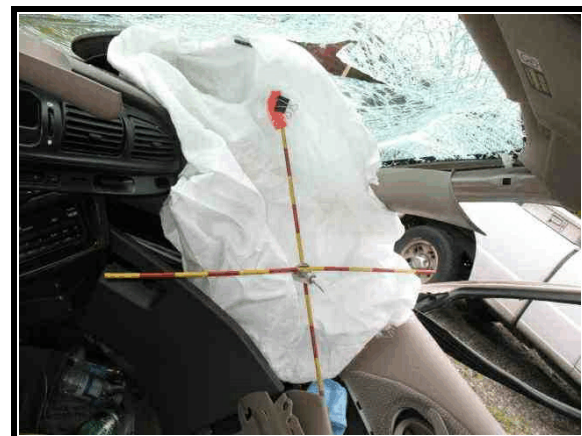
Figure 6. Front right passenger's deployed air bag

The front right passenger's air bag deployed from a top mount module with a rectangular cover flap that was hinged at the forward aspect (**Figure 6**). There was damage to air bag as a result of contact with the windshield. There were no reported occupant contacts to the air bag.

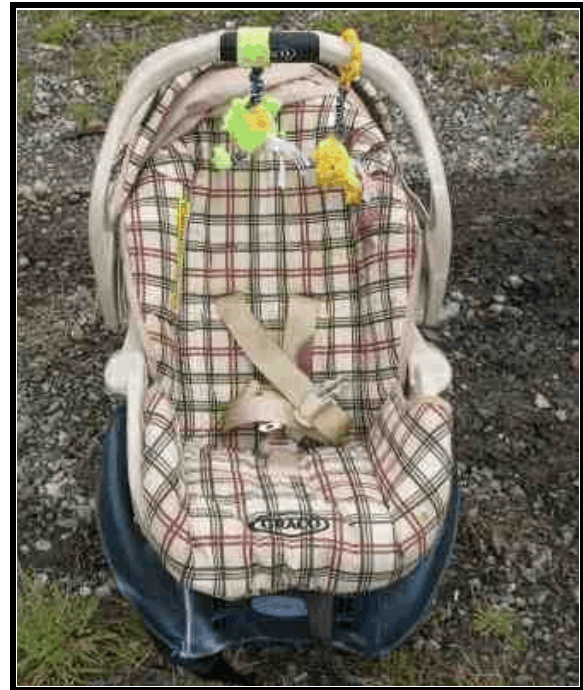
Figure 7. Graco Snug Ride ISS

A Graco Snug Ride ISS was positioned in the second row of the Mercury Mystique (**Figure 7**). The model number was 7F02GLM3 and the date of manufacture was November 15, 2006. The serial number was JJ1115060543. The ISS was designed for rear-facing use only and was configured with a stay-in-vehicle base. The ISS was configured with a 5-point internal harness system and a two-piece, locking harness retainer clip. The harness shoulder straps had been adjusted to the lower slot position. The harness retainer clip was used but its position was not known. The seat was equipped with a sun shield that was broken during the crash but remained attached to the seat. According to a label found on the seat base, this ISS was rated for children who weighed 9 kg (20 lbs) or less and were 66 cm (26 in) or less in height. According to the Graco manual, this seat was rated for children who weighed between 2.3-10 kg (5-22 lbs) and whose height was 73 cm (29 in) or less. The child's height was 62 cm (24.4 in) and his weight was 13 kg (28.6 lbs), which was within the manufacturer's recommended height guidelines and over the recommended weight guidelines.

The ISS was installed in a rear-facing orientation, using the seat base, and was secured to the vehicle by the vehicle's lap and shoulder belt. The belt was routed through the rear facing belt path. The safety belt was configured with a switchable retractor but the retractor mode was not known.

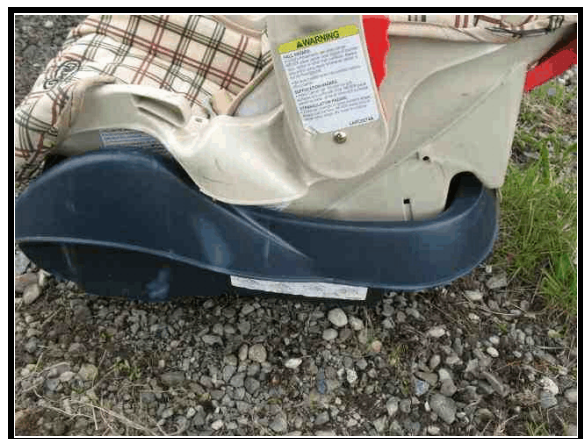
Figure 8. ISS damage (left side of seat in rear-facing orientation).

The ISS sustained minor damage as a result of the crash (**Figure 8**). The middle to forward most portion of the left side of the seat base sustained minor deformation/crazing from engagement against the right rear door interior, and sustained induced buckling to the back of the base. There was deformation to the outboard aspect of the left side of the ISS shell, primarily between the carrying handle and the seat belt guide. There was blood located on the left upper portion of the ISS padding.

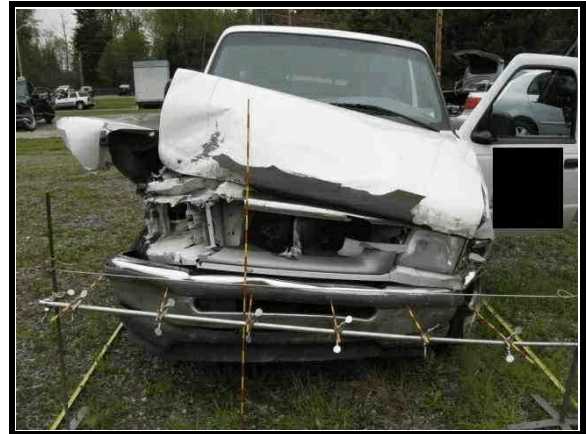
Figure 9. Other vehicle, 1997 Ford Ranger pickup

1997 Ford Ranger sustained moderate front end damage as a result of the impact with the Mercury Mystique (**Figure 9**). The direct damage began at the front right bumper corner and extended 146 cm (57.4 in) laterally along the frontal plane. The maximum longitudinal crush was located at the front right bumper corner and measured 27 cm (10.6 in). The direct contact damage extended vertically from the bumper into the hood. There was induced damage to the left fender, the hood, and the right fender. Both front tires were restricted.

Six crush measurements were documented at the bumper level as follows: C1 = 26 cm (10.2 in), C2 = 14 cm (5.5 in), C3 = 12 cm (4.7 in), C4 = 14 cm (5.5 in), C5 = 13 cm (5.1 in), C6 = 27 cm (10.6 in). The CDC for the impact with the Mystique was 11FDEW2.

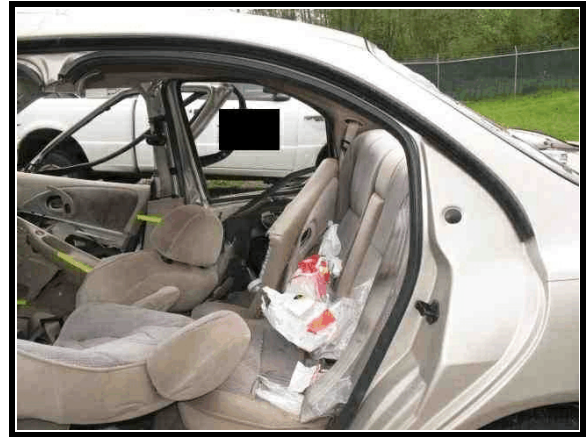
Figure 10. Second row seat, showing right rear door panel.

There was blood located on the right door and the right B-pillars. There was also blood located on the shell of the CSS and on the driver's air bag. The right front door panel and right armrest were cracked and deformed by the front right occupant. The plastic fascia covering the right A-pillar was dislodged and the fascia on the upper portion of the right B-pillar was missing. The center console was displaced laterally to the left due to contact from the right front occupant. There was integrity loss to the right front door, the side windows, and the backlight. Both right side doors were jammed shut.
