REMOTE NOT IN TRAFFIC SURVEILLANCE ROLL AWAY INVESTIGATION

CASE NUMBER - IN08007

LOCATION - TEXAS

VEHICLE - 1975 FORD F150 EXPLORER PICKUP TRUCK

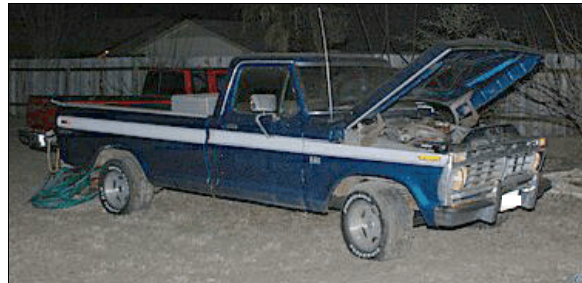
Figure 1: The 1975 Ford F150 Explorer pickup at its final rest position

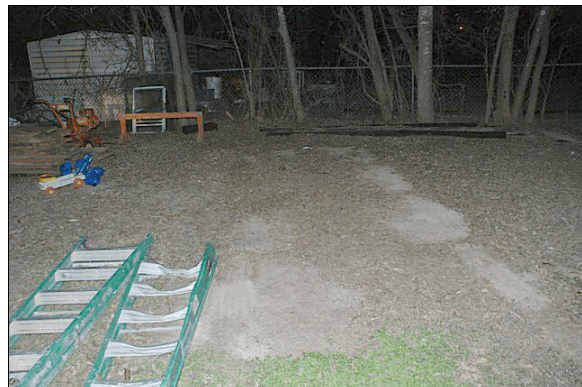
Figure 2: Overview of the Ford's parked location; arrow shows approximate location of where front of vehicle was located

Crash Environment: The Ford was parked in the back yard of the owner's residence on a level dry grass and dirt surface (**Figure 2**). At the time of the incident, the light condition was dusk and the weather was clear and dry.

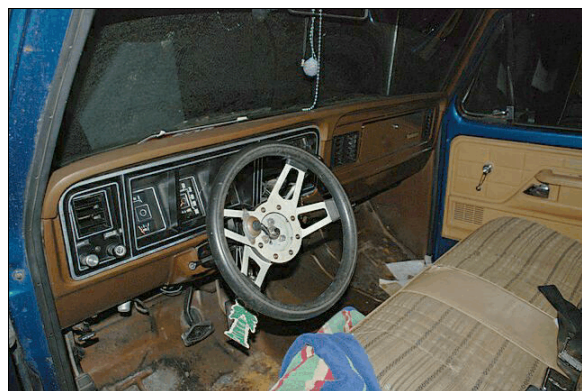
Figure 3: Ford's front seat area

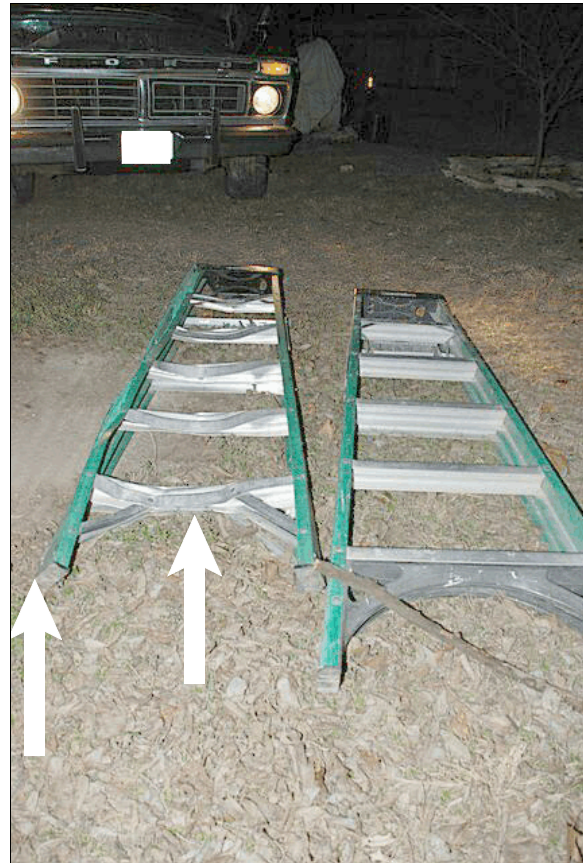
Figure 4: Ladder on left was run over by vehicle's left rear and left front tires; final rest position of Ford in background; left arrow shows left rear tire mark and damage to ladder; right arrow shows damage to ladder from left front tire

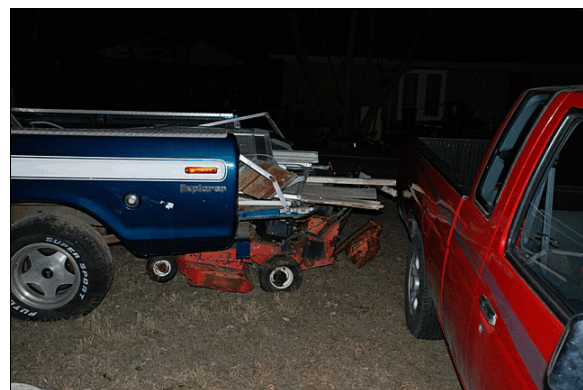
Figure 5: Left side view of Ford's final rest position; the Ford's cargo did not impact the other vehicle

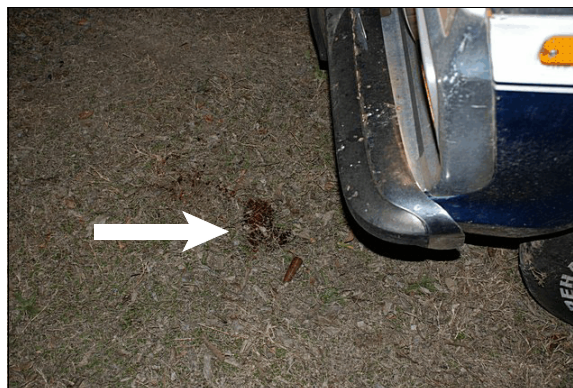
Figure 6: Blood on ground (arrow) shows final rest position of victim's head

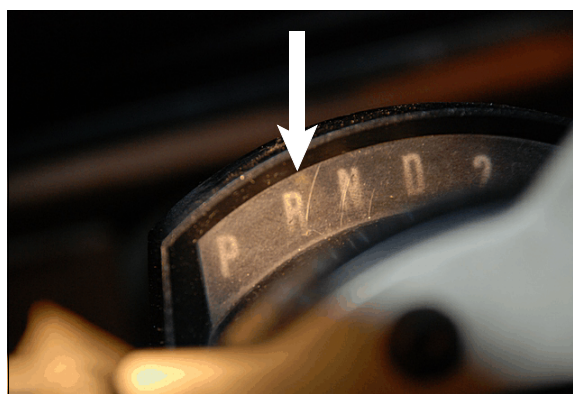
Figure 7: Arrow shows position of gear selector indicator as found by police

The police reported that the Ford's steering column mounted gear selector lever was in reverse following the incident (**Figure 7**). The police investigation determined that it was possible to move the gear selector lever from park to reverse without depressing the brake pedal. A police video showed the gear selector lever being moved from park to reverse as well as through all the gear positions without depressing the brake pedal. The vehicle was also subject to a manufacturer's notice (NHTSA campaign ID number: 81V008000) to advise owners that the parking gear may not be securely engaged after the operator

has attempted to shift to park. While it is possible that the vehicle's parking gear was not securely engaged and moved to reverse while the father was revving the engine, or the unattended 3-year-old within the vehicle moved the gear selector lever from park to reverse, a specific causal factor for this incident could not be determined.
