Remote Not In Traffic Surveillance Hyperthermia Investigation
Dynamic Science, Inc. (DSI), Case Number DS08010
2005 Saturn Ion
Arizona
March 2008

**Dynamic Science, Inc.
Crash Investigation
Case Number: DS08010**

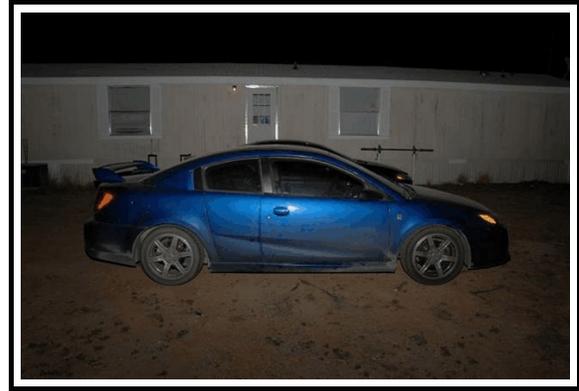
Figure 1. Subject vehicle, 2005 Saturn Ion Quad Coupe Red Line.

This remote investigation focused on the circumstances surrounding the death of a 4-month old male who was left unattended in a 2005 Saturn Ion Quad Coupe Red Line (**Figure 1**). The child had been placed in a rear facing Graco SnugRide Infant Car Seat in the second row right position of the vehicle during a family trip. When the father and child returned home, the father exited the vehicle, entered the residence, and left the child in the vehicle. The incident occurred between 1300 and 1609 hours. During those hours the father was inside the residence and had forgotten his son was in the vehicle. At approximately 1609 hours, the father went outside and observed the child in the vehicle. He removed the child from the vehicle and observed that the child was not breathing. The child was carried into the residence and placed on a sofa, where another adult began administering cardiopulmonary resuscitation (CPR) to the child. Paramedics were called and arrived at the scene and transported the child to a local hospital. The child was treated in the hospital emergency room (ER) for a short time and then was declared deceased. An autopsy was performed and the pathological diagnosis was listed as hyperthermia.

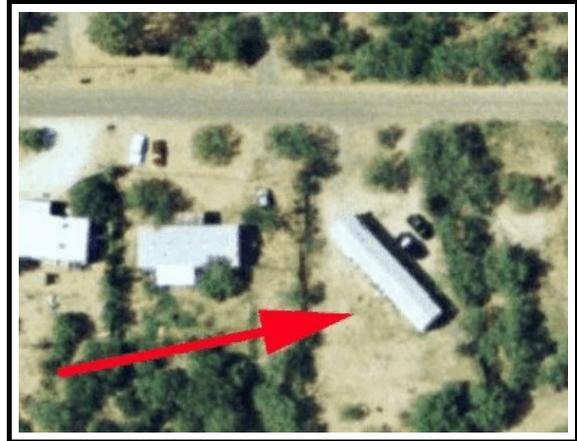
Figure 2. Aerial view of scene, arrow shows location of subject vehicle at time of incident.

The incident occurred between in March 2008 in a sand, dirt and gravel parking area near the driver's residence. The residence was a mobile home that was oriented generally northwest/southeast on the property. The building's exterior height measured 3.2 m (10.4 ft). The subject vehicle was parked on the west side and parallel to the building, heading southeast. The vehicle was located approximately 6.6 m (21.5 ft) from the building (**Figure 2**). Another vehicle was parked between the subject vehicle and the building.

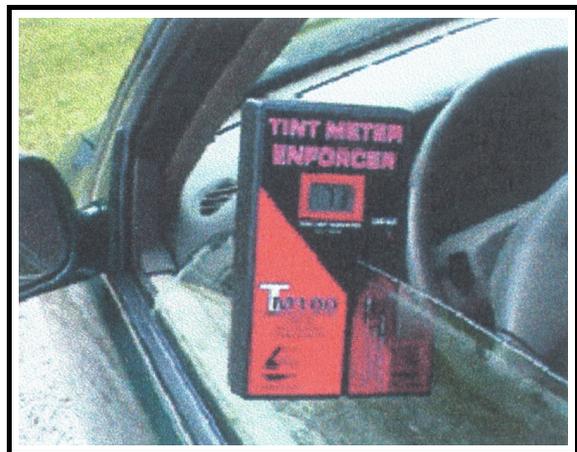
Figure 3. Tint test using Laser Labs Model 100 tint meter.

Investigating law enforcement performed a tint test of the front and rear side window glazing, using a Laser Labs Model 100 tint meter (**Figure 3**). The tint meter measures the Visible Light Transmission (VLT) of a tinted window versus the VLT seen by the human eye. The difference between the two values is given as a percentage. A reading of 54 percent was obtained for both the

front and rear windows. Arizona law requires front row windows to have a VLT of greater than 33 percent. The state has no tint restrictions for rear side windows or back lights. The type of tint meter used in the test measures the darkness of a tinted window and not the reflective qualities. The reflective elements of window glazing and tinting reduce glare and heat generated by visible light.

Window tinting does effect the transmission of shortwave radiation into a vehicle. However, the reflective elements of the subject vehicle's glazing were not determined, and the darkness of the windshield, backlight, and sun roof were not measured due to the limitations of the tint meter used. Due to the southerly orientation of the vehicle, the time of year, the time of day, and reflective properties of the surrounding environment, an optimal amount of shortwave radiation was allowed to enter the vehicle's interior. Therefore, the child was probably exposed to direct shortwave radiation for much of the time he was left unattended, which was approximately three hours.

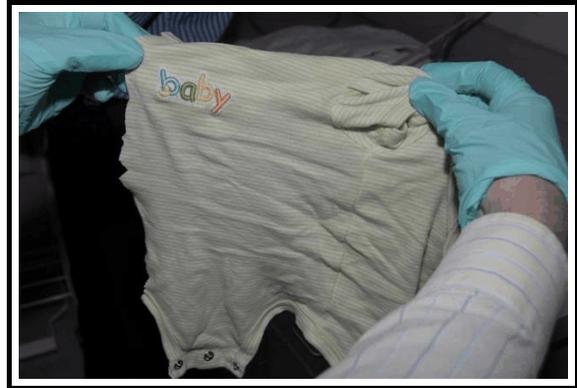
Figure 4. Clothing worn by non-motorist.

The child was wearing a green and white striped Onesie¹ outfit (**Figure 4**) and a diaper. In the ER, the child had a postmortem temperature of 106 degrees F (41.1 C). An investigating sheriff examined the child's body in the ER and noted the following: the child's eyes were partially open and appeared very dry; there was a small abrasion on the right abdomen, and a small abrasion on the right testicle.

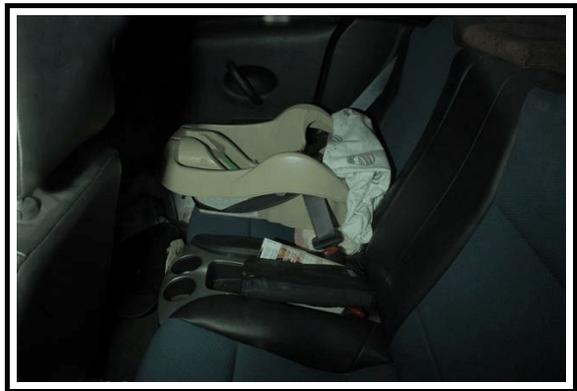
Figure 5. View showing Graco SnugRide stay-in-car base, secured in subject vehicle.

A stay-in-car base from a Graco SnugRide infant safety seat was anchored by the lap and shoulder belt in the second row right seat.

On the day of the incident, the child was placed in the infant safety seat within the vehicle prior to 1100 hours. The seat was a rear facing only Graco SnugRide infant safety seat with a stay-in-vehicle base. The SnugRide was equipped with an adjustable base, a 5-point harness, expanded polystyrene (EPS) energy absorbing foam, and a removable head support. The base was later observed in police photos to be secured by the vehicle's manual lap and shoulder belt in the second row right position (**Figure 5**). A small blanket was placed between the infant seat base and the vehicle's seat back. Photos of the child seat were taken within the residence.

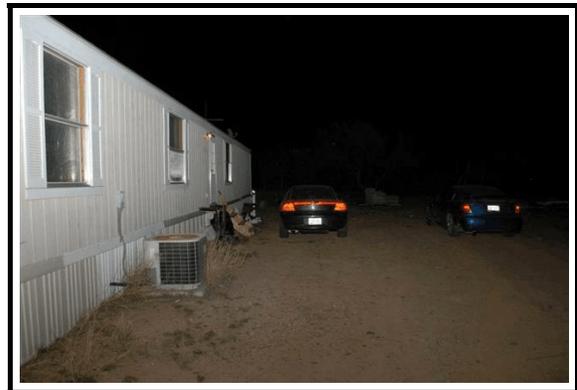
Figure 6. View of west side of residence, facing southeast. The subject vehicle is on the far right.

The father and child arrived at the residence at approximately 1300 hours (**Figure 6**). The father reported that when he arrived at the residence he noticed a door to the residence was open, and that he exited the vehicle and went to find out why the

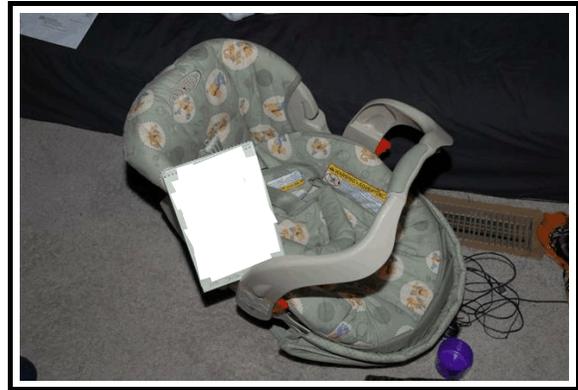
Figure 7. Graco SnugRide infant safety seat, without base attached.

The child was in the infant seat (**Figure 7**). The father removed the child from the vehicle and shouted to the people inside the residence. One adult came outside and told the father to bring the child inside so that he could administer CPR, for which he had been trained. The child was carried inside and placed on a sofa, and one adult began performing CPR on the child. The father dialed 911 on a cellular phone. Sheriffs were dispatched at 1610 hours and the first officer arrived at 1614 hours. Between 1614 and 1615 hours, the fire department arrived, placed the child in an ambulance, and transported him by ground to a local hospital. The paramedics reported that, during transport, the child was without cardiac rhythm or pulse. The paramedics reported that the child's skin appeared blue in color and the child was warm to the touch. The child was treated for a short time, and then was declared deceased in the hospital ER.
