**CALSPAN REMOTE CHILD AIR BAG RELATED FATALITY INVESTIGATION
SCI CASE NO: CA08014**

**VEHICLE: 1996 DODGE INTREPID
LOCATION: FLORIDA
CRASH DATE: FEBRUARY, 2007**

14. Sponsoring Agency Code		
15. Supplementary Note An investigation of an intersection crash involving a child air bag related fatality in a 1996 Dodge Intrepid.

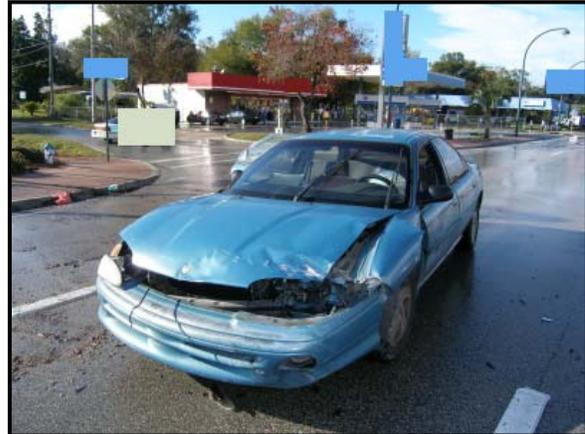
Figure 1: Left front oblique view of the Dodge.

This remote investigation focused on the crash dynamics and injury sources resulting in the death of an 8 year old unrestrained male seated in the front right passenger seat of a 1996 Dodge Intrepid, **Figure 1**. The Dodge was equipped with 1st-generation driver and front right passenger air bags that deployed as a result of a front-to-side impact crash with a 2004 Chevrolet Malibu Classic. Reportedly, the Chevrolet failed to yield the right-of-way and pulled forward from a stopped position at a three-leg intersection across the path of the Dodge. The 49 year old female driver of the Dodge applied the brakes in an attempt to avoid the collision; however, there was insufficient distance for the Intrepid to stop. The crash occurred with the front plane of the Dodge impacting the left rear quarterpanel of the Chevrolet. The force of the impact caused the frontal air bags in the Dodge to deploy.

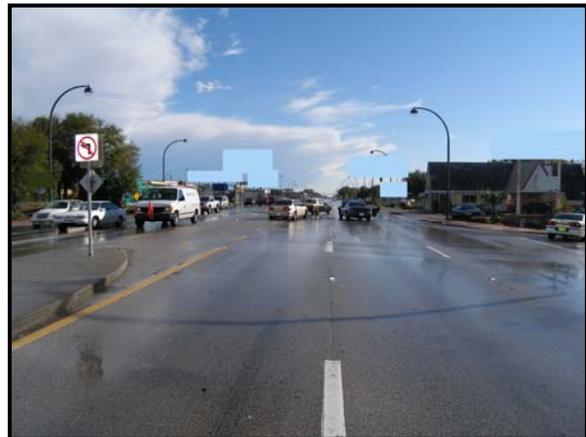
Figure 2: Southward view of the crash site.

Figure 2 is a police image of the crash site looking to the south depicting the intersection and the final rest positions of the vehicles. Due to the wet road surface, no tire marks were observed at the scene by the investigating police officers.

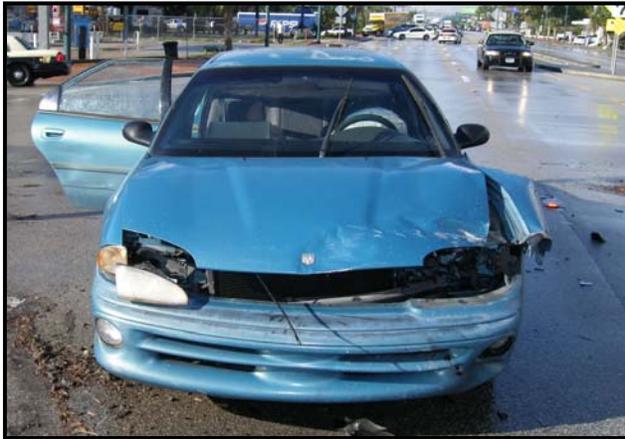
Figure 3: Front view of the Dodge.

Figures 3 and 4 are the front and left lateral views of the Dodge. The front plane of the vehicle sustained a combined width of direct and induced damage that extended across the entire 160 cm (63 in) frontal end width. The direct contact damage began approximately 5 cm (2 in) right of the center and extended to 85 cm (33.5 in) to the left corner. The components damaged in the

direct contact included the bumper fascia, reinforcement bar, left head lamp assembly, hood and left fender. The residual damage was limited to the vehicle's structures forward of the radiator support plane. The police photographs were used to estimate the frontal deformation of the vehicle. The estimated residual crush along the bumper reinforcement bar was as follows: C1 = 23 cm (9 in), C2 = 15 cm (6 in), C3 = 10 cm (4 in), C4 = 5 cm (2 in), C5 = 2 cm (1 in), C6 = 0. The maximum crush was located at C1, the left front bumper corner. The left fender buckled rearward and outboard. The windshield was not fractured and there was no damage to the side glazing or backlight. The Collision Deformation Classification (CDC) of the Dodge was determined to be 01-FYEW1.

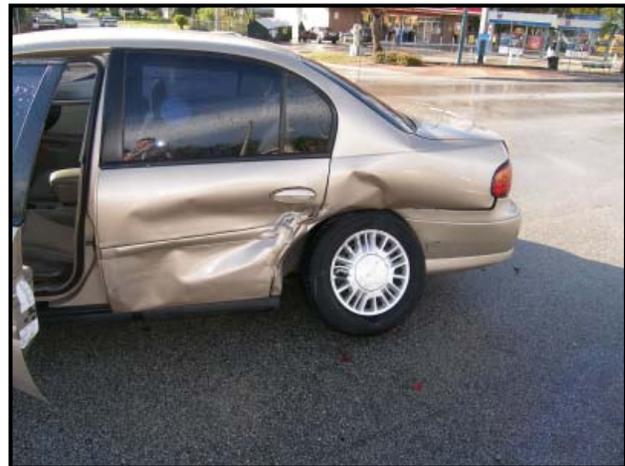
Figure 5: Left side view of the Chevrolet's impact damage.

Figure 5 is a left side view of the damaged Chevrolet. The damage began in the area of the left B-pillar and extended rearward across the left rear door and quarterpanel to the left rear corner. The damage pattern was an estimated 254 cm (100 in) in length. The estimated residual crush profile along the mid door elevation as follows: C1 = 5 cm (2 in), C2 = 10 cm (4 in), C3 = 15 cm (6 in), C4 = 15 cm (6 in), C5 = 10 cm (4 in), C6 = 2 cm (1 in). The left rear tire/wheel was directly involved in the impact. The upper aspect of the tire was deformed inboard indicating bending of the axle. The left rear door was jammed shut by the deformation. There was no damage to the windshield, side glazing or backlight. The CDC of the Chevrolet was determined to be 10-LZEW2.

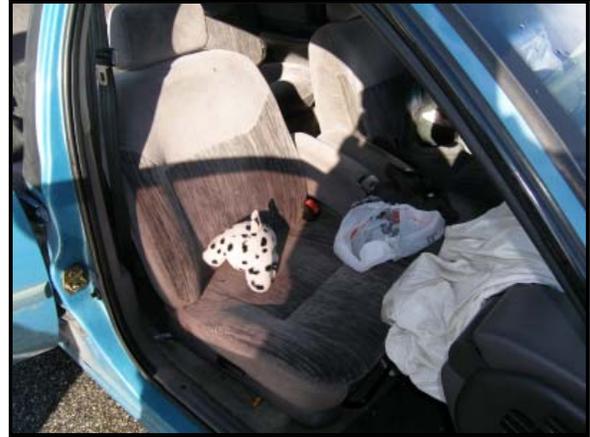
Figure 6: Front right passenger seat of the Dodge.

The interior damage to the Dodge was limited to the deployment of the vehicle's frontal air bags. There was no occupant compartment intrusion from the exterior crash force. The available police images did not adequately document the Dodge's interior in order to determine specific points of occupant contact. The driver seat was adjusted to a mid-track position. The front right seat was adjusted to a rear track position. The seat track adjustment was based on a review of the police images, **Figure 6**.

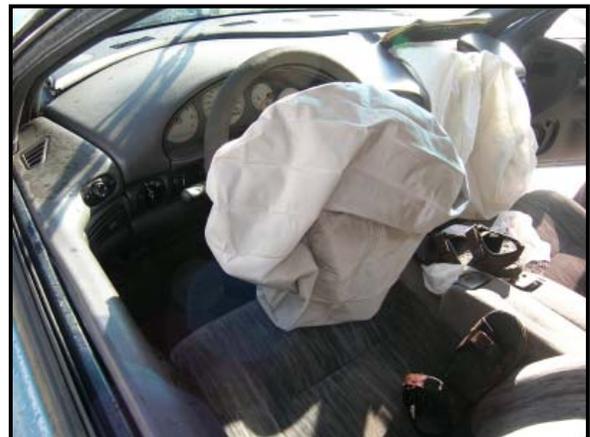
Figure 7: Front interior view of the Dodge.

The 1996 Dodge Intrepid was equipped with 1st-generation driver and front right passenger air bags that deployed as a result of the crash. The driver air bag deployed from a module that was located in the center hub of the steering wheel rim. **Figure 7** is a view of the deployed driver air bag. There was no residual driver contact evidence observed in the image. The front right passenger air bag deployed from a top-mount module located in the right aspect of the instrument panel. The module cover flap was rectangular and hinged at its forward aspect. The cover flap did not appear to be damaged (refer to **Figure 7**). The child passenger's contact to the deploying front right air bag membrane was not documented by the police investigators.

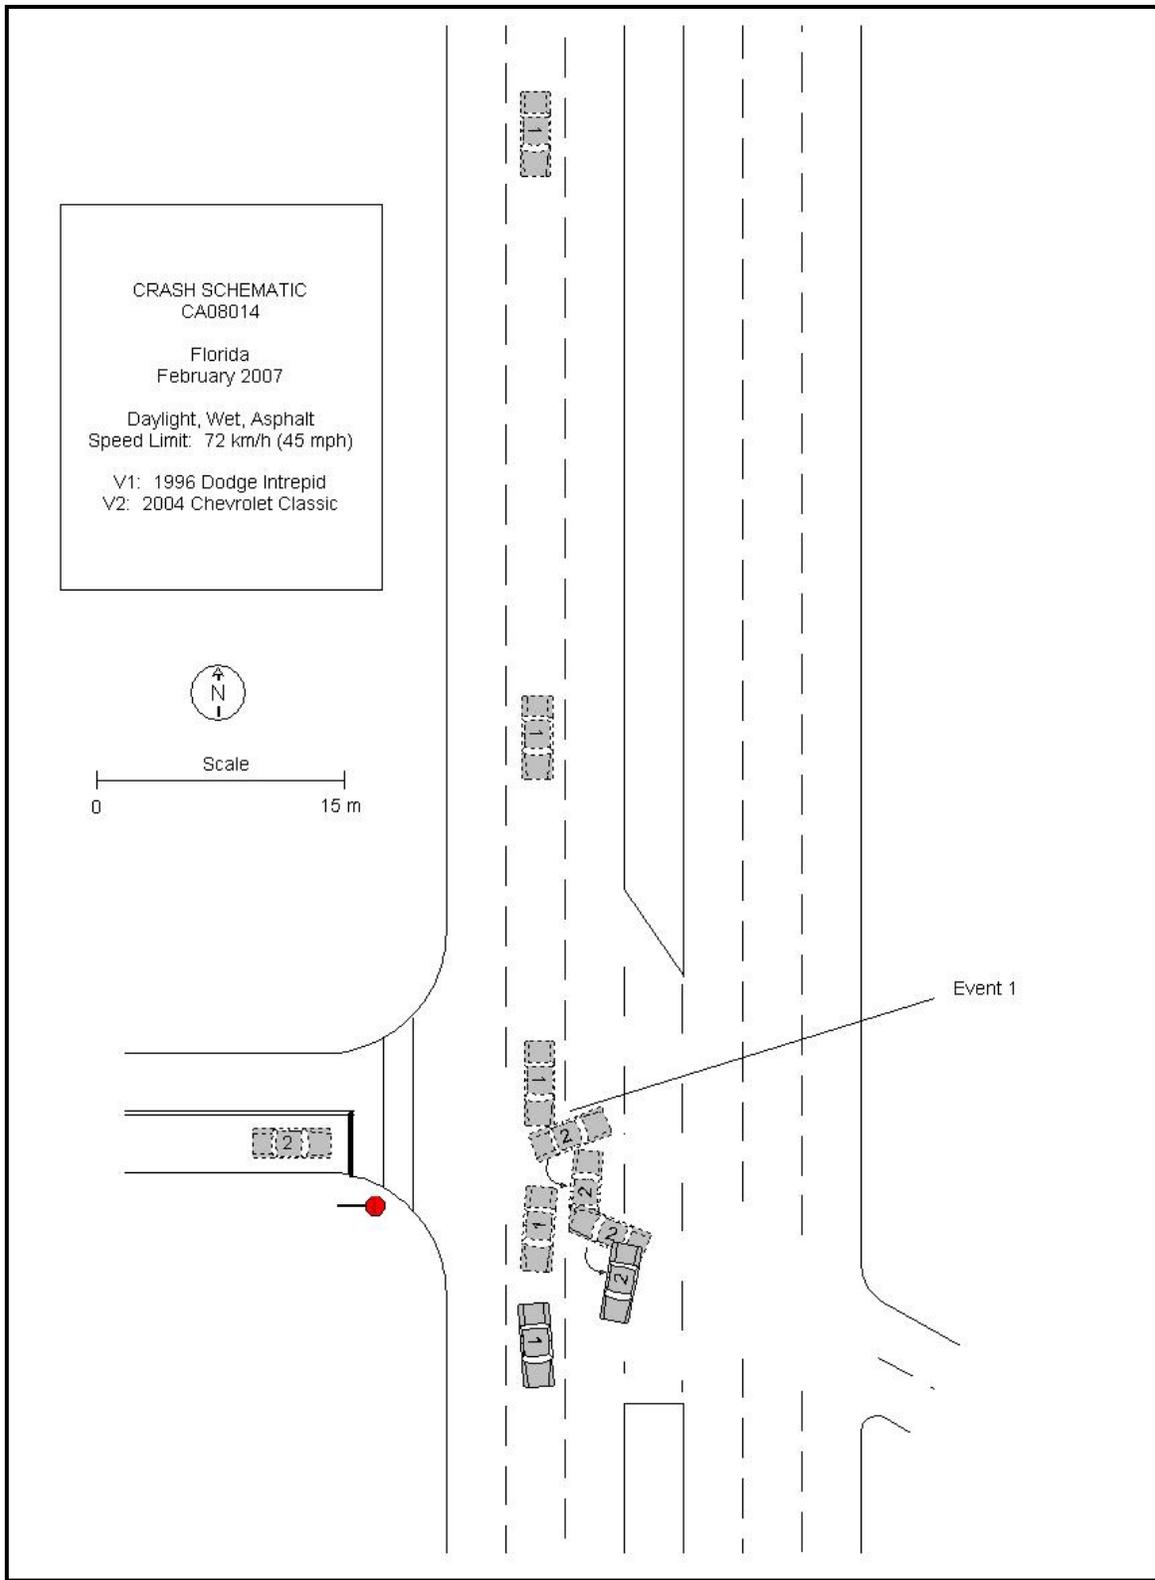
Figure 8: Crash schematic

The center and left aspects of the Dodge's frontal plane struck the left quarterpanel area of the Chevrolet. The direction of the impact force was in the 1 o'clock sector for the Dodge and the 10 o'clock sector for the Chevrolet. The force of the impact caused the frontal air bags in the Dodge to deploy. The impact, located rearward of the Chevrolet's center of gravity, resulted in a counterclockwise (CCW) rotation of the vehicle, and the momentum of the Dodge pushed the Chevrolet laterally to the south. The Dodge remained within the center travel lane and came to rest approximately 15 m (50 ft) from the impact facing south. The Chevrolet came to rest in the center of the road facing south approximately 9 m (30 ft) from the area of the impact. The severity of the impact (delta V) was calculated by the Damage Algorithm of the WINSMASH model using estimated crush measurements. The total delta V of the Dodge was 15 km/h (9.3 mph). The longitudinal and lateral components of the Dodge's delta V were -14 km/h (-8.7 mph) and -5 km/h (-3.1 mph), respectively. The total delta V for the Chevrolet was 16 km/h (9.9 mph). The longitudinal and lateral components were -8 km/h (-5.0 mph) and 14 km/h (8.7 mph), respectively. A schematic of the crash is attached to the end of this narrative report as **Figure 8**.
