Remote Not-In-Traffic Surveillance Power Window Entrapment Investigation
Dynamic Science, Inc. (DSI), Case Number DS08035
2001 Ford Windstar
California
September 2008

**Dynamic Science, Inc.
Crash Investigation
Case Number: DS08035**

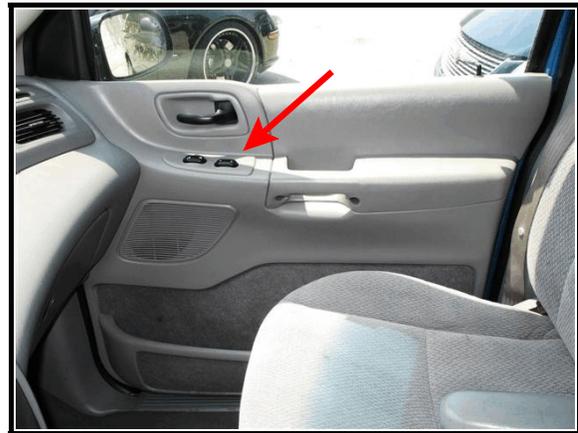
Figure 1. 2001 Ford Windstar exemplar vehicle showing power window switch location

The front row right side power window switch control panel was mounted on the forward aspect of the armrest in a near horizontal position (**Figure 1**). The switch panel consisted of a rocker-style switch that was marked with up and down arrows. This vehicle was not equipped with a lockout feature to prevent passengers from operating the windows. The front right power window switch was positioned on top of the door armrest, just forward of the door midpoint and 13 cm (5.1 in) below the bottom of the window frame. The side door glazing measured 78 cm (30.7 in) in width at the base and 51 cm (20.1 in) in height. The rear door panel was configured with an armrest that extended the full length of the door panel. The arm rest was approximately 13 cm (5.1 in) below the level of the side window frame. The door handle was integrated into the door panel and was above the power window button and arm rest.

The subject vehicle of this investigation was a 2001 Ford Windstar minivan. The Vehicle Identification Number (VIN) was unknown. Standard features included power windows and power door locks with the master control switch panel located at the forward aspect of the driver's door armrest. The vehicle had no lockout feature on the driver's door to prevent passengers from operating the windows.

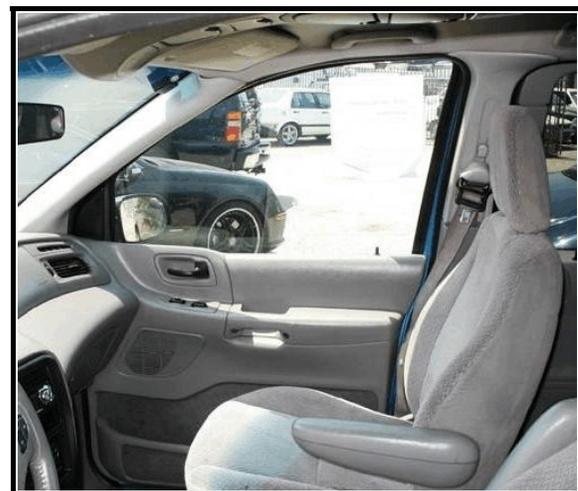
Figure 2. 2001 Ford Windstar exemplar vehicle showing window used for closing force test

An exemplar 2001 Ford Windstar was tested to determine the closing force of the front row right power window (**Figure 2**). The test used a spring scale that had a maximum weight capacity of 34 kg (75 lb). The scale attached to the window glazing and the closing force was measured. With the engine off, a peak closing force of 107 newtons (N) (24 lb) was recorded and with the engine on, a peak closing force of 133 N (30 lb) was recorded.
