Remote Passenger Air Bag Serious Injury Investigation
Dynamic Science, Inc. (DSI), Case Number DS09004
2001 Honda Accord
Washington
March 2006

1. Report No. DS09004	2. Government Accession No.		3. Recipient Catalog No.	
4. Title and Subtitle Remote Passenger Air Bag Serious Injury Investigation			5. Report Date July 22, 2010

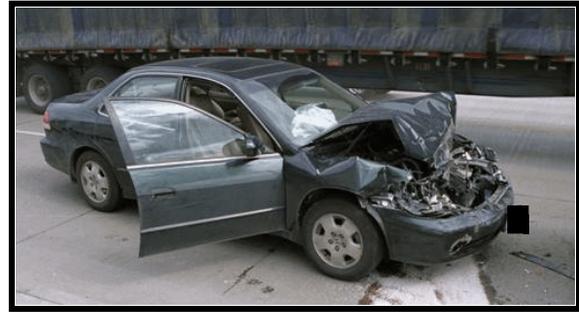
Figure 1. Subject vehicle, 2001 Honda Accord (police photo)

This remote investigation focused on the air bag related injuries sustained by a child seated in a rear-facing Graco SnugRide infant safety seat (ISS). The subject vehicle was a 2001 Honda Accord (**Figure 1**) being driven by a restrained 21-year-old female and occupied by a 4-month-old female, a 2-year-old female, and a 3-year-old female. The 4-month-old female occupant was seated in the ISS which had been installed in the front right seat position. The Honda was initially being driven southbound in the inboard lane of a four-lane, undivided roadway. There were two other vehicles involved in the crash. The first other vehicle was a 2001 Chrysler Town and Country and the second was a 2002 Ford Taurus. The two other vehicles were stopped in heavy traffic ahead of the Honda in the outboard traffic lane. The Honda changed lanes from the inboard lane to the outboard lane. The Honda was unable to stop in time and the front of the Honda impacted the rear of the Chrysler. The Chrysler was then pushed it into the rear of the Ford.

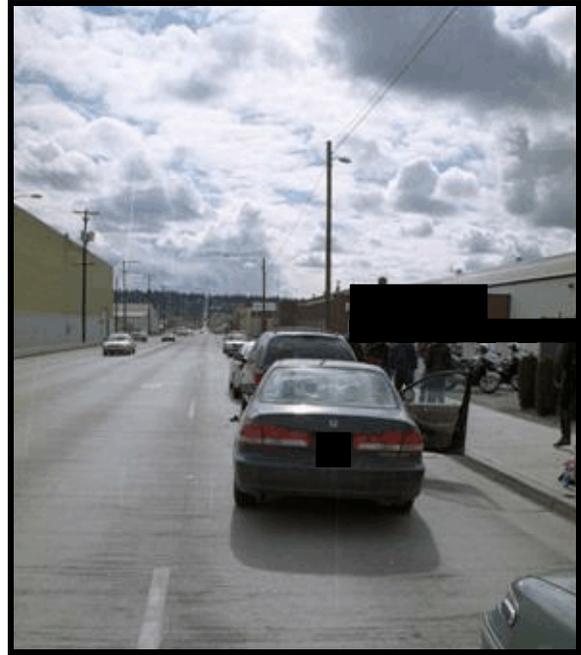
Figure 2. Overview of crash scene, southbound view (police photo)

The three-vehicle crash occurred in the southbound outboard lane approaching a three-leg intersection (**Figure 2**). A second intersection was located south of the three-leg intersection and was controlled by a three-phase traffic signal that was red at the time of the crash. The north/south

roadway was comprised of two southbound travel lanes and two northbound travel lanes. The north and south travel lanes were separated by double yellow painted lines. The concrete roadway was straight, level, dry and free of any defects at the time of the crash. The posted speed limit was 48 km/h (30 mph).

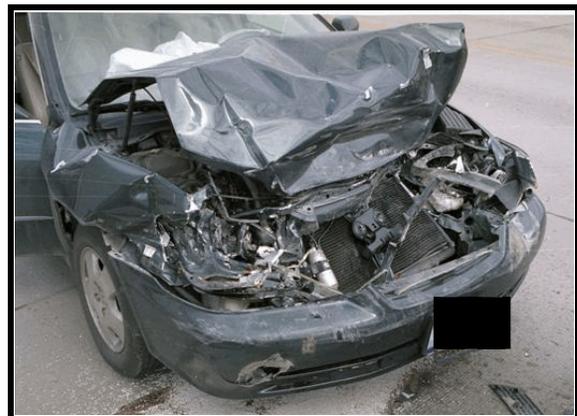
Figure 3. Frontal damage (police photo)

The Honda sustained moderate front end damage during the impact with the Chrysler (**Figure 3**). The direct damage extended across the entire front bumper. There was underride-type damage to the

hood and upper radiator support. The hood was buckled rearward and the leading edge was abraded from contact with the Chrysler. Both headlight assemblies were displaced and the top of the bumper fascia was abraded. The maximum averaged crush was estimated to be 20-25 cm (7.8-9.8 in). The Collision Deformation Classification (CDC) for the frontal impact was 12FDEW1.

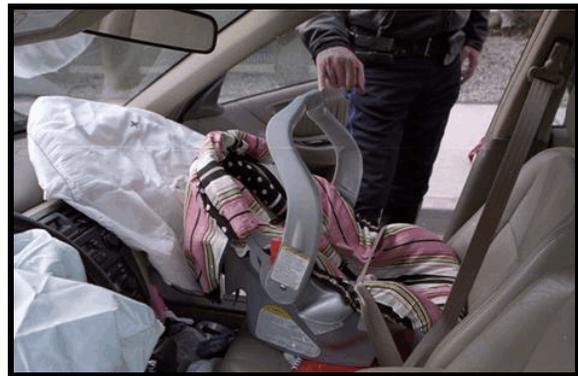
Figure 4. Front row right seat position (police photo)

The Honda's front row seating was equipped with 3-point manual lap and shoulder belts with sliding latch plates and adjustable D-ring assemblies. The D-ring on the right was adjusted to the full-up position; the adjustment on the left was not known. The driver's safety belt had an Emergency Locking Retractor (ELR). The remaining safety belts had switchable ELR/Automatic Locking Retractors (ALR). The front right seat belt was used to secure a rear-facing ISS (**Figure 4**). The retractor mode was not known for this seat belt. The second row left belt was used to secure a forward-facing combination Child Restraint System (CRS) and, according to the police report, the retractor was in the ELR mode. The front seat belts were equipped with retractor pretensioners; it is not known if they actuated during the crash.

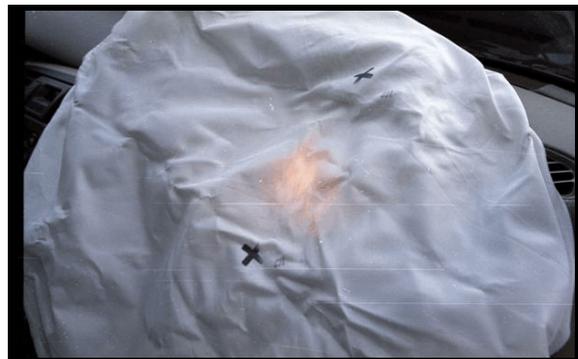
Figure 5. Front right passenger air bag (police photo)

The Supplemental Restraint System (SRS) included an air bag control module, dual-stage driver and passenger frontal air bag, seat-mounted side air bags, and seat belt pretensioners for the front row. The frontal air bags deployed at impact with the Chrysler. The driver's air bag deployed from the steering wheel hub and the front right passenger air bag deployed from the top of the right instrument panel. The passenger air bag face exhibited an area of faint striations that may have been deposited from the ISS during the deployment (**Figure 5**).

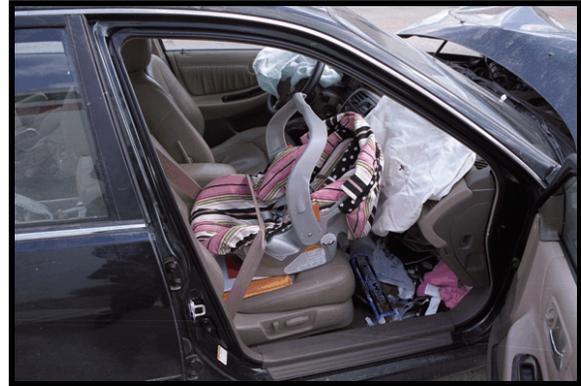
Figure 6. Graco rear-facing ISS (police photo)

A Graco SnugRide rear-facing ISS was positioned in the front row right of the Honda (**Figure 6**). The model number and date of manufacture were unknown. The ISS was designed with a carrying handle, a 5-point harness, and a stay-in-vehicle base. The ISS can be used with or without the base. Labeling on the ISS indicated that the manufacturer recommended that the seat be used for children with a weight between 2.3-10 kg (5-22 lbs) and whose height is 73 cm (29 in) or less. The 4-month-old child was within both the height and weight guidelines. Photos show that the ISS harness was routed through the lower slots. It could not be determined if the ISS had sustained any damage from the air bag deployment.

Shortly after the crash, the driver of the Honda removed the ISS from the vehicle. Later, the ISS was placed back in the vehicle by the police and witnesses to show how the seat had been installed. The shoulder portion of the belt was placed behind the seat. The police made the following observations:

- The stay-in-vehicle base was not used with the ISS. It was located in the second row right seat and was not anchored to the vehicle.
- The ISS had been placed in the vehicle by the driver.
- The cover on the ISS was homemade.
- The carrying handle was in the upright position.
- There were folders and notebooks under the ISS.
- The harness appeared to be very loose for a child that was 4 months old.
- The lap belt portion was used to anchor the ISS and had been routed through the left and right belt hooks.

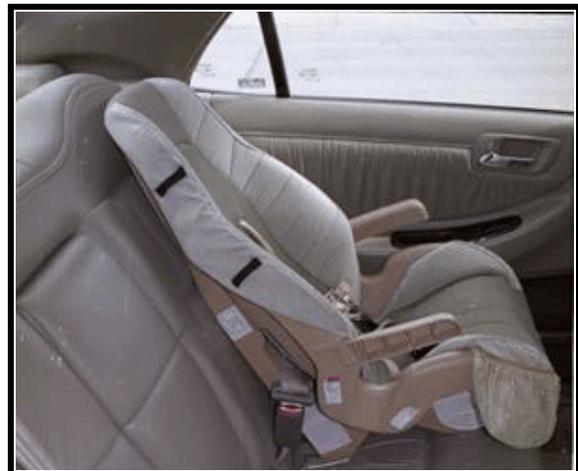
Figure 7. CRS, Dorel High Back Booster (police photo)

A Dorel High Back Booster forward facing CRS was positioned in second row left seat position in the Honda (**Figure 7**). It was not known if the 2-year-old child in this seat position met the CRS age, height, weight recommendations. The police made the following observations:

- The CRS harness straps were twisted to a point where they were only 1.3 cm (0.5 in) wide.
- The CRS was anchored to the vehicle using the 3-point lap and shoulder belt.
- The retractor was in the ELR mode.
- The CRS moved freely 3.0-5.0 cm (1.2-2.0 in) in the forward direction.

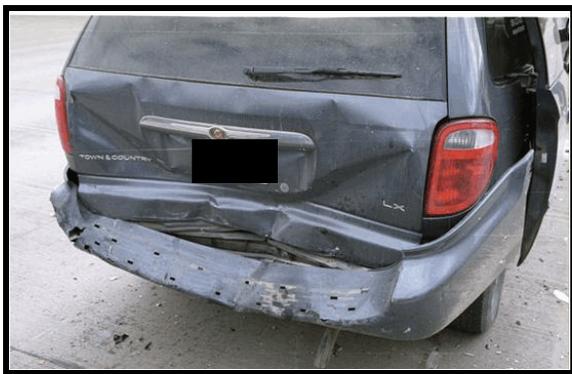
Figure 8. Rear end damage to Town and Country (police photo)

The 2001 Chrysler Town and Country LX 4-door van was identified by the VIN: 2C4GP44311Rxxxxxx. The Chrysler 4-door van was equipped with a 3.3-liter, 6-cylinder engine, and a 4-speed automatic transmission. The Chrysler was being driven by a 29-year-old male and was stopped in traffic before the crash. The vehicle sustained rear end damage from the impact with the Honda and front end damage from the subsequent impact with the Ford. The CDCs for the frontal and rear impacts were 12FDEW1 and 06BDEW1, respectively (**Figures 8-9**). The Chrysler was towed from the scene.

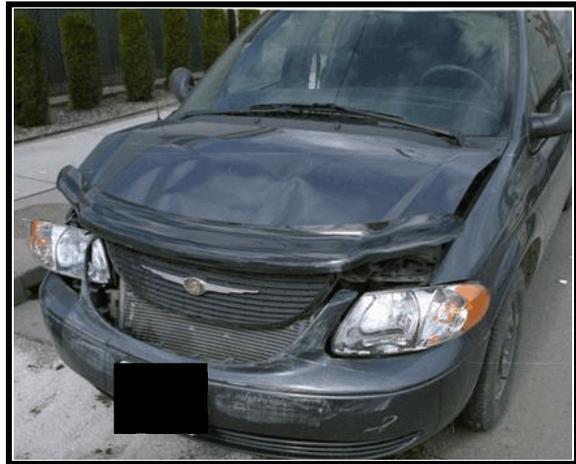
Figure 9. Front end damage to Town and Country (police photo)

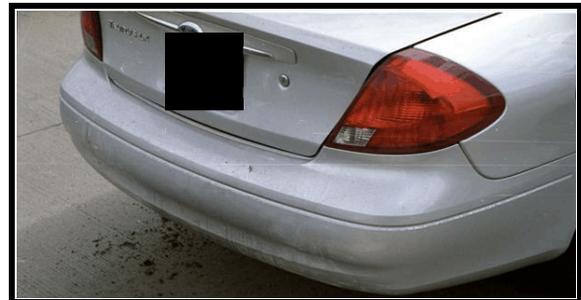
Figure 10. Rear end damage to Ford (police photo)

The 2002 Ford Taurus was identified by the VIN: 1FAFP52262Gxxxxxx. The Ford 4-door sedan was equipped with a 3.0-liter, 6-cylinder engine, front wheel drive, and a 4-speed automatic transmission. The Ford was being driven by a 23-year-old female and was stopped in traffic before the crash. The vehicle sustained rear damage from the impact with the Chrysler and was assigned a CDC of 06BDLW1 (**Figure 10**). The Ford was driven from the crash site by the driver.
