**NOT-IN-TRAFFIC SURVEILLANCE
CALSPAN REMOTE FALLING VEHICLE INCIDENT INVESTIGATION
SCI CASE NO.: CA09010**

VEHICLE: 2002 PONTIAC GRAND PRIX

LOCATION: TEXAS

INCIDENT DATE: FEBRUARY 2009

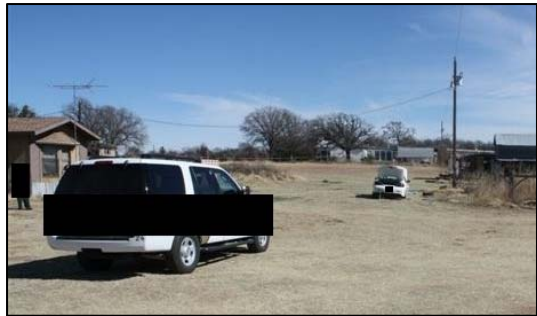
Figure 1. On-scene view of the position of the Pontiac within the yard. (Image provided by the investigating police department.)

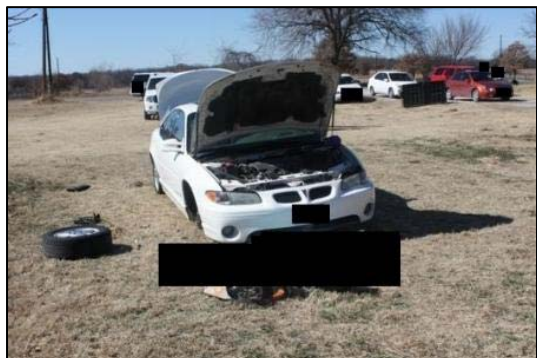
This falling vehicle incident occurred in the backyard area of the victim's residence (**Figure 2**). The yard consisted of cut grass with a subtle cross slope of the yard, sloping downward from left to right across the heading of the Pontiac. The investigating officer

Figure 2. Overall view of the Pontiac on the lawn area. (Image provided by the investigating police department.)

reported that the ground was soft. According to local weather forecasts, the conditions at the time of the incident were dry with a temperature of 10 degrees C (50 degrees F). The sky was clear and the wind speed was reported at 16 km/h (10 mph). A schematic of the incident is included as **Figure 15**.

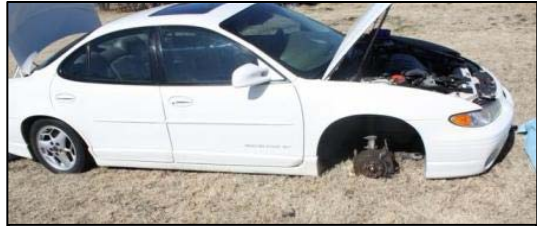
The involved vehicle in this incident was a 2002 Pontiac Grand Prix GT, four-door sedan. The police Informational Report did not capture the Vehicle Identification Number (VIN). The Pontiac Grand Prix GT model was equipped with a transverse-mounted 3.8 liter, V-6 gasoline engine linked to a 4-speed automatic transmission with a console mounted transmission selector lever. This vehicle was front-wheel drive platform. The service brakes were power-assisted 4-wheel disc. The parking brake was pedal activated with the foot pedal located adjacent to the left lower kick panel. The cable actuated parking brake mechanically engaged the rear disc brake pads against the rotor. It is unknown if the parking brake was set on this vehicle at the on-set of the victim's attempted mechanical repairs.

Figure 3. View of the 2002 Pontiac Grand Prix. (Image provided by the investigating police department.)

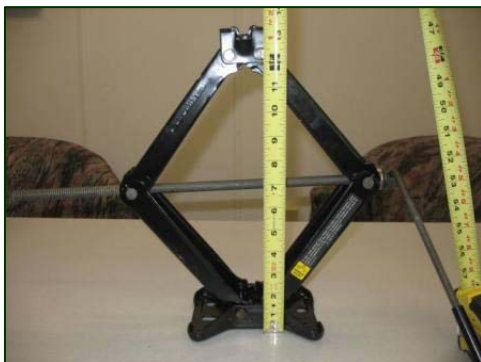
A 2001 Pontiac Grand Prix was used as an exemplar vehicle to document the OEM jack for this falling vehicle investigation. The exemplar OEM scissors jack was examined and the Vehicle Owner's Manual was reviewed for safety warnings. The exemplar jack was a scissors-style jack with a maximum extension height (**Figure 4**) of 34 cm (13.5 in). The H-configuration base

Figure 4. Maximum extension of the exemplar jack.

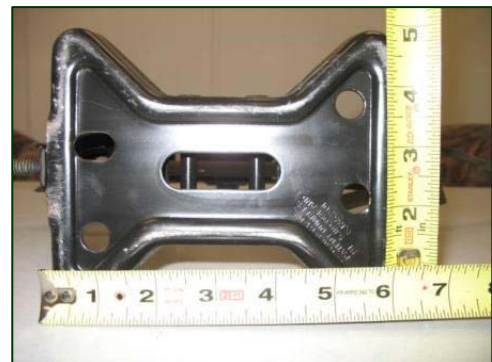
Figure 5. Base dimensions of the exemplar jack.

(Figure 5) of the jack was 15x13 cm (6x5 in). The saddle of the jack was channel-shaped (Figures 6 and 7) to fit the lip of the vehicle's sill. The saddle measured 7 cm (2.75 in) in length, 1 cm (0.375 in) in width and 1 cm (0.5 in) in depth.

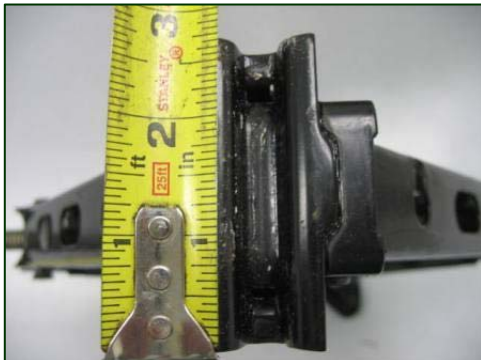
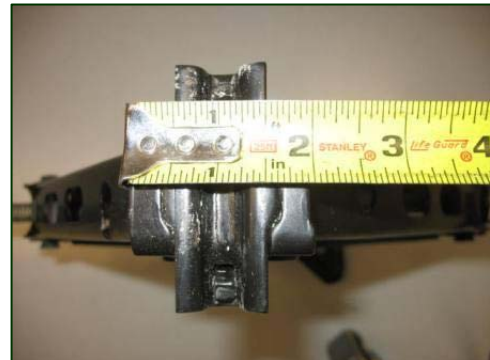
Figure 6. Length of the saddle of the exemplar jack.

Figure 7. Width of the saddle of the exemplar jack.

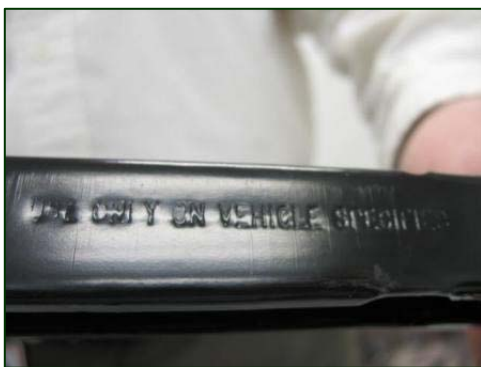
The jack was stamped with a warning that read “Use Only On Vehicle Specified” (Figure 8). A yellow and black warning label affixed to the jack (Figure 9) advised the following:

Figure 8. Stamped warning on the exemplar jack.

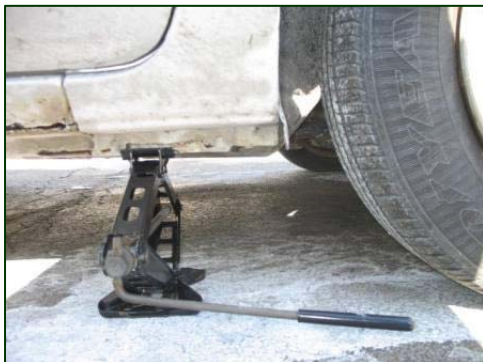
Figure 11. Exemplar vehicle manufacturer’s recommended position of the jack at the right front position.

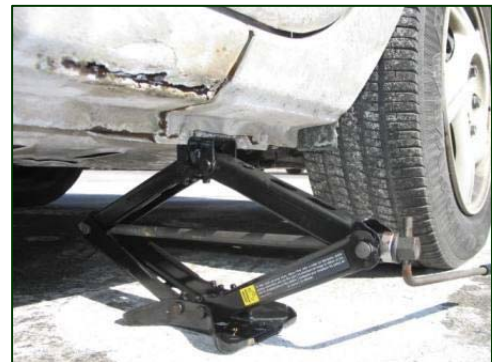
Figure 12. Aft view of the recommended jack position of the exemplar vehicle.

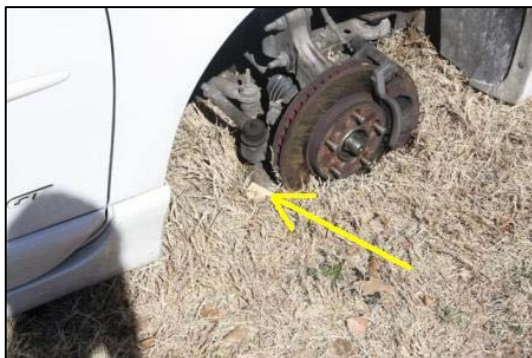
As the victim initiated his process to change the oil in the Pontiac, the vehicle either rolled rearward and fell off the scissors jack, or the base of the jack compressed into the soft soil, causing the Pontiac to roll rearward. It could not be determined if the wood block found under the right front brake rotor (**Figure 13**) was initially under the jack, and as the vehicle rolled rearward, the rotor came to rest on top of the block.

Figure 13. Wood block under the right front brake rotor. (Image provided by the investigating police department.)

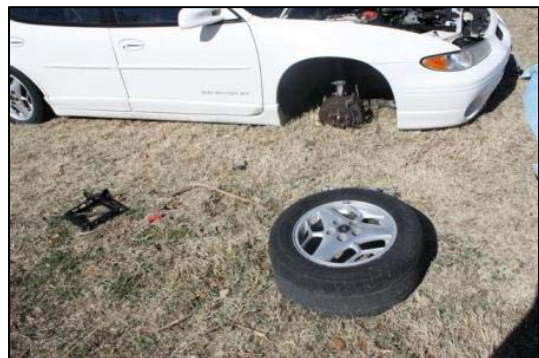
The victim removed the right front tire and wheel from the Pontiac and placed the tire approximately 1 m (3 ft) to the right of the axle position. The removal of the tire was to provide the victim with greater access to the undercarriage of the vehicle. With the Pontiac supported on the OEM jack, the victim crawled under the right front aspect of the vehicle. He was positioned on his right side, facing the back of the Pontiac with his lower extremities extending outboard of the right side surface of the vehicle. The first responders reported that his body was parallel to the front bumper of the vehicle and was completely concealed by the undercarriage.

Figure 14. Post-incident status of the OEM scissors jack and the removed right front tire. (Image provided by the investigating police department.)
