Remote Not-In-Traffic Surveillance Falling Vehicle Investigation
Dynamic Science, Inc. (DSI), Case Number DS09012
1994 GMC Jimmy
Nebraska
January 2009

1. Report No. DS09012		2. Government Accession No.		3. Recipient Catalog No.	
4. Title and Subtitle Remote Not-In-Traffic Surveillance Falling Vehicle Investigation			5. Report Date October 22, 2009

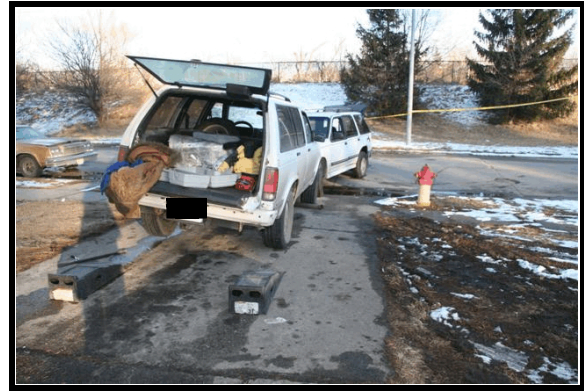
Figure 1. 1994 GMC Jimmy (police photo)

This remote investigation focused on the circumstances surrounding the fatal injuries sustained by a non-motorist when a vehicle rolled off a pair of repair ramps. The subject vehicle was a 1994 GMC Jimmy sport utility vehicle (**Figure 1**). The rear of the vehicle was suspended on a pair of vehicle ramps and was being worked on by a 44-year-old male. For unknown reasons, the vehicle rolled down the ramps and trapped the non-motorist beneath the left rear tire. He was found to be unresponsive when discovered and was transported to a local trauma center by ground ambulance. He died later that day of compression asphyxia to the chest.

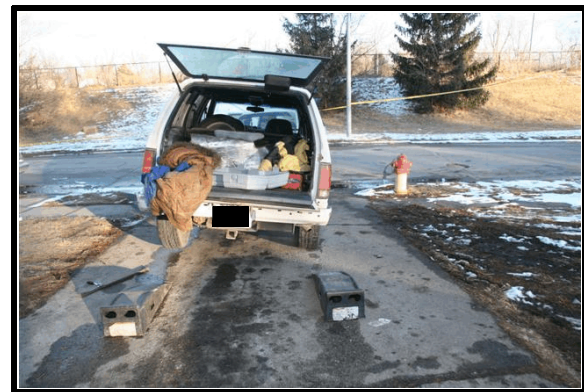
Figure 2. View east from driveway (police photo)

The GMC was parked facing east with its rear tires raised by the ramps (**Figure 2**). The vehicle was owned by another party and was being repaired by the non-motorist in this incident. The ramps were placed with the inclines in the direction of the driveway's negative grade and the ramp's molded tire stops were behind the tires. The police photos show that the right ramp had been placed slightly forward of the left ramp. It was not known if the ramps had been moved post-incident. There was no data available to determine if the vehicle transmission was in PARK or if the parking brake had been engaged. The non-motorist was lying on his back underneath the GMC, forward of the left rear tire. The driver was working on the vehicle's drive shaft; the shaft had been removed and was located on the ground near the right front tire. The manufacturer specifically states on their warning sticker not to remove the drive shaft while the vehicle is on the ramps (see ramp information on the following page).

This incident occurred in January 2009 during the daylight hours. The incident occurred in an east/west driveway adjacent to a private residence that intersected a north/south roadway. The driveway was on private property and was located adjacent to a residence. The driveway was concrete composition and had an estimated eastbound downhill grade of negative 2 percent. There was grass on either side of the driveway. The temperature at the nearest reporting station was 2 degrees C (35 degrees F). The weather was clear and the wind was out of the west northwest at 29 km/h (18 mph). Based on the police photos, it appeared that the driveway was wet in spots from melted snow and that it was wet beneath the repair ramps.

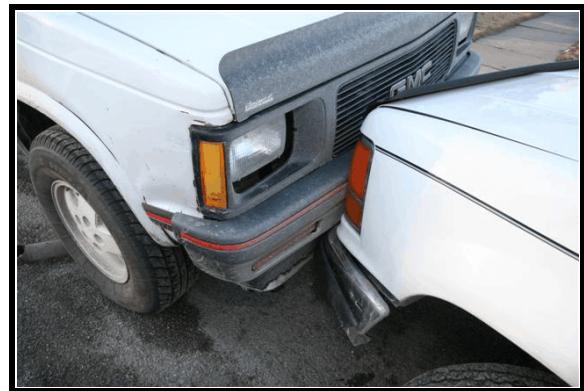
Figure 3. Contact between GMC and Ford. GMC on left side of image (police photo).

The owner of the GMC used his Ford Explorer in an attempt to either push the GMC rearward off the non-motorist or to prevent the GMC from rolling any further forward (**Figure 3**). The effort to free the non-motorist using the Ford was not successful. A floor jack was used by police and rescue personnel to extricate the non-motorist and he was transported to a local trauma center by ground ambulance. He died later that day from crush-related injuries to his chest. According to the coroner's office, the cause of death was compression asphyxia.

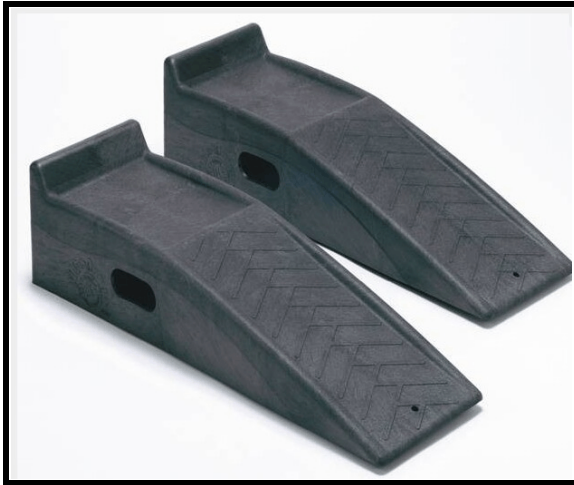
The GMC was being supported on a pair of Blitz RhinoRamps Model 8000 vehicle ramps (**Figures 4-5**). The Model 8000 was designed for vehicles with a Gross Vehicle Weight (GVW) up to 3629 kg (8000 lbs). The GMC had a GVW of 2132 kg (4700 lbs). The ramps were constructed of structural foam plastic and had non-skid bases. The ramp specifications are as follows:

- Weight tolerance:** 907 kg (2000 lbs) per ramp or 1814 kg (4000 lbs) per pair
- Length:** 88.9 cm (35.0 in)
- Width:** 26.6 cm (10.5 in)
- Height:** 21.6 cm (8.5 in)
- Incline:** 17 degrees

Figure 4. Blitz RhinoRamp (exemplar view)

- Do not exceed rated capacity of 907 kg (2000 lbs) each or 1814 kg (4000 lbs) per pair or 3629 kg (8000 lbs) GVW.
- Use only on hard level surface.
- Center loads between ramps.
- Use only as a matched pair to support either front or back end of vehicle.
- Inspect ramps before each use.
- Use on vehicles with maximum tire width of 19 cm (7.5 in).
- Do not use other lifting equipment in conjunction with the ramps.
- Do not disconnect brakes, engine, transmission components, driver train, drive shaft, universal joints, or wheels while the vehicle in on the ramps.
- Never accelerate or apply brakes suddenly.
- Do not use ramps on slick surfaces.
- Set emergency brake.
- Place vehicle in park (or in reverse for manual transmissions).
- Chock wheels on ground.

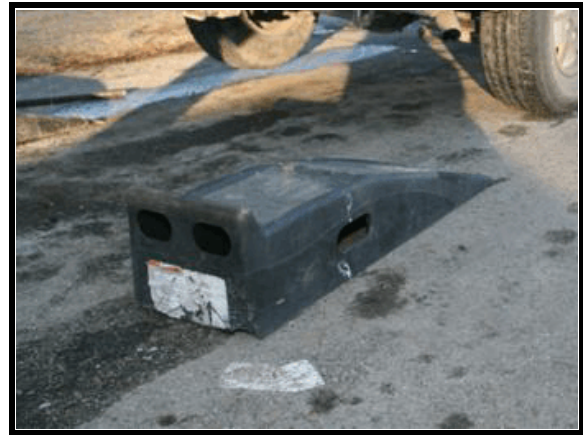
Figure 5. Wheel ramp (police photo)
