Remote Not-In-Traffic Surveillance Falling Vehicle Investigation  
Dynamic Science, Inc. (DSI), Case Number DS09015  
1996 Pontiac Grand Am  
Indiana  
November 2008

**Dynamic Science, Inc.**  
**Crash Investigation**  
**Case Number: DS09015**  
**TABLE OF CONTENTS**

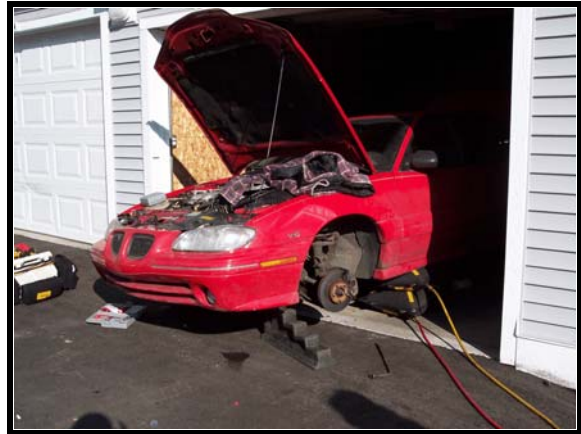
**Figure 1.** 1996 Pontiac Grand Am

This incident occurred in November 2008 at 1300 hours. The subject vehicle was a 1996 Pontiac Grand Am four-door sedan (**Figure 1**). The vehicle was lifted and supported on a jack. The left front wheel had been removed and a 51-year-old male was under the vehicle working on a hose located at the front end near the engine. For undetermined reasons, the vehicle slipped off the jack and fell onto the victim's chest. The victim was pinned by the left front brake assembly. The wife of the victim called for help and the victim's son heard his mother's calls. The son unsuccessfully attempted to lift the vehicle off the victim. The fire department arrived shortly after the incident and determined that the victim did not have a pulse. Emergency personnel were able to extricate the victim and, after performing CPR for several minutes, were able to establish a pulse. The victim sustained rib and sternum fractures, as well as a collapsed lung. He was transported to a local hospital for treatment. He remained in the hospital for 11 days until succumbing to his injuries.

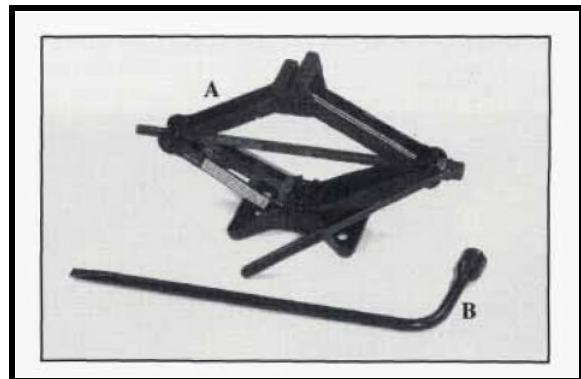
**Figure 2.** Exemplar view of scissors style jack

The Pontiac was equipped with a scissors style jack that was stored in the trunk (**Figure 2**). According to one interviewee, the vehicle owner was using the original equipment jack and the vehicle was being hoisted from the left side. The vehicle was designed to be hoisted with the jack head positioned in the frame notch nearest the tire being removed (**Figure 3**). It is not known if the jack had been positioned correctly. In one police photo, it appeared that a block of wood had been used to chock the right rear tire (**Figure 4**).

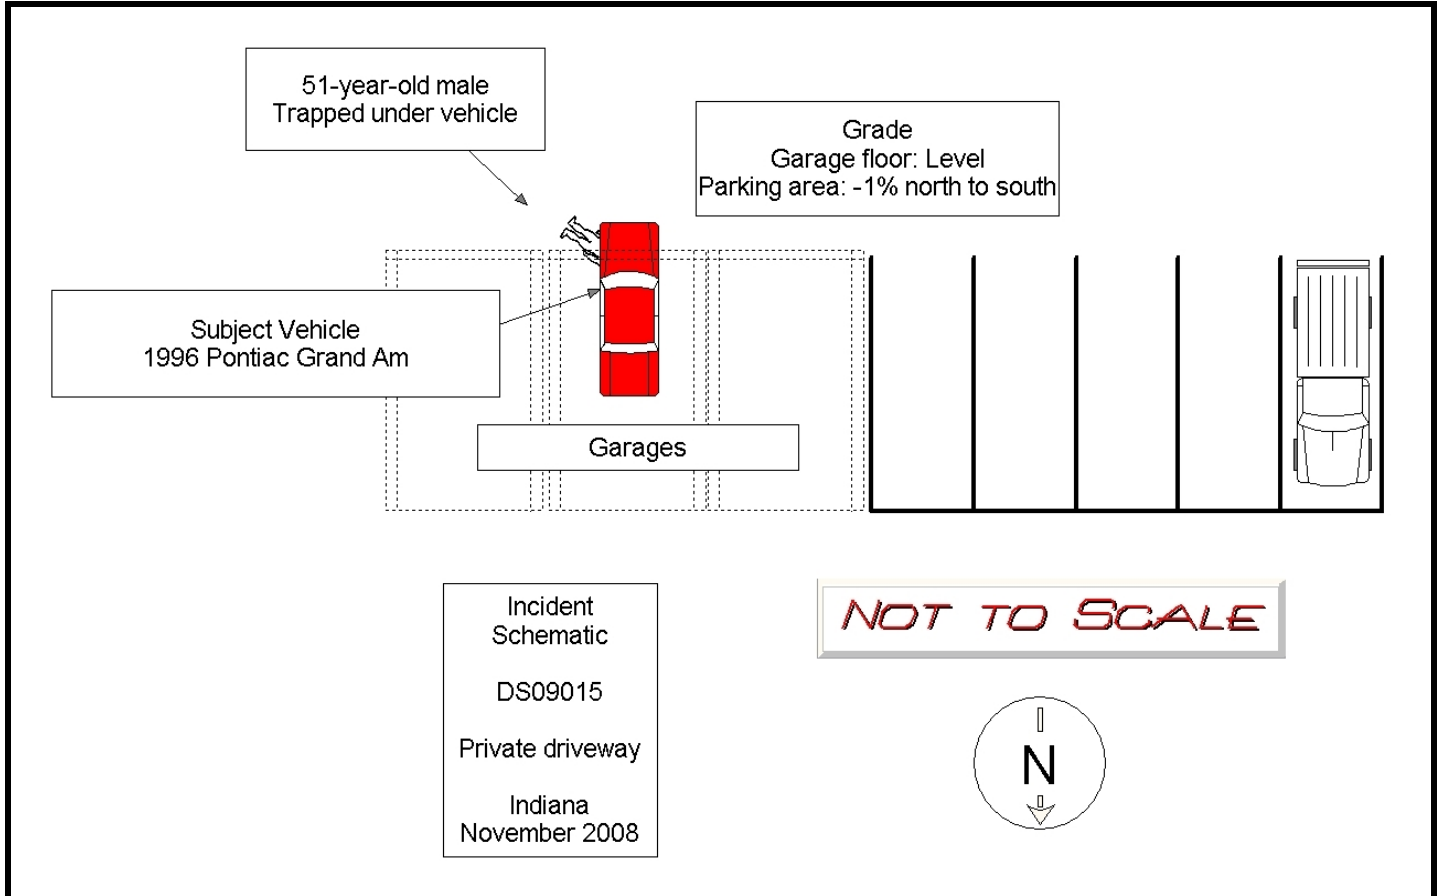
**Attachment 1. Scene Diagram**

The incident occurred in a residential garage located in an apartment complex. The vehicle was partially in the garage and partially in the parking area. The floor of the garage was concrete and the parking area was of asphalt composition. The floor of the garage was level; the parking area appeared to have had a slight negative grade of approximately 1 percent. The garage floor and parking area were dry.

The Pontiac was parked with the front end partially in the parking area. The vehicle was on a jack and the left front wheel had been removed. The 51-year-old male was on his back under the left front of the vehicle, with his feet oriented towards the east. He was working on a hose that was located at the front of the vehicle near the engine compartment.
