**VERIDIAN REMOTE AIR BAG DEPLOYMENT/FRACTURED STEERING WHEEL
ASSEMBLY INVESTIGATION
SCI TECHNICAL SUMMARY REPORT**

SCI/NASS COMBO CASE NO. : 97-45-032J

SUBJECT VEHICLE: 1997 JEEP GRAND CHEROKEE

CRASH DATE - MARCH 1997

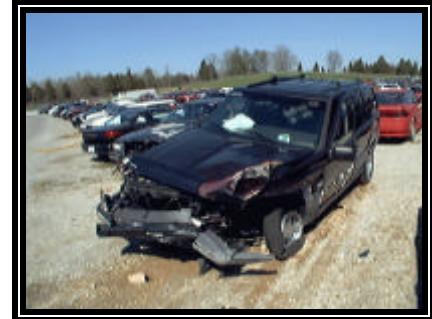
This remote investigation focused on a single vehicle crash involving a 1997 Jeep Grand Cherokee equipped with a dual frontal air bag system (**Figure 1**). The Jeep Grand Cherokee was traveling westbound on a six-lane (three westbound, three eastbound), divided interstate roadway when it departed the right side of the roadway and sideswiped a concrete bridge wall with the right side plane of the vehicle. The Grand Cherokee crossed the three westbound travel lanes where it departed the left side of the roadway and struck the concrete median barrier with the left front corner area of the vehicle. The impact with the median barrier deployed the frontal air bag system in the vehicle and the driver initiated a forward trajectory. His upper body probably compressed the deployed driver's air bag and loaded the underlying steering wheel rim which contributed to the steering wheel spokes separating the wheel from the steering wheel assembly. The Grand Cherokee was redirected in a clockwise direction and struck the concrete median barrier a second time with the left rear side plane. It traveled back onto the travel lanes and came to rest in the center westbound travel lane. The 75-year-old driver was probably unrestrained and sustained a fracture of the left zygoma body with a slightly depressed left zygomatic arch fracture, fracture of the maxillary sinus, fractures of the left 4th, 5th ribs, and fracture of the left malleolus. He also suffered a laceration of the left eye, left periorbital ecchymosis, contusion of the left chest, abrasion of both wrists, and contusion of the left ankle. He was transported by ambulance to a trauma center and released two days following the crash.

Figure 1. Damaged 1997 Jeep Grand Cherokee

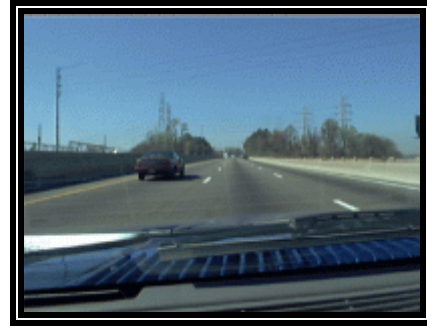
This single vehicle crash occurred on the westbound lanes of a six-lane divided interstate highway during the daylight hours of March 1997 (**Figure 2**). At the time of the crash, the asphalt roadway was dry and there were no adverse weather conditions. The eastbound and westbound travel lanes were separated by a concrete median barrier. The posted speed limit for the interstate highway was 89 km/h (55 mph).

Figure 2. Crash scene

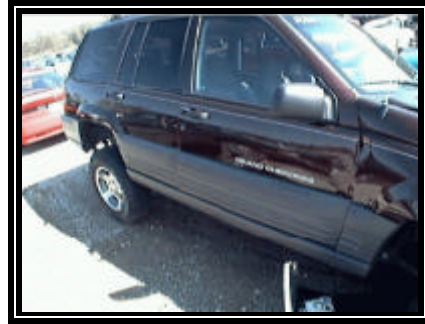
The 1997 Jeep Grand Cherokee sustained moderate frontal damage as a result of the frontal impact with the concrete median and minor damage as a result of the sideswipe impacts. The initial right side impact resulted in abrasions and minor deformation to the right front and right center aspects (**Figure 3**). The combined direct and induced damage began 237 cm (93") forward of the right rear axle and measured 285 cm (112") forward along the right side of the vehicle. The Collision Deformation Classification (CDC) was revised based on the SCI case review and was 12-RYES-1. The direct damage that resulted from the frontal impact with the concrete median barrier began 5 cm (2") left of center and extended laterally 73 cm (29") to the left bumper corner. The combined direct and induced damage measured 140 cm (55") from bumper corner to bumper corner (**Figure 4**). The bumper fascia was fractured inboard of the front left corner and the entire fascia was displaced to the right. The front left fender sustained longitudinal and lateral crush from the impact. The entire frontal structure was displaced to the right as a result of direct contact and induced damage. The headlight assemblies and grille were separated from the vehicle. The offset frontal impact caused the rotation of the front axle which resulted in the shortening of the left wheelbase by 25 cm (10") and the extension of the right wheelbase by 19 cm (7"). Six crush measurements were taken by the NASS researcher along the front bumper and were as follows: C1 = 43 cm (17") C2 = 11 cm (4"), C3 = 4 cm (2"), C4 = 1 cm (1"), C5 = 0 cm , C6 = 1 cm (1"). The CDC for the frontal impact with the concrete median barrier was revised by SCI and was 11-FYEW-2. The left rear sideswipe impact resulted in minor damage to the left rear aspect of the Grand Cherokee (**Figure 5**). The direct damage began 87 cm (34") rear of the left rear axle and measured 121 cm (48") forward along the left side. The max crush was located 48 cm (19") aft of the left rear axle at C3 and measured 3 cm (1"). The SCI revised CDC for this impact was 12-LBES-1.

Figure 3. Right side damage

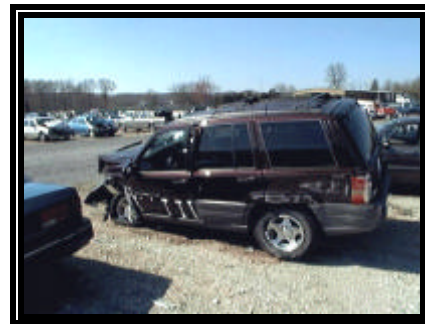
Figure 5. Left side damage

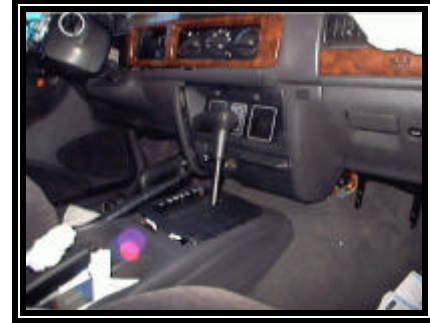
Interior damage to the 1997 Jeep Grand Cherokee was a result of occupant contact and compartment intrusion. The windshield was fractured from impact forces. Longitudinal intrusions included the left steering assembly and left floor pan. The knee bolster left side instrument panel trim were displaced (**Figure 6**). The steering wheel fractured and separated from the tilt steering column. The tilt steering column was adjusted to the center position. The accelerator and brake pedals were displaced from occupant contact.

Figure 6. Interior view

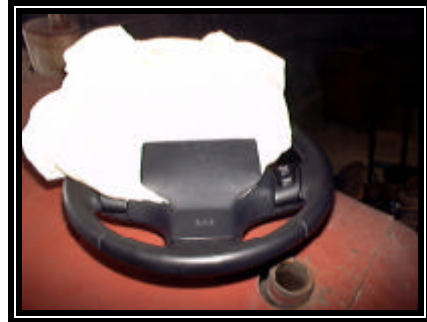
The Supplemental Restraint System (SRS) was comprised of a driver air bag and front right passengers air bag. The driver's air bag module cover opened in the typical "H" pattern during the deployment sequence (**Figure 7**). The air bag was designed with two tethers and no visible vent ports in the air bag membrane. It appeared to have fully inflated during the deployment sequence. The inflator unit was manufactured by Morton International. The front right passenger's air bag deployed from a mid-mount module configured with a single cover flap design. The cover flap was rectangular in shape and was hinged at the top aspect. The front right passenger's air bag was not vented and was not tethered.

Figure 7. Driver's air bag

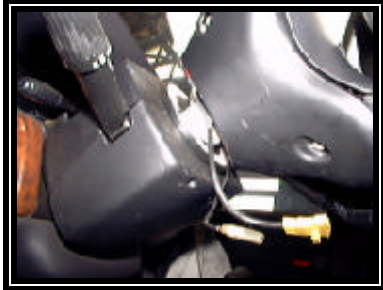
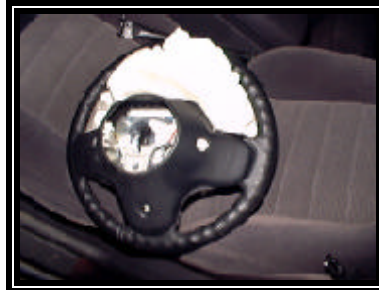
The steering wheel rim and spokes fracture consisted of a one-piece cast alloy material. The spokes fractured at the flange adjustment in the steering shaft which resulted in the steering wheel separation (Figures 8 and 9).

Figure 8. Lateral view of fractured steering wheel assembly

Figure 9. View of the rear aspect of the steering wheel

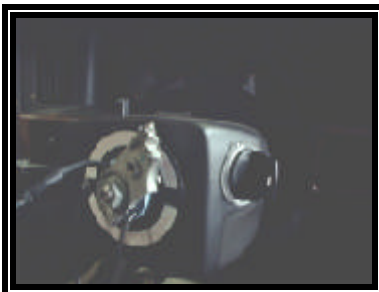
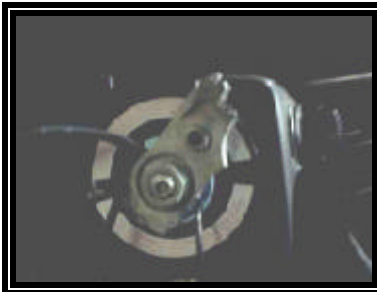
The first fractured area involved the left steering wheel spoke located near the center of the wheel while the second area was located radially at the outer limit of the right spoke (Figures 10 and 11).

Figure 10. Fractured mounting bracket

Figure 11. Close up view of fractured mounting bracket

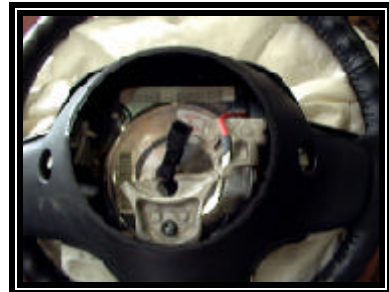
In the images below showing the underside of the steering wheel assembly (Figure 12), it appeared that the inflator housing was not compromised during the inflation cycle. The base of the unit is clearly visible and is shown with the manufacturers identification labels still in place. Additionally, there were no reported hot spots or generant debris found in the vehicle interior which would have been present in a typical inflator housing failure.

Figure 12. Close-up of rear aspect of the steering wheel and inflator module
