**CALSPAN REMOTE DRIVER AIR BAG/FATALITY**

**DEPLOYMENT CRASH INVESTIGATION**

**CALSPAN CASE NO. CA 97-021**

**SUBJECT VEHICLE - 1994 OLDSMOBILE CUTLASS CIERA S  
VEHICLE #2-1997 FORD TAURUS  
VEHICLE #3-1994 DODGE RAM 4X2 PICK-UP TRUCK**

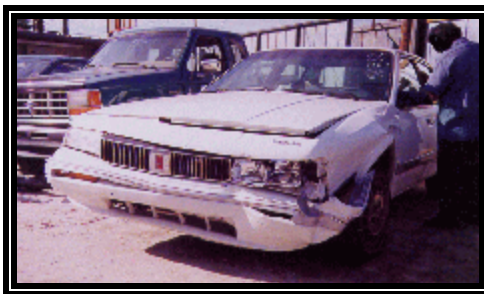
**Figure 1.** Left front three-quarter view

The Oldsmobile sustained moderate frontal damage which resulted in a Collision Deformation Classification (CDC) of 12-FYEW- 1. Maximum crush was estimated at 25 cm (10 in) at the left front bumper corner from police and insurance photographs (refer to Figures 1 and 2). The SMASH missing vehicle algorithm calculated a total Delta V of 24.3 km/h (15.0 mph) and a longitudinal change in velocity of -24.3 km/h (15.0 mph) for the Oldsmobile. This impact initiated the deployment of the driver's side air bag.

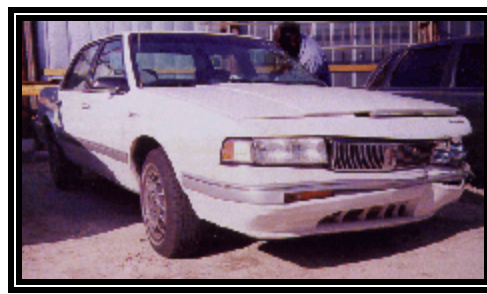
**Figure 2.** Right front three-quarter view

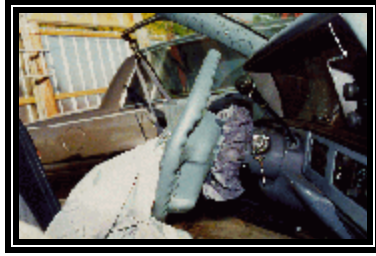
**Figure 3.** Perpendicular view of the deployed air bag and the steering wheel rim

The driver side air bag module cover opened in the typical H-configuration. There were symmetrical vertical abrasions and cloth transfers on the lower segment of the upper module cover flap. The face of the air bag had several drops of blood on its fabric that may have been a result of a nosebleed possibly sustained by the driver. Injury information did not reveal external lacerations that may have resulted in the discharge of blood.

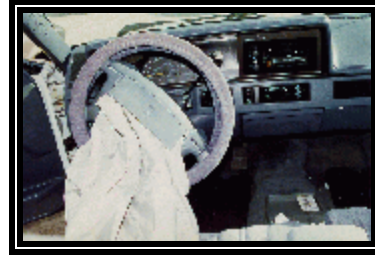
**Figure 4.** Upper module cover flap and the deployed air bag

The Oldsmobile was occupied by the 78 year old female driver with a reported height of 157 cm (62 in) and weight of 64 kg (142 lbs). The supplement to the Police Accident Report (PAR) reported the driver as unrestrained. Lack of evidence within the vehicle confirmed this. There were no apparent transfers on the belt webbing from clothing, contact from the air bag module cover flap, and/or the air bag. In addition there was no loading evidence on the belt webbing. She was presumably seated with the seat track adjusted to a forward position. The forward positioned, unrestrained driver was at, or within a close proximity to the air bag module cover flap when it opened to deploy the air bag. She sustained vertical abrasions on the medial aspect of her chest (refer to Image No. 19) that were consistent with the vertical abrasions on the cover flap (refer to Image No. 6). The flap opened against the female driver\*s chest and caused the following injuries:

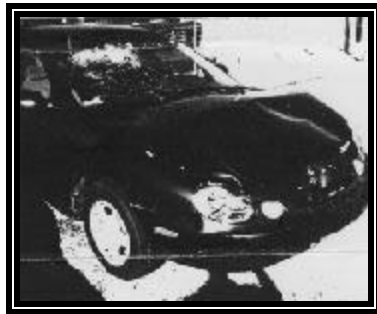
**Figure 5.** Ford Taurus right front three-quarter view

The Ford Taurus sustained moderate rear damage from contact with the Oldsmobile as well as minor damage to its frontal plane from striking the rear of the Dodge. The rear damage had an estimated CDC of 06-BDEW-1 (from insurance company photographs). The missing vehicle algorithm of the SMASH program calculated the total Delta V at 21.2 km/h (13.0 mph). The frontal damage was located primarily to the grill and hood and had an estimated CDC of 12-FDMW-1 (from insurance photographs). This impact caused the driver and passenger side air bag systems to deploy. Windshield cracking on the passenger side resulted from passenger side air bag flap contact.

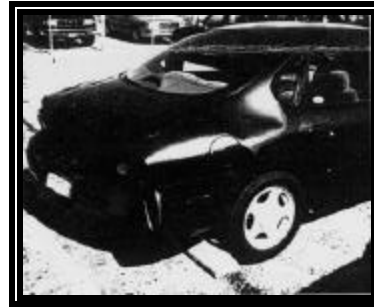
**Figure 6.** Ford Taurus right rear three-quarter view
