On-scene investigation, Vehicle v. Parked Vehicle
Dynamic Science, Inc. (DSI), Case Number (DS97027)
1998 Dodge Ram
California
December, 1997

1. Report No. DS97027		2. Government Accession No.		3. Recipient Catalog No.	
4. Title and Subtitle In-Depth Accident Investigation				5. Report Date June 1998

Dynamic Science, Inc.
Accident Investigation
Case Number: DS97027

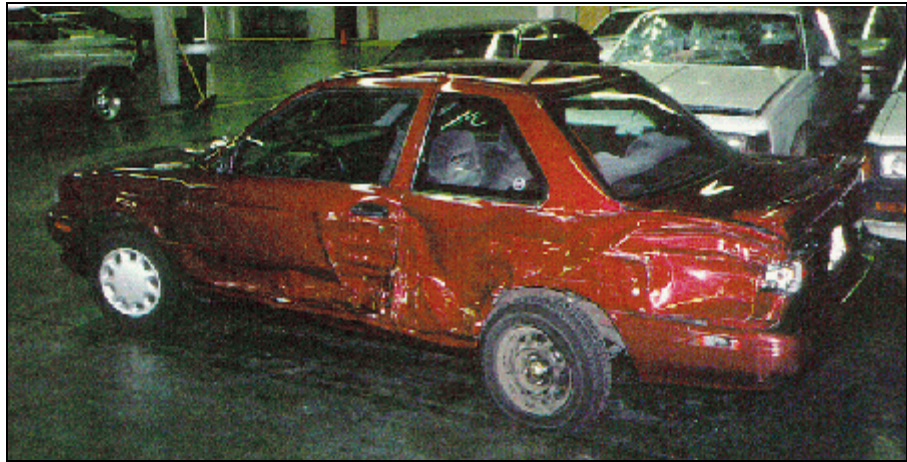
Figure 3. Parked vehicle 1, 1994 Nissan Sentra

This collision occurred in California in December 1997 at 0020 hours. The crash took place on a five-lane, two-way, east/west oriented residential roadway. It was raining at the time of the collision. The roadway was dark, but the streetlights were on. On the right side of the roadway were two properly parked, unoccupied vehicles: a 1994 Nissan Sentra and a 1993 Acura sedan. The vehicles were situated at either end of a No Parking area associated with a fire hydrant. The vehicles were approximately 14 M (46 ft.) apart.

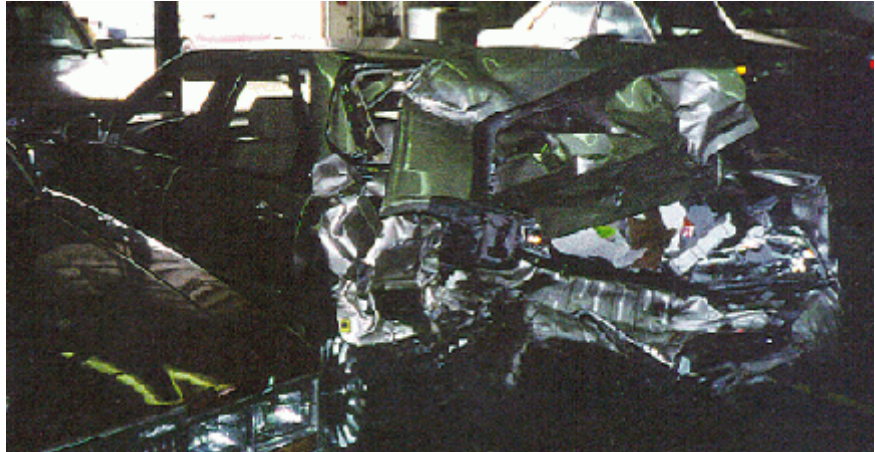
Figure 5. Parked vehicle 2, 1993 Acura Legend

rear-ending the Acura. Vehicle 1 sustained a longitudinal delta V of -26 km/h (-16 MPH)¹ while impacting the Acura. According to the owner of the parked vehicles, the police believed that the first impact caused the air bag deployment. It is more likely that the second impact was the more severe and likely deployed the air bags in the case vehicle. The parked Acura was pushed forward and to the left so that it was blocking the travel lane. Vehicle 1 came to rest in the area formerly occupied by the parked Acura.

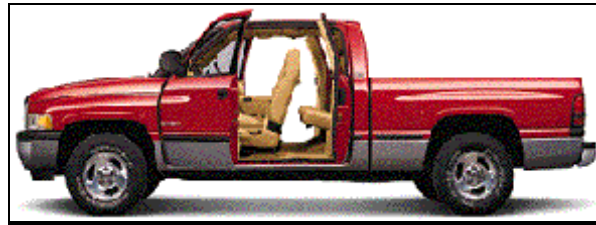
Figure 9. Exemplar view, case vehicle

Description:	1998 Dodge Ram Club Cab 4 door pickup 4x2
VIN:	1B7HC13Z6WJXXXXXX
Odometer:	Unknown
Engine:	5.9 L 8 cyl
Reported Defects:	None
Cargo:	Unknown
Damage Description:	Moderate rearward crush to the front bumper and grille.
CDC - Impact 1:	Unknown
CDC - Impact 2:	12FDEW1
