**REMOTE AIR BAG RELATED DRIVER FATALITY INVESTIGATION**

**VERIDIAN CASE NO. CA97-035**

**VEHICLE - 1994 CHEVROLET CORSICA**

**LOCATION - NEW HAMPSHIRE**

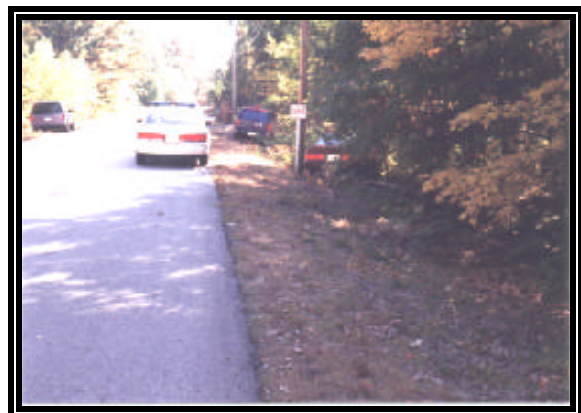
This single vehicle crash occurred during the afternoon hours of October 1997. At the time of the crash, it was daylight and the weather was not a factor. At the crash scene, the roadway was configured with a two-lane and served as an access road to a lake side residential area. The road was predominately straight and level and was north/south in direction. Trees and brush bordered both sides of the roadway. The unposted speed limit was 56 km/h (35 mph). **Figure 1** is a southbound trajectory view at the crash scene and depict the vehicle at final rest.

**Figure 1:** Southbound trajectory view of the vehicle at final rest.

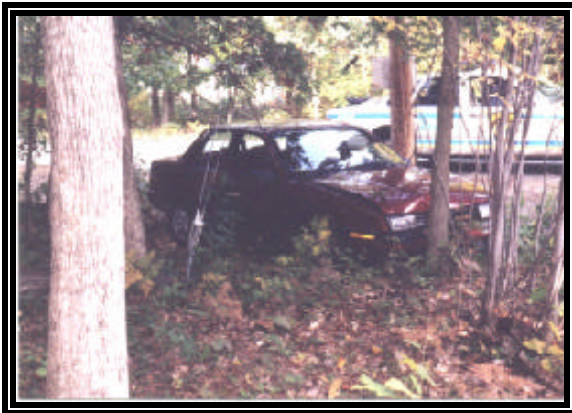
**Figure 2:** Right view of the vehicle at final rest.

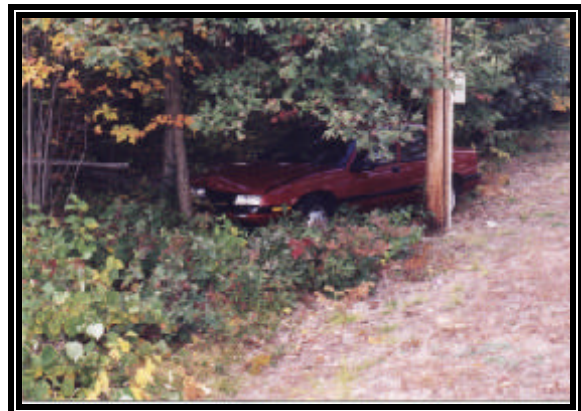
**Figure 3:** Left view of the vehicle at final rest.

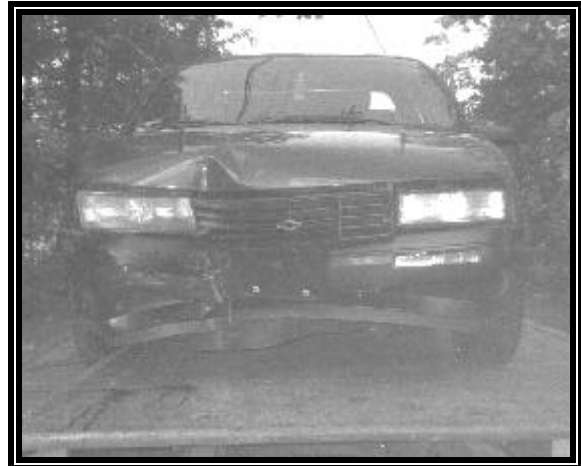
**Figure 4** is a front view of the Chevrolet Corsica taken during the police investigation. The vehicle's front plane sustained an estimated 15 cm (8 in) of direct contact damage that was centered 25 cm (10 in) right of the vehicle's centerline. The width of the combined direct and induced damage appeared to extend across the vehicle's entire front end width. The maximum deformation was estimated by the police investigation to be 30 cm (12 in). The energy of the crash was managed primarily by the vehicle's structure forward of the radiator support plane. There was no change in the wheelbase dimensions. The front fenders were not damaged. The delta V calculated by the Barrier Algorithm of the WINSMASH (using the estimated damage profile was 22.7 km/h (14.1 mph). The estimated Collision Deformation Classification (CDC) was 12-FZEN-2.

**Figure 4:** Front view of the Chevrolet.

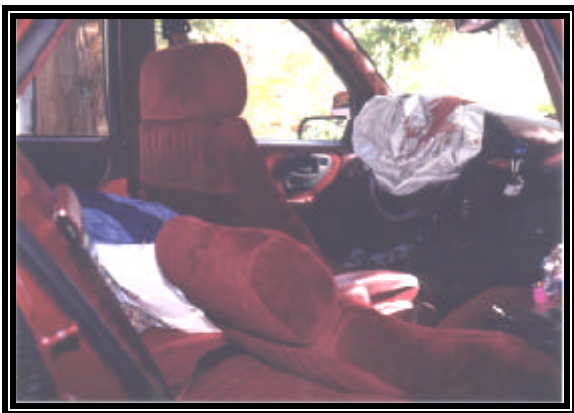
Information regarding the post-crash condition of the vehicle's interior was limited. The following data was taken from the supplemental report of the police investigation and a review of the interior photographs, **Figure 5 and 6.**

A large volume of blood was identified on the interior carpet beneath the front seats, with the heaviest concentration near the center tunnel. Blood was also found on the right aspect of the driver's seat. A large blood stain was evident on the face of the deployed driver air bag, **Figure 5.**

**Figure 5:** Interior view of the Chevrolet.

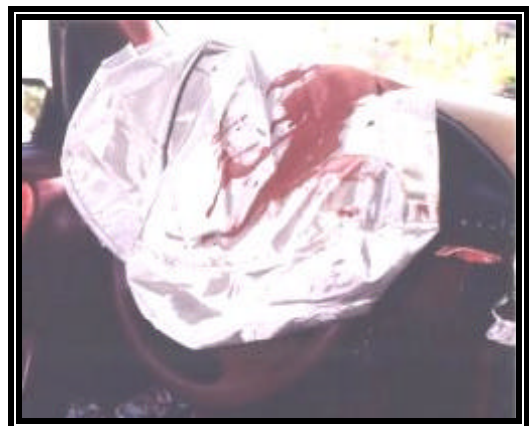
**Figure 6:** Driver air bag.
