**REDESIGNED AIR BAG SPECIAL STUDY (RABSS)
SCI TECHNICAL SUMMARY REPORT**

NASS RABSS CASE NO. 1998-12-808E

RABSS VEHICLE - 1999 TOYOTA COROLLA

LOCATION - STATE OF MICHIGAN

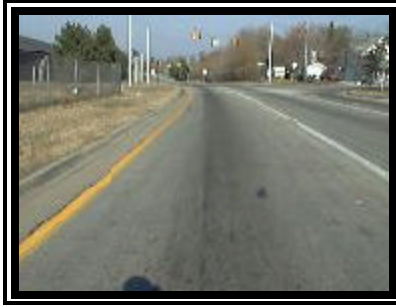
Figure 1. Northbound approach for the 1999 Toyota Corolla.

The 32 year old male driver of the 1999 Toyota Corolla was operating the vehicle northbound (**Figure 1**) on the inboard travel lane of the highway off-ramp at a (driver reported) speed of 56 km/h (35 mph) when he failed to observe the red overhead traffic signal or eastbound Ford as he proceeded straight through the 4-leg intersection. Upon recognition of the impending harmful event, the Toyota driver steered right/braked in avoidance. The 31 year old female driver of the 1991 Ford Aerostar was operating the vehicle eastbound (**Figure 2**) in the center travel lane when she observed the northbound Toyota cross

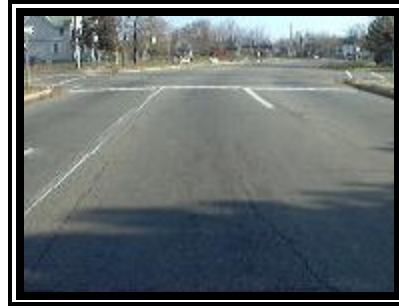
Figure 2. Eastbound approach for the 1991 Ford Aerostar.

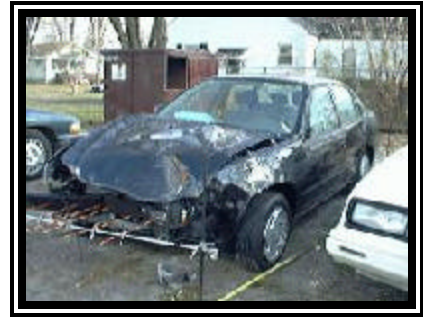
The 1999 Toyota Corolla sustained moderate frontal damage as a result of the initial impact with the Ford Aerostar (**Figure 3**). The direct contact damage encompassed the entire frontal width resulting in a combined direct and induced damage length (Field L) of 125.0 cm (49.2 in). Six crush measurements were documented at the level of the reinforcement bar (*bumper fascia separation*): C1= 16.0 cm (6.3 in), C2= 19.0 cm (7.5 in), C3= 25.0 cm (9.8 in), C4= 21.0 cm (8.3 in), C5= 10.0 cm (3.9 in), C6= 0 cm. The (*SCI revised*) Collision Deformation Classification (CDC) for this initial impact to the Toyota was 11-FDEW-2 with a principal direction of force of (-)30 degrees. The bumper assembly shifted approximately 16.0 cm (6.3 in) to the right (entire end structure must shift to increment the principal direction of force). The grille and headlight assemblies fractured and separated from the vehicle during the collision sequence. The right fender was deformed rearward which restricted the right front wheel/tire (not deflated). The hood was displaced up and rearward from engagement against the side surface of the Ford. No reduction in the vehicle's wheelbase was sustained. The windshield was fractured from (exterior) impact forces and the (interior) front right air bag. All tempered glazing remained undamaged.

Figure 3. Frontal damage to the 1999 Toyota Corolla.

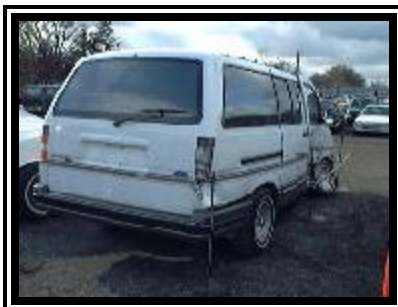
Figure 4. Right side surface damage to the 1991 Ford Aerostar.

The 1991 Ford Aerostar sustained moderate right front side surface damage as a result of the impact with the Toyota Corolla (**Figure 4**). The direct contact damage began 18.0 cm (7.1 in) aft of the right front axle and extended rearward 112.0 cm (44.1 in). The combined direct and induced contact damage (Field L) began 53.0 cm (20.9 in) forward of the right front axle and extended rearward 187.0 cm (73.6 in). The (*SCI revised*) CDC for this initial impact to the Ford was 02-RYEW-3 with a principal direction of force of (+)70 degrees. This damage pattern was concentrated mainly along the right front door area with outward bowing of the upper door/window frame noted. All

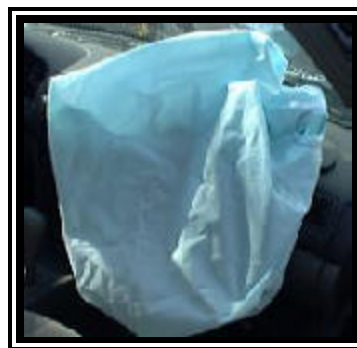
The front right passenger air bag deployed from the right top instrument panel area with a horizontally oriented flap tear seam (H-configuration). No contact evidence was identified on the air bag or exterior surface of the module cover flaps. The cover flaps were nearly symmetrical in shape as the forward flap measured 23.0 cm (9.1 in) in width and 4.0 cm (1.6 in) in height while the aft flap measured 23.0 cm (9.1 in) in width and 6.0 cm (2.4 in) in height. The NASS researcher measured the passenger air bag at 60.0 cm (23.6 in) in width and 70.0 cm (27.6 in) in height in its deflated state (**Figure 6**). No internal tether straps were present. The bag was vented by two ports located at the 9 o'clock and 3 o'clock sectors on the side aspect of the air bag. No cutoff switch was found for the front right air bag.

Figure 6. 1999 Toyota Corolla redesigned passenger air bag.
