Remote, Redesigned Air Bag Special Study  
Dynamic Science, Inc., Case Number (1998-049-806G)  
1998 Ford Mustang  
Texas  
August, 1998

**Summary**

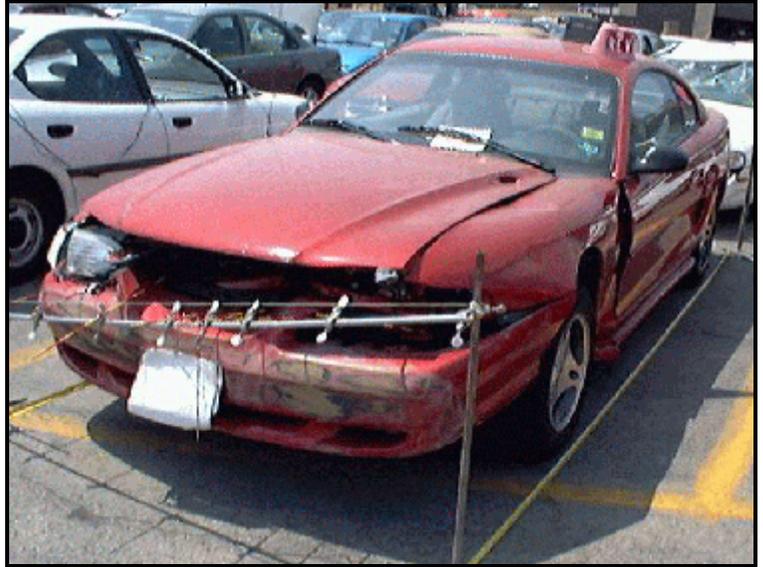
Figure 1. Exterior, Vehicle 1 (Ford Mustang)

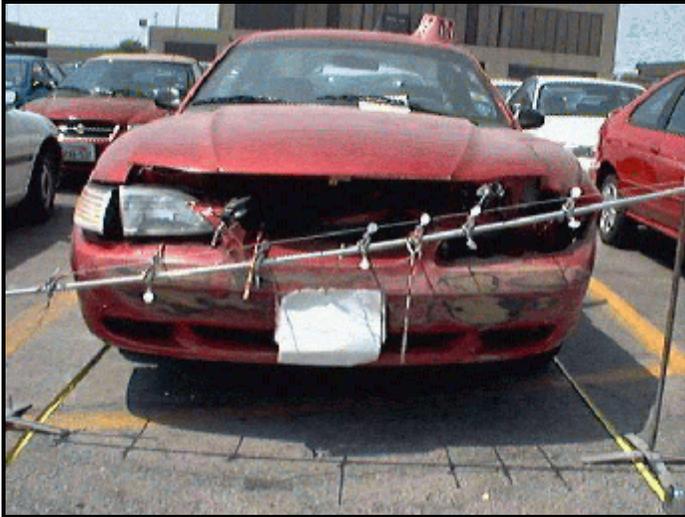
**Figure 2.** Exterior, Vehicle 1 (1998 Ford Mustang 2-door coupe)

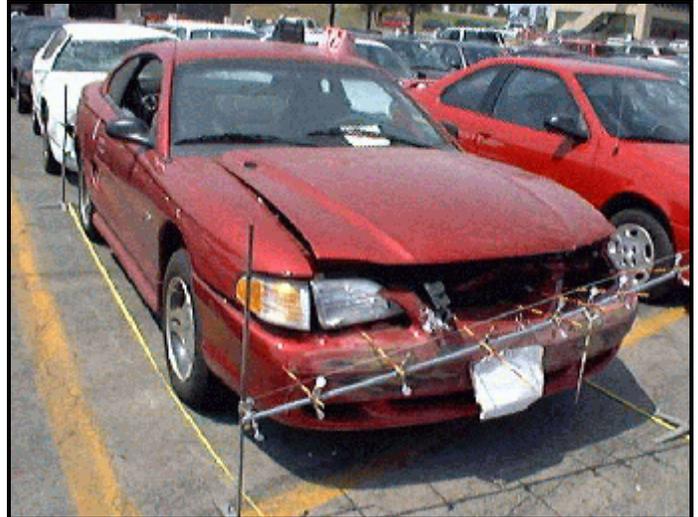
**Figure 3.** Exterior, Vehicle 1 (1998 Ford Mustang 2-door coupe)

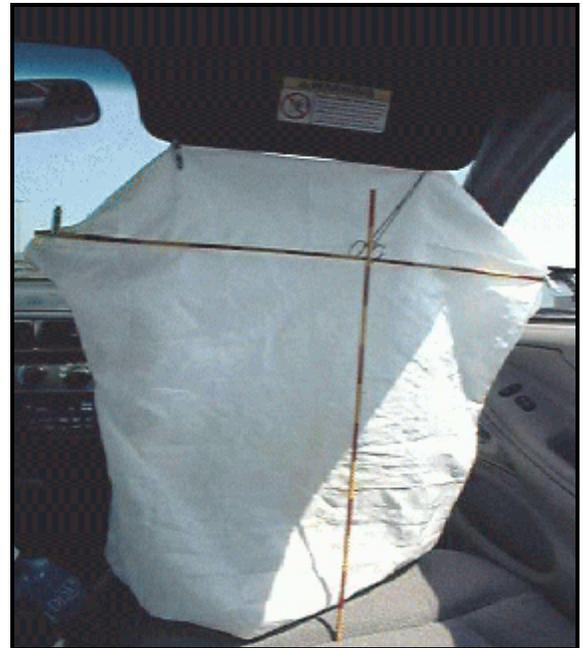
The front right air bag was housed in the top-instrument panel position and was concealed by asymmetrical H-configuration cover flaps. The rectangular air bag was not equipped with tethers nor vent ports. Contact evidence consisting of what appeared to be blood was found on the bag. The air bag was not damaged.

**Figure 4.** Interior, case vehicle. Passenger's side air bag.

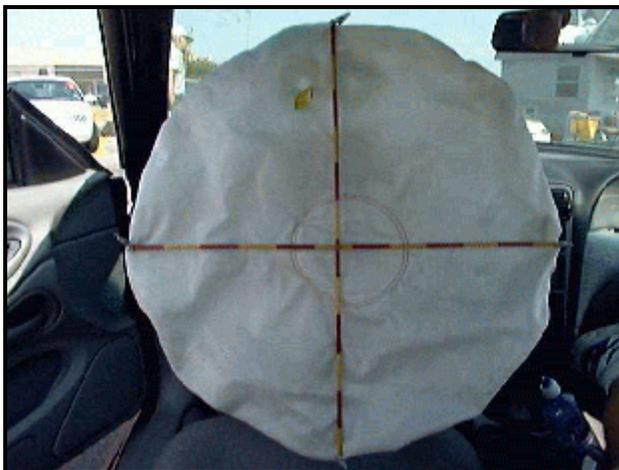
The front left air bag was housed in the steering wheel hub and was concealed by asymmetrical H-configuration cover flaps. The circular air bag was equipped with two tethers and two vent ports. Contact evidence consisting of what appeared to be blood was found on the bag. The air bag was not damaged.

**Figure 5.** Interior, case vehicle. Driver's side air bag.

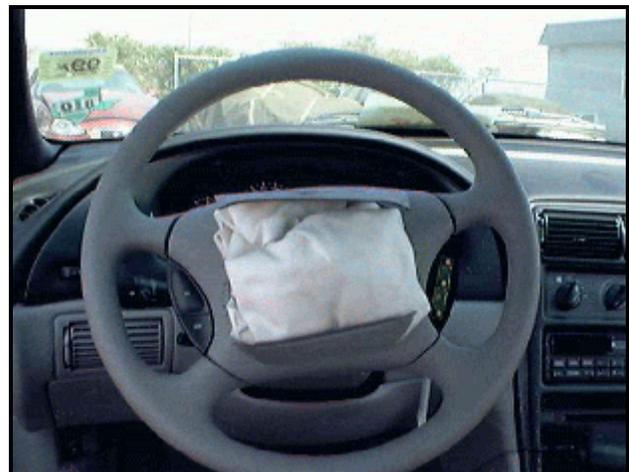
**Figure 6.** Interior, case vehicle. Driver's side air bag.

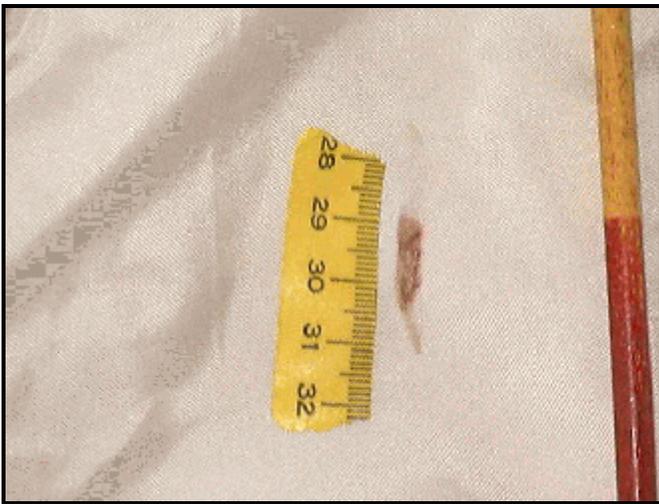
At impact, the locked lap/shoulder restraints prevented the occupants from moving far enough forward to contact the vehicle's interior. The driver appears to have engaged the deploying front left air bag-causing the forearm contusion. The driver's right index and middle fingers sustained 1<sup>st</sup> degree burns from contact with the hot gases escaping through the right side air bag vent port. The passenger also appears to have engaged the deploying front right air bag-causing the facial abrasion and contusion, and also the neck abrasion.

**Figure 7.** Interior, case vehicle. Driver's side air bag contact evidence.
