Remote, Redesigned Air Bag Special Study

Dynamic Science, Inc., Case Number ( 1998-81-801E)

1998 Ford Ranger pickup

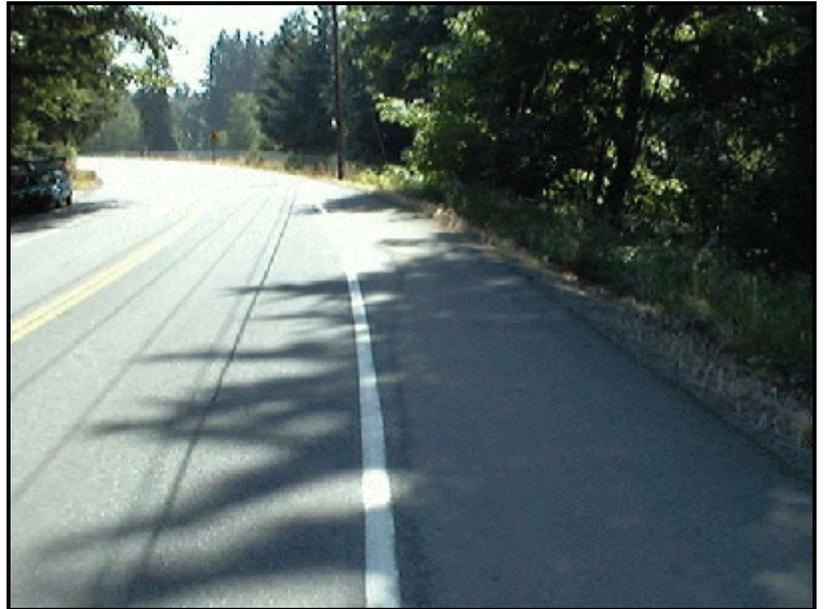
**Figure 1.** Overview of impact area and final rest (east)

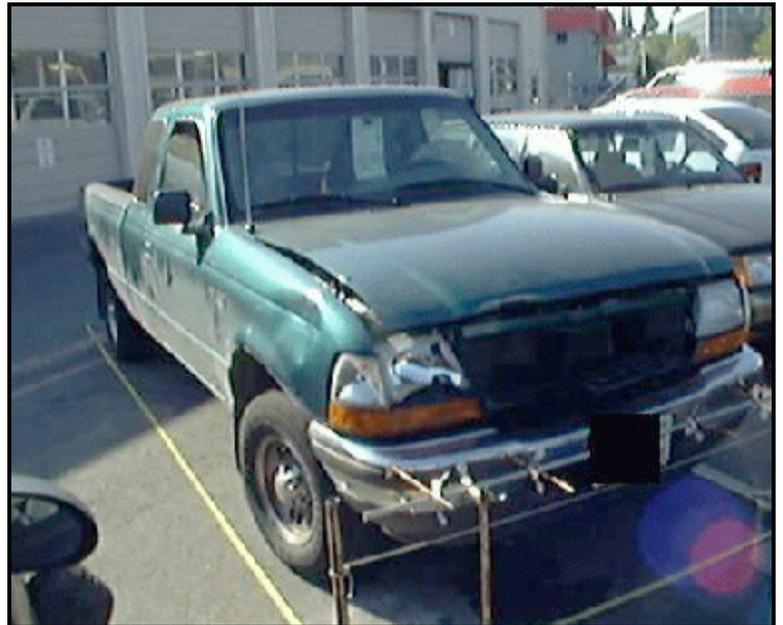
**Figure 2.** Exterior, Vehicle 1

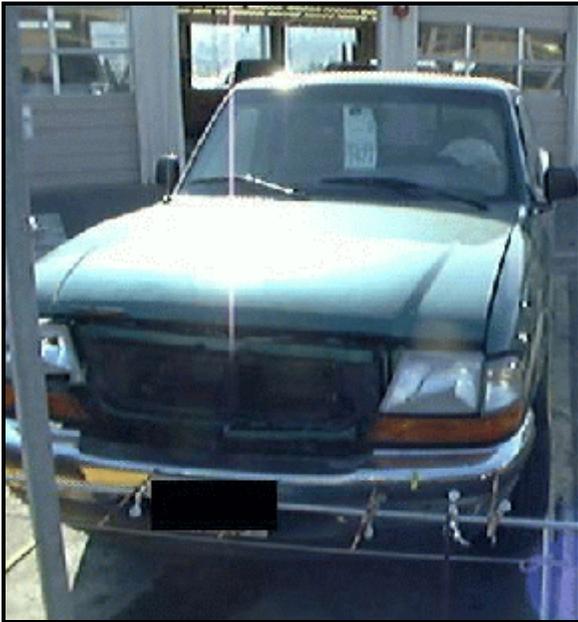
**Figure 3.** Exterior, Vehicle 1

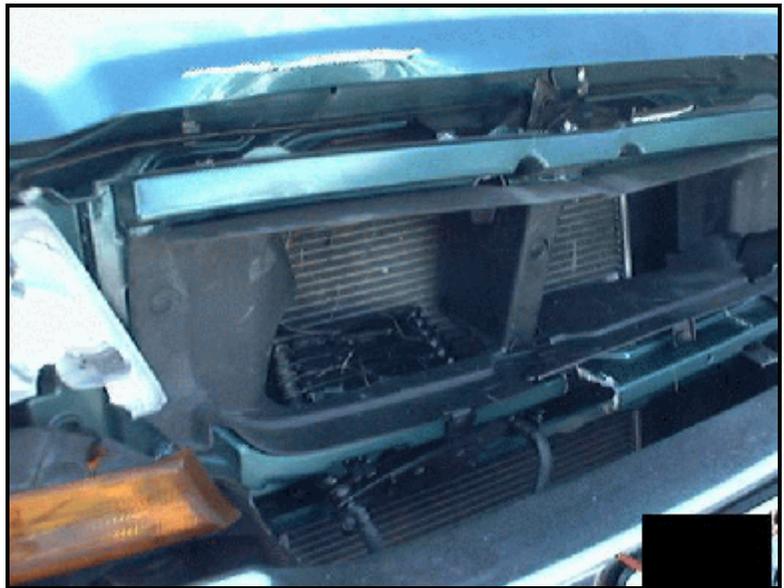
**Figure 4.** Close up view of frontal damage

Plane of Impact	Field L cm/in.	C1 cm/in.	C2 cm/in.	C3 cm/in.	C4 cm/in.	C5 cm/in.	C6 cm/in.
Bumper	150	2	2	1	0	0	0
	59.1	0.8	0.8	0.4	0	0	0

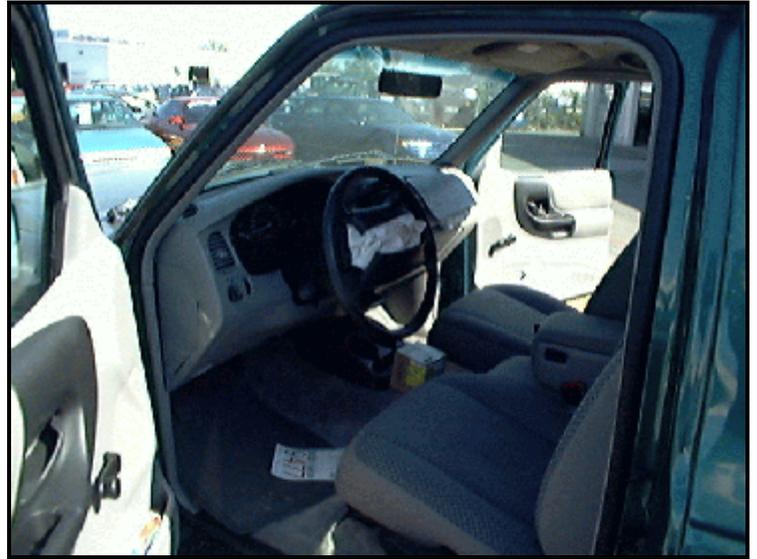
The interior of the 1998 Ford Ranger pickup truck was basically undamaged due to this minor frontal impact. The vehicle maintained its integrity and there were no intruding components. The interior was void of any detectable occupant contact evidence. This vehicle is equipped with a cloth covered split bench seat with folding backs. The front seat outboard positions are equipped with integral head restraints. The front left seat track was adjusted to the middle track position and the shoulder belt manual adjuster was in the mid position. The front right seat track was adjusted to the forward most track position and the shoulder belt manual adjuster was in the down position.

**Figure 5.** Driver's seated area

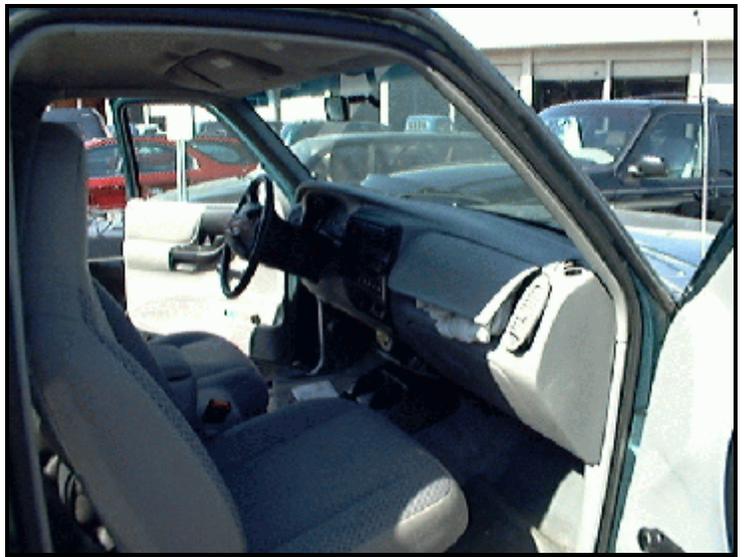
**Figure 6.** Front right passenger seated area

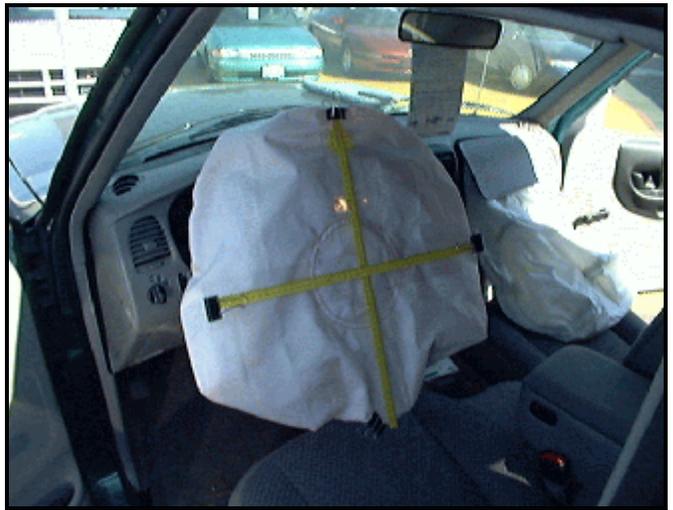
The 1998 Ford Ranger was equipped with the redesigned air bag systems. The driver's air bag is housed in the steering wheel hub and encases the nylon air bag unit. The module cover consists of dual rectangular flaps that opened at their designated tear points. The circular air bag is tethered by one strap and is equipped with two vent ports. The rigid plastic knee bolster was undamaged and did not reveal any detectable occupant contacts.

**Figure 8.** Driver's air bag

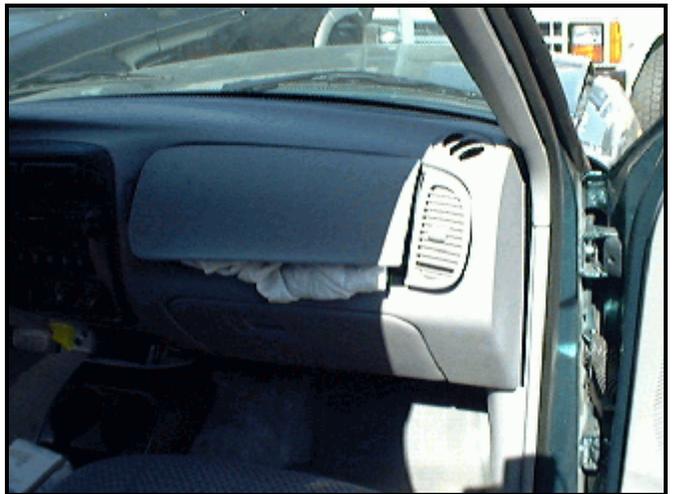
The front, right passenger air bag is located in the right hand side of the instrument panel (mid-mount). There is an ON/OFF key switch for this air bag; the switch was in the ON position. The single, rectangular module deployment door opened at its designated tear points. Upon deployment, the encased air bag fully deployed. The non-tethered air bag was undamaged and was not equipped with exhaust vent ports.

**Figure 7.** Passenger air bag

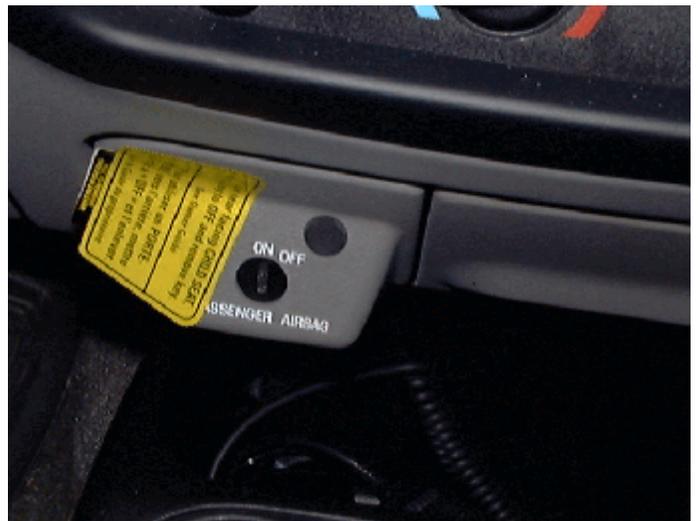
**Figure 9.** Passenger front air bag ON/OFF switch
