Remote, Redesigned Air Bag Special Study  
Dynamic Science, Inc., Case Number (1998-082-804G)  
1998 Chevrolet Cavalier  
Washington  
August/1998

**Summary**

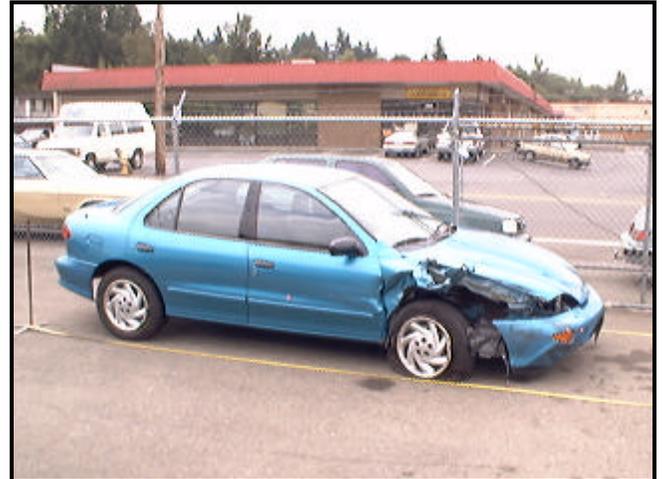
**Figure 1.** Exterior, Vehicle 1 (Chevrolet Cavalier)

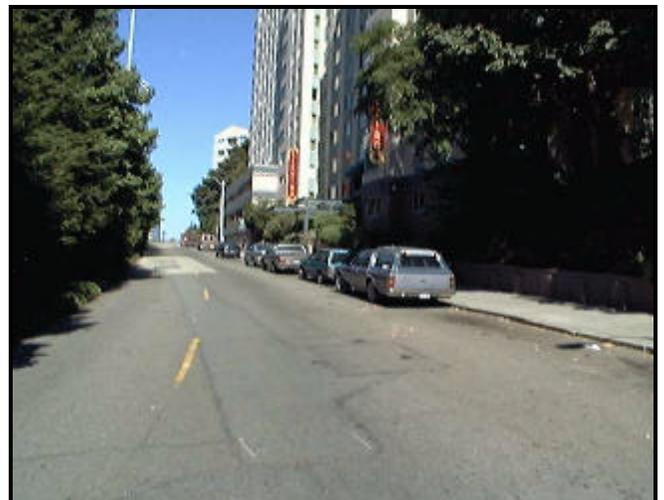
The driver of Vehicle 1 failed to properly negotiate the left curve in the roadway and entered the right/east parking lane. The front plane of Vehicle 1 (12FREE7) impacted the back plane of a legally parked vehicle.

**Figure 2.** Crash scene, approach to impact.

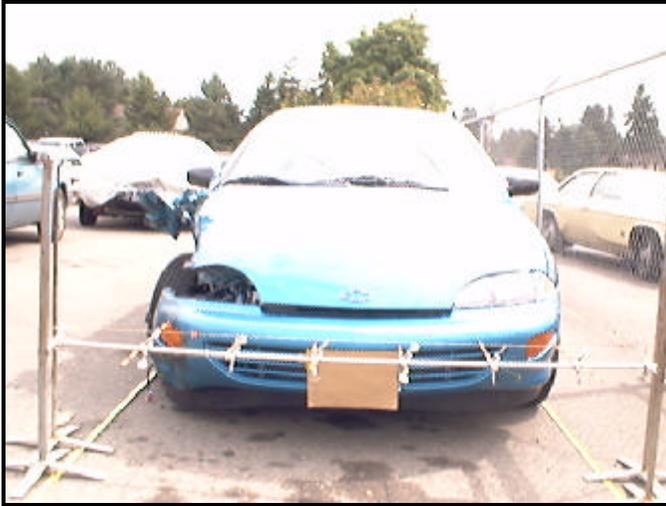
**Figure 3.** Exterior, Vehicle 1 (1998 Chevrolet Cavalier)

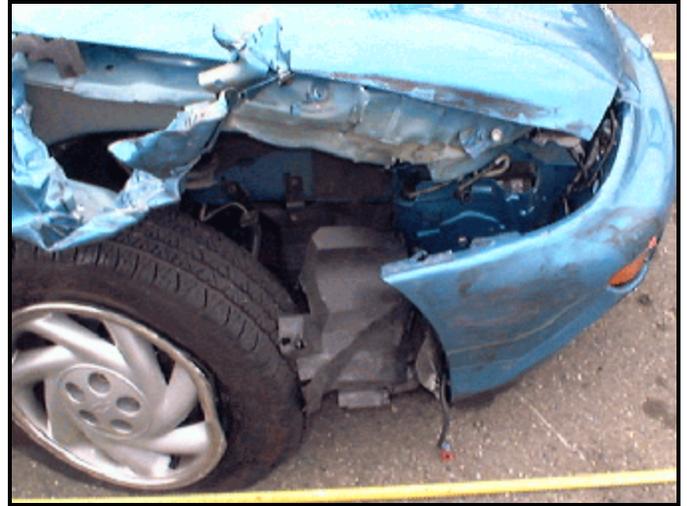
**Figure 4.** Direct damage, Vehicle 1 (1998 Chevrolet Cavalier)

Plane of Impact	Field L cm/in.	C1 cm/in.	C2 cm/in.	C3 cm/in.	C4 cm/in.	C5 cm/in.	C6 cm/in.
Bumper	134	1	0	0	0	1	3
	52.8	0.4	0	0	0	0.4	1.2

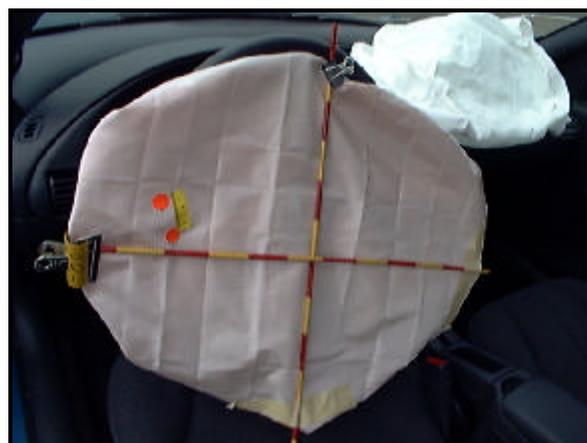
The front left air bag was housed in the steering wheel hub and was concealed by symmetrical I-configuration cover flaps which were not damaged in the crash. The circular air bag was equipped with two vent ports and no tether straps. Contact evidence consisting of a small "brown transfer" was found on the upper left quadrant of the front of the bag. The air bag was not damaged.

**Figure 5.** Driver's frontal air bag.

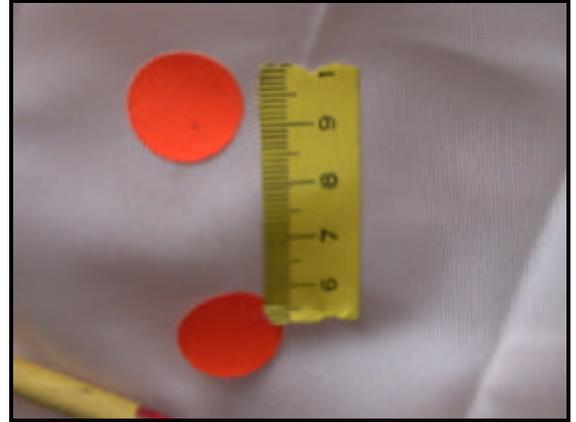
At impact, the driver reacted to the 0 degree principle direction of force by moving forward and loading the manual lap/shoulder restraint. As the restraints locked, further frontal movement of the driver was prevented. The driver had moved far enough forward to engage the deploying driver's frontal air bag with her chest/face. A small transfer was found on the front of the bag, but no injury was caused by this contact. No other contact evidence was found in the vehicle. The driver was not injured in the crash and did not seek medical attention.

**Figure 6.** Driver's frontal air bag contact evidence.
