CALSPAN REMOTE ASYMMETRICAL AIR BAG DEPLOYMENT

CALSPAN CASE NO. CA98-011

SUBJECT VEHICLE - 1996 FORD TAURUS

LOCATION - STATE OF NEW YORK

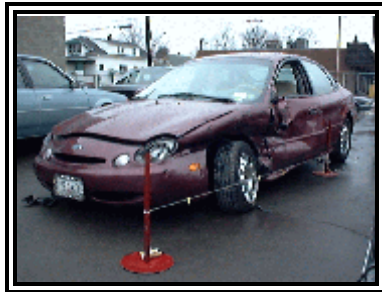
Figure 1. Left side damage to the Ford Taurus.

The initial impact to the left front fender and passenger compartment area resulted in moderate damage which initiated the deployment of the front right air bag, but not the front left air bag. Direct damage for the left side impact began 181.0 cm (71.3 in) forward of the left rear axle and extended 181.6 cm (71.5 in) forward. Maximum crush was located 147.0 cm (57.9 in) forward of the left rear axle and measured 14.6 cm (5.7 in). The damage resulted in a Collision Deformation Classification (CDC) of 11-LZEW-2.

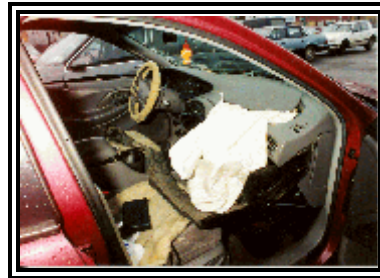
Figure 2. View of the non-deployed front left air bag and deployed front right air bag

The front right air bag was housed in a top mount module in the right instrument panel area. The module cover flap was tethered by two nylon straps which measured approximately 3.8 cm (1.5 in) in width. The air bag was not equipped with vent ports, but was tethered with one wide band. The front right air bag deployed as a result of the crash (**Figure 2**).

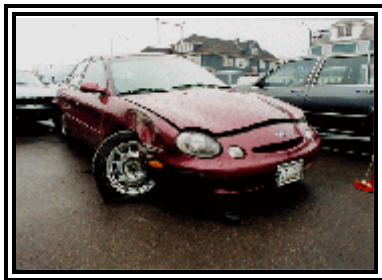
The right plane of the Taurus sustained two impacts. The first moderate severity impact produced direct contact damage which began 274 cm (108 in) forward of the right rear axle and extended 61 cm (24 in) forward. Maximum crush was measured at 5 cm (2 in). A CDC of 03-RFEW-1 was assigned for this impact. **Figure 3** identifies the damage sustained by the right front fender of the Taurus. This impact resulted in the separation of the right front lower ball joint from the lower control arm (**Figure 4**). In addition, the right front drive axle separated from the transmission.

Figure 3. Right front damage to the Ford Taurus

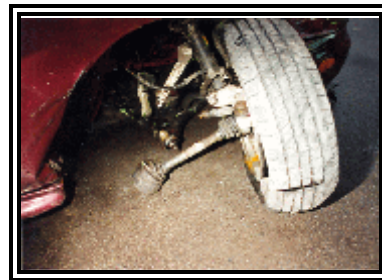
Figure 4. Separation of right front ball joint from the spindle and the fractured rod shaft

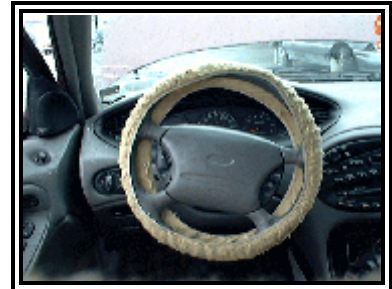
The non-deployed front left air bag module was located in the hub of a four-spoke steering wheel. The module cover flap was an asymmetrical H-configuration. The air bag did not deploy from the module during this crash (**Figure 5**).

Figure 5. Ford Taurus' non-deployed front left air bag
