Remote, Redesigned Air Bag Special Study

Dynamic Science, Inc., Case Number (1999-075-134C)

1998 Ford Taurus

September/1999

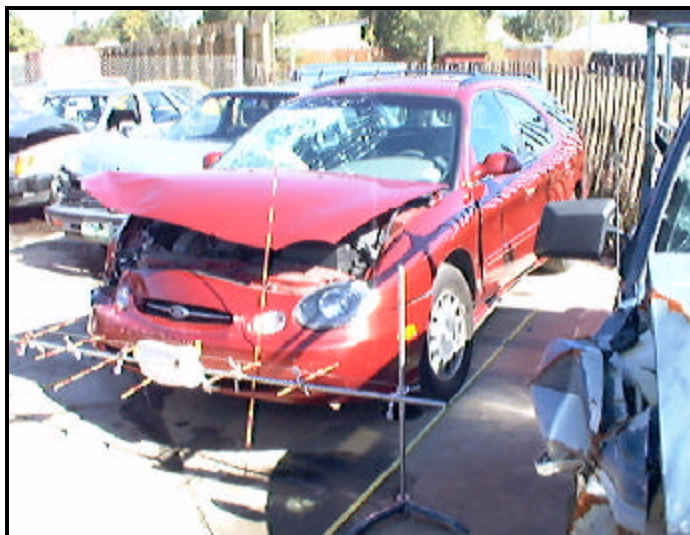
Figure 1. Exterior, Vehicle 1 (Ford Taurus)

Vehicle 1, a 1998 Ford Taurus station wagon (case vehicle) driven by a 53 year old female (170 cm/67 in, 104 kg/230 lbs), was traveling east in eastbound lane #3 approaching the intersection at a police estimated speed of 72 km/h (45 mph). The driver was preparing to travel straight through the intersection. The overhead traffic signal was in the red phase at this time. The driver was restrained by the available manual lap/shoulder restraint. There were no other occupants in Vehicle 1.

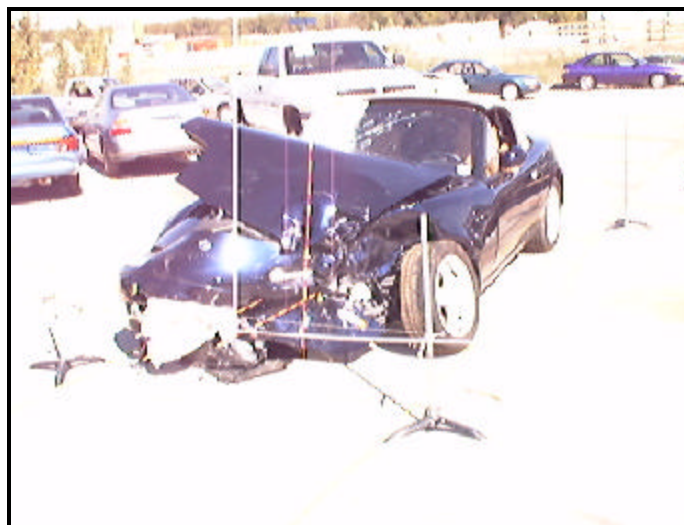
Figure 2. Exterior, Vehicle 2 (Mazda Miata)

Vehicle 2, a 1996 Mazda Miata 2-door convertible driven by a 52 year old male, was traveling north in the northbound left-turn lane approaching the intersection at a police estimated speed of 32 km/h (20 mph). The driver was preparing to make a left turn at the intersection. The overhead traffic signal was in the green phase at this time. The driver was restrained by the available manual lap/shoulder restraint. The front right seat was occupied by a 22 year old male who also was restrained by the available manual lap/shoulder restraint.

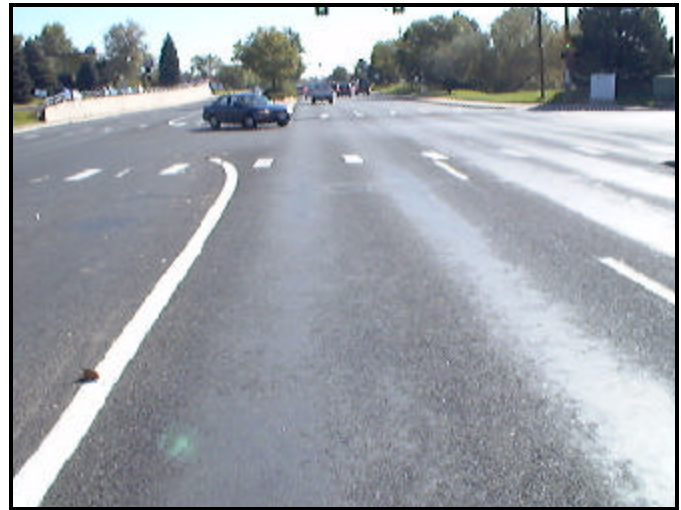
Figure 3. Crash scene. Vehicle 1 approach path.

This remote investigation focused on the redesigned air bag system deployment of 1998 Ford Taurus station wagon. This crash occurred in September, 1999 in the afternoon. The weather was clear and the bituminous roadways were dry. The crash occurred in a four leg intersection. The eastbound leg of the intersection is a two-way divided roadway and is comprised of seven travel lanes; three eastbound thru-lanes, one eastbound left-turn lane, and three westbound lanes. Eastbound traffic is separated from westbound traffic by a raised concrete median strip. The speed limit for this road is 72 km/h (45 mph). It is controlled by overhead traffic signals at the intersection. This road has a greater than 2% eastbound downhill grade at this location. The northbound leg of the intersection is a two-way undivided roadway and is comprised of four travel lanes; one northbound right-turn lane, one northbound thru-lane, one northbound left-turn lane, and one southbound lane. The speed limit for this road is 56 km/h (35 mph). It is controlled by overhead traffic signals at the intersection. This road has a greater than 2% northbound uphill grade at this location.

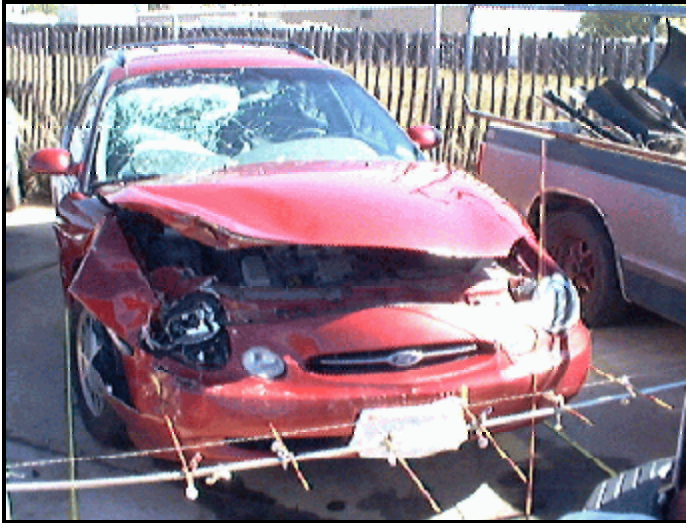
**Figure 4.** Exterior, Vehicle 1 (1998 Ford Taurus station wagon)

Model year, make and model	1998 Ford Taurus
VIN	1FAFP58S2WG
CDC	01FREE2

Plane of Impact	Field L cm/in.	C1 cm/in.	C2 cm/in.	C3 cm/in.	C4 cm/in.	C5 cm/in.	C6 cm/in.
Bumper	139	0	0	2	6	7	19
	54.7	0	0	0.8	2.4	2.8	7.5

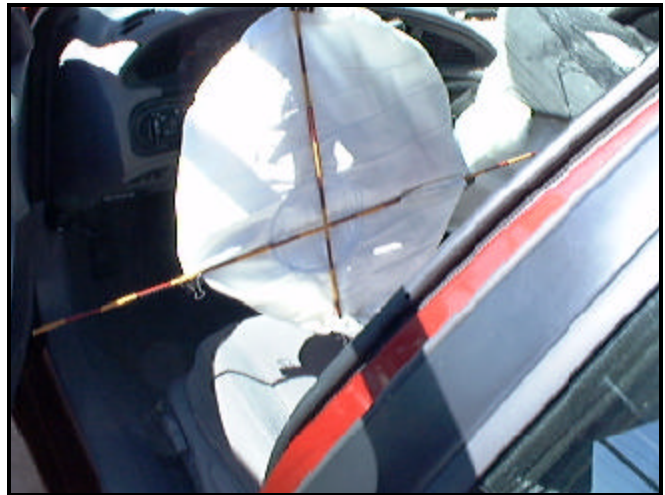
**Figure 6.** Driver's frontal air bag.

The front left air bag was housed in the steering wheel hub and was concealed by asymmetrical H-configuration cover flaps which were not damaged in the crash. The circular air bag was equipped with two vent ports and two tether straps. No contact evidence was found on the air bag and the bag was not damaged.

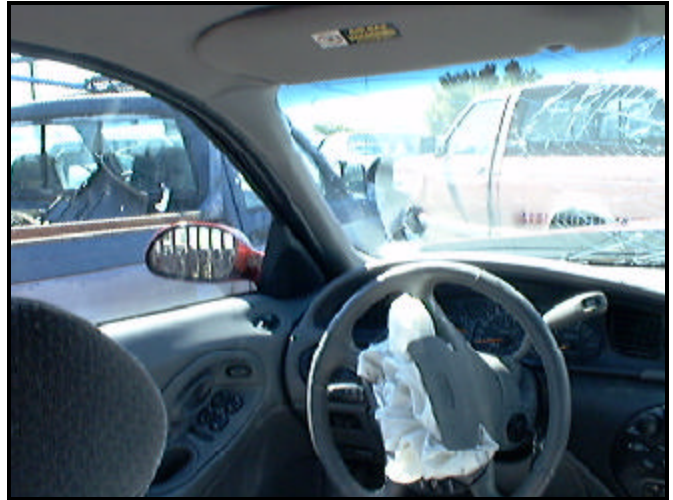
**Figure 7.** Interior, Vehicle 1. Case occupant seating position.

The interior of the Ford Taurus sustained no damage from occupant contact. There were no areas of intrusion into the passenger compartment. No evidence of occupant contact was found in the vehicle.

The case vehicle was equipped with split bench seats with separate backs in the three frontal seating positions. The outboard frontal seats were equipped with adjustable head restraints which were not damaged. All three seats were adjusted to the rear most track positions. The rear of the vehicle was equipped with bench seats with folding backs in all three seating positions. The back seats are not adjustable.

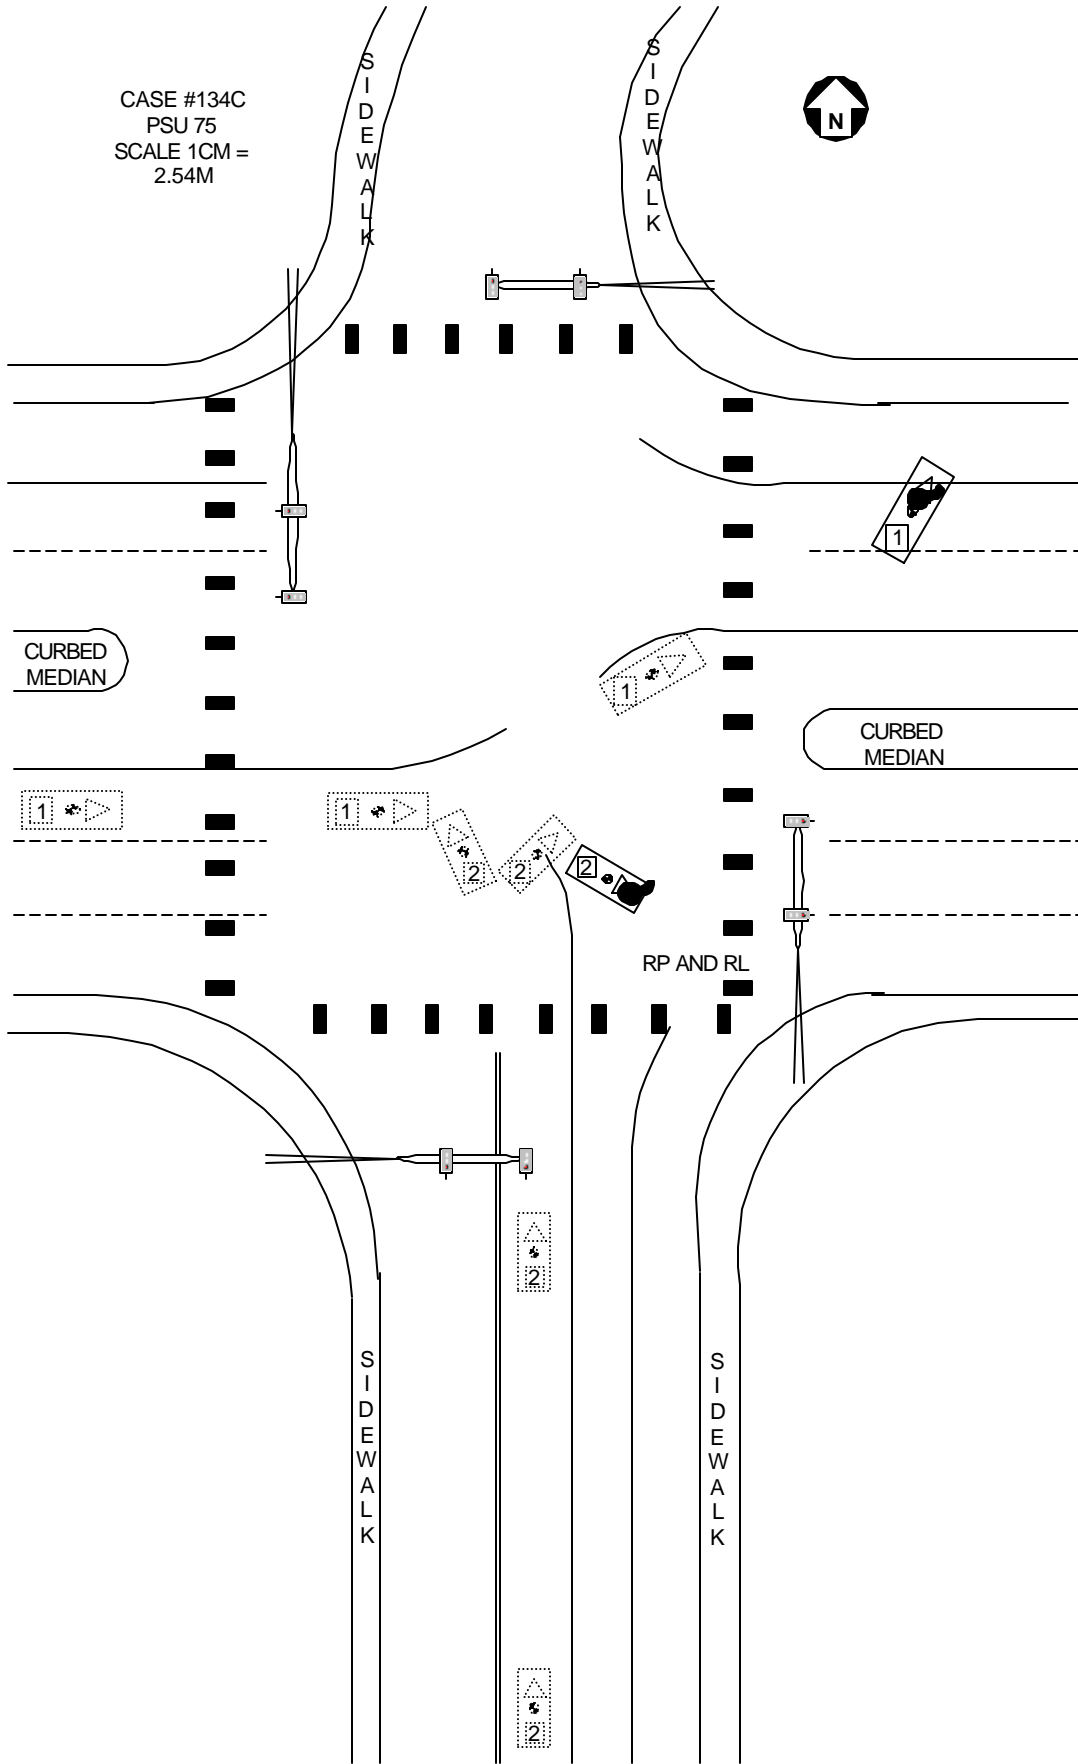
Scene  
Diagram

As Vehicle 2 was initiating the left turn, Vehicle 1 also entered the intersection. The front plane of Vehicle 1 (01FREE2) struck the front plane of Vehicle 2 (10FLEE3) in the intersection.

After impact, Vehicle 1 traveled across the intersection and came to rest in the westbound lanes on the east side of the intersection facing northeast. Vehicle 2 rotated clockwise after impact and came to rest on the south side of the intersection facing southeast.
