Remote, Redesigned Air Bag Special Study

Dynamic Science, Inc., Case Number (1999-081-028C)

1999 Pontiac Grand Am

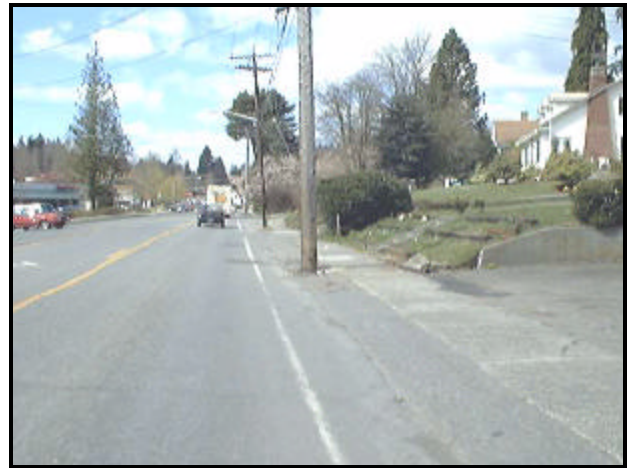
Figure 3. Crash scene, approach to impact with pole.

The driver lost control of the vehicle around the curve and Vehicle 1 departed the right roadside where it struck a wooden utility pole (event 1) with its front plane (12FYEW3). Vehicle 1 then rotated counter-clockwise approximately 90 degrees and struck a concrete wall (event 2) with its right-rear wheel (03RBWN1). Vehicle 1 came to rest engaged with the concrete wall facing west.

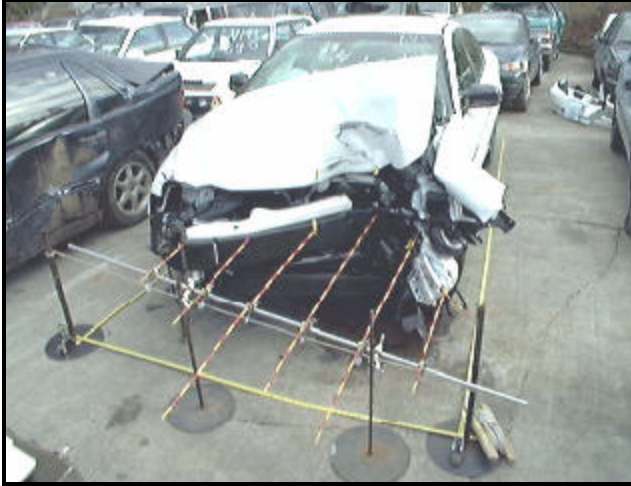
Figure 4. Exterior, Vehicle 1 (1999 Pontiac Grand Am)

Plane of Impact	Field L cm/in.	C1 cm/in.	C2 cm/in.	C3 cm/in.	C4 cm/in.	C5 cm/in.	C6 cm/in.
Bumper	111	16	61	74	51	23	0
	43.7	6.3	24	29.1	20.1	9.1	0

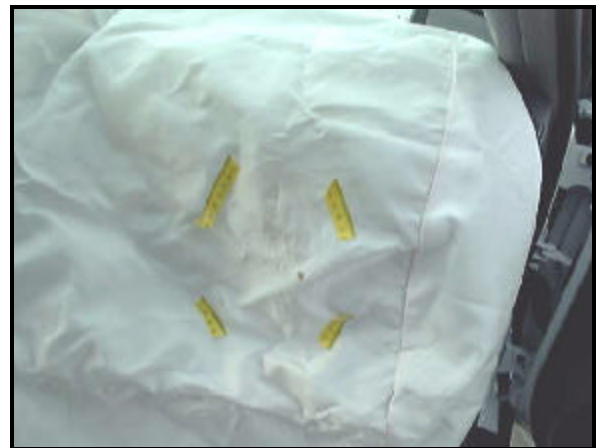
Figure 6. Interior, case vehicle. Passenger's frontal air bag contact evidence.

The front right air bag was housed in the top-instrument panel position and was concealed by a single rectangular shaped cover flap which was not damaged in the crash. The rectangular air bag was not equipped with vent ports or tether straps. Contact evidence consisting of a scuff/transfer was found on the front of the bag. The air bag was not damaged.

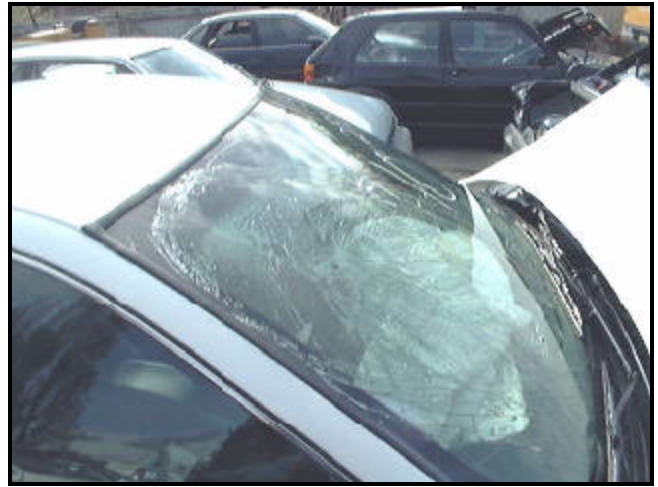
Figure 7. Case vehicle, windshield contact evidence.

At impact, the occupants reacted to the 10 degree principle direction of force by moving forward and slightly right. As the driver moved forward, his left foot was driven into the intruding toe pan-causing the left ankle dislocation. The driver's upper legs struck the bottom of the steering wheel at this time-causing the bilateral upper leg contusions. He also engaged the deploying driver's frontal air bag-causing the nose abrasion and chest contusion. The passenger, possibly due to being out of position, overrode the passenger's frontal air bag and struck the windshield with substantial force. His face contacted the windshield-causing the facial laceration and fractured tooth. Both occupants were transported from the scene to a hospital where they were treated and released.
