Remote, Redesigned Air Bag Special Study  
**FOR NHTSA'S INTERNAL USE ONLY**  
Dynamic Science, Inc., Case Number ( DS9942)  
1998 Ford Ranger XL 4x2 pickup  
Nevada  
November/1998

This remote investigation was initiated in response to a possible redesigned air bag deployment. The case was selected from the FARS data files. The redesigned air bag was installed in a 1998 Ford Ranger LX 4x2 pickup.

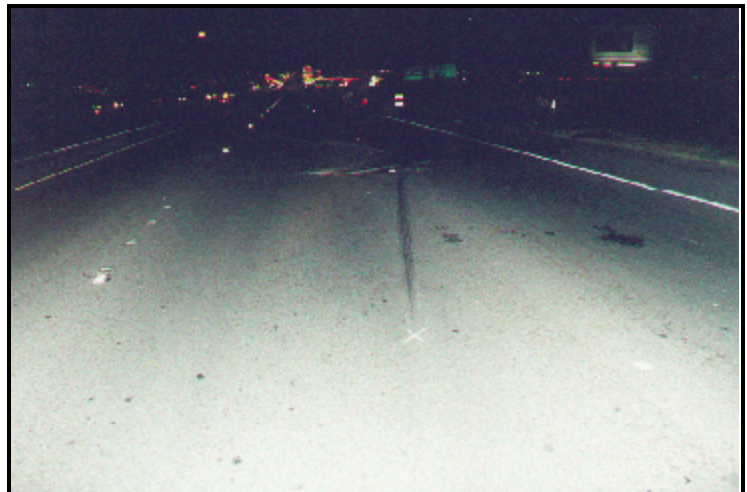
**Figure 1.** Pre-impact braking for Dodge pickup Point of impact in background—facing north.

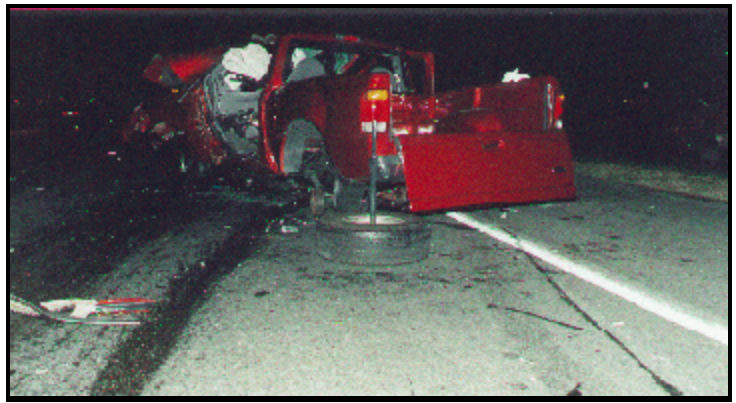
**Figure 2.** Final rest, Ford Ranger (case vehicle)

The case vehicle was pushed into a sharp counterclockwise rotation and there was a second, side-slap type impact with Vehicle 2 (09LBEW3). Vehicle 1 continued traveling north until coming to rest 33.8 m (111 ft) from the point of impact in the first lane of the northbound roadway facing north.

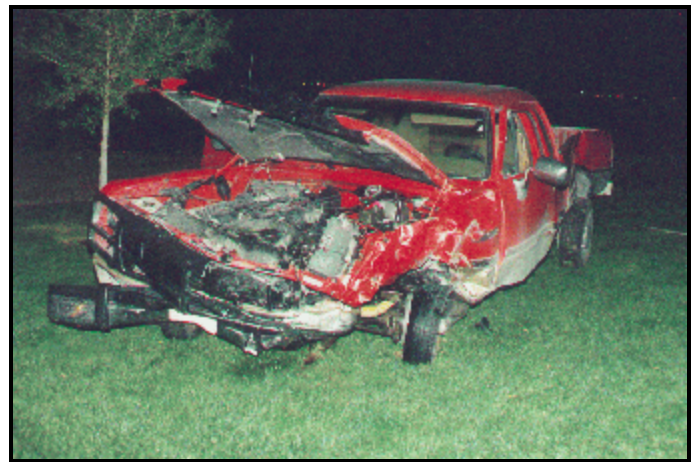
**Figure 3.** Final rest, Dodge Ram (other vehicle)

The Dodge Ram was redirected to the right, traveled approximately 10.3 m (34 ft) before leaving the right side of the roadway. The vehicle continued for an additional 28 m (92 ft) before coming to rest on the grass roadside.

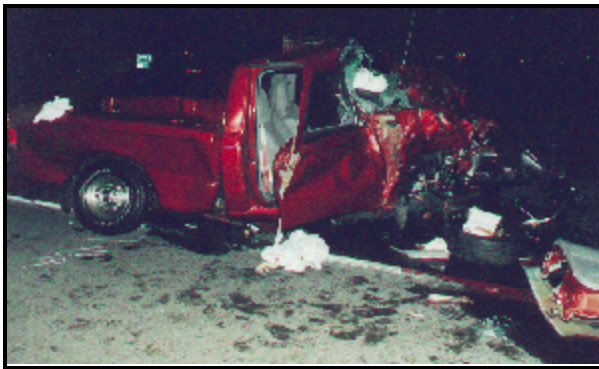
**Figure 4.** Exterior, Ford Ranger (right side)

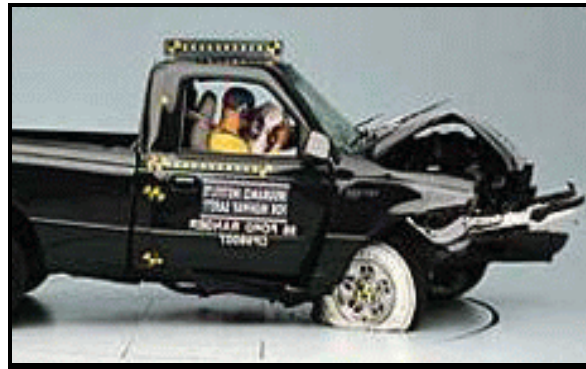
**Figure 5.** Adapted from IIHS photo depicting results of 40 mph frontal offset crash test with a 1998 Ford Ranger

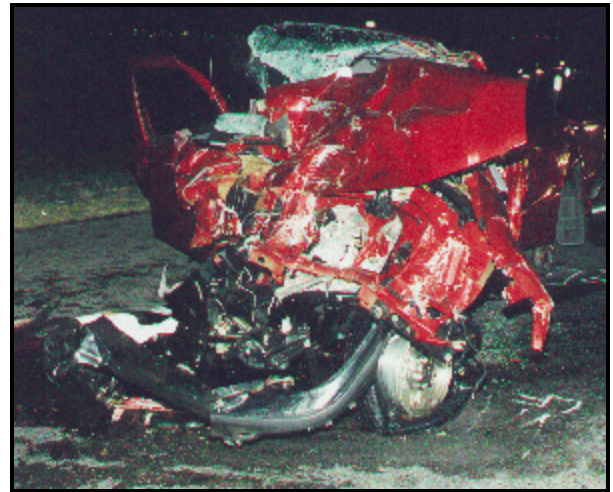
**Figure 6.** Exterior, Ford Ranger (front)

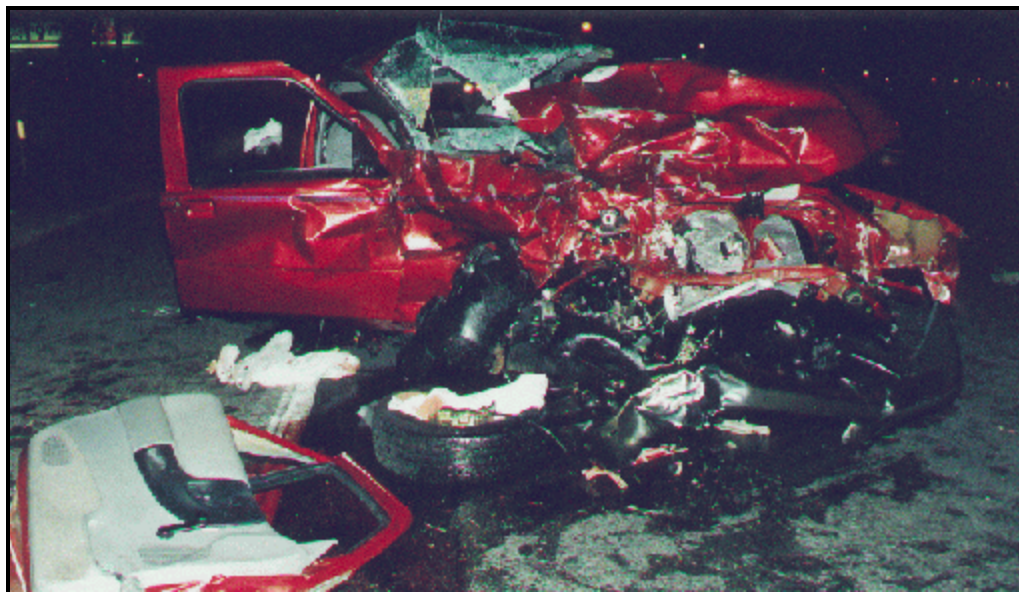
**Figure 7.** Exterior, Ford Ranger

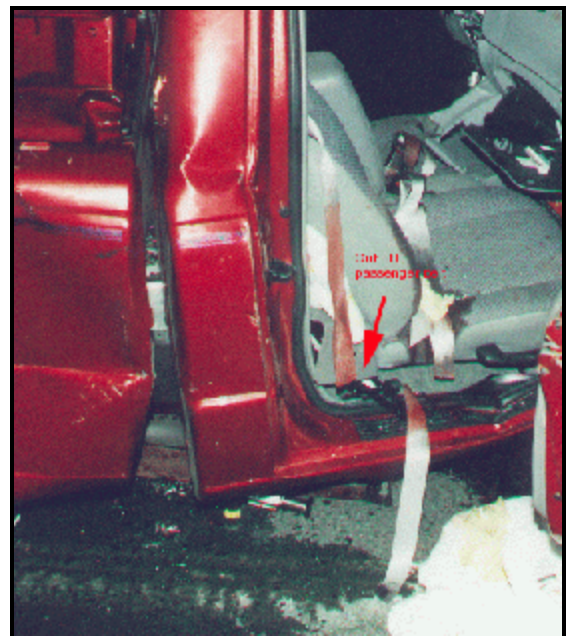
**Figure 10.** Seat belts cut by extrication personnel
