**TRANSPORTATION SCIENCES CENTER
ACCIDENT RESEARCH GROUP**

**CALSPAN ON-SITE AIR BAG NON-DEPLOYMENT INVESTIGATION
CALSPAN CASE NO. 93-6
VEHICLE - POLICE 1991 CHEVROLET CAPRICE
LOCATION - [REDACTED] NY
ACCIDENT DATE - [REDACTED] 1993**

Contract No. DTNH22-93-P-07222

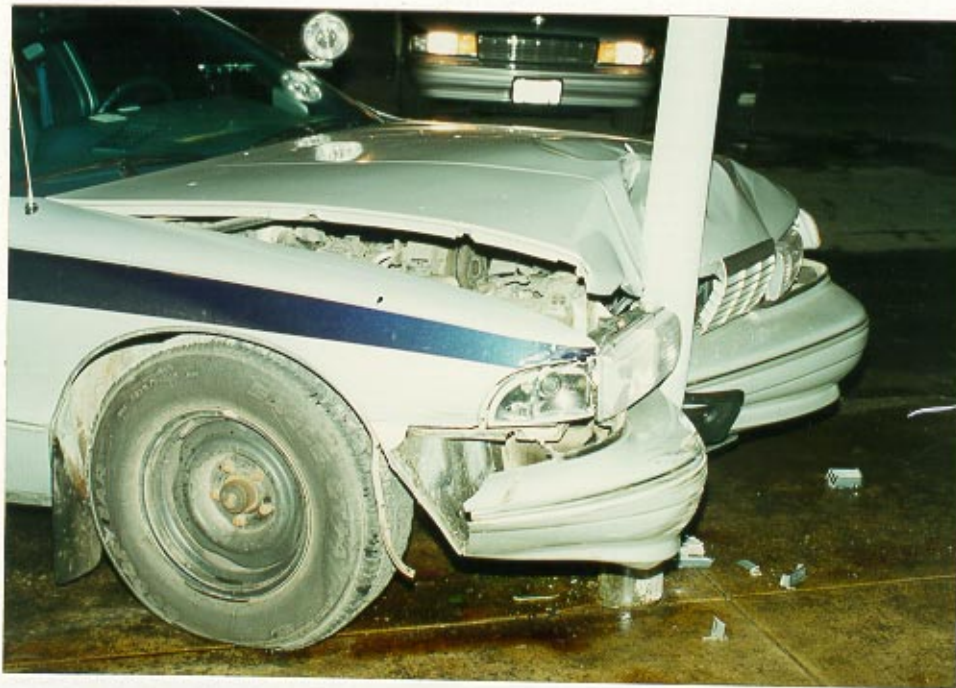
On-scene photograph of the Chevrolet Caprice at final rest

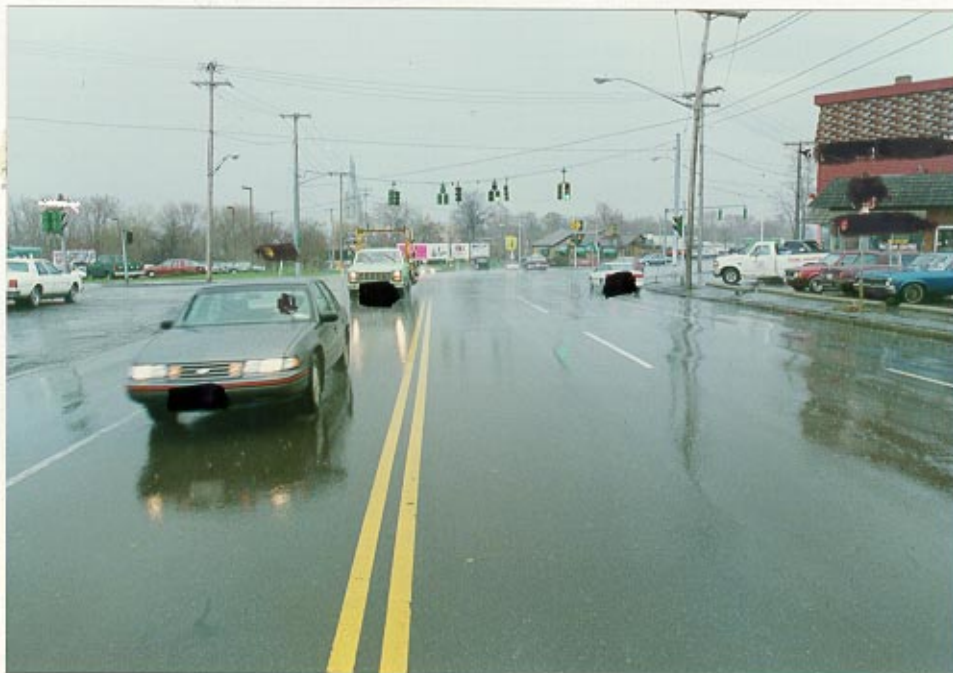
Pre-crash trajectory of the vehicles

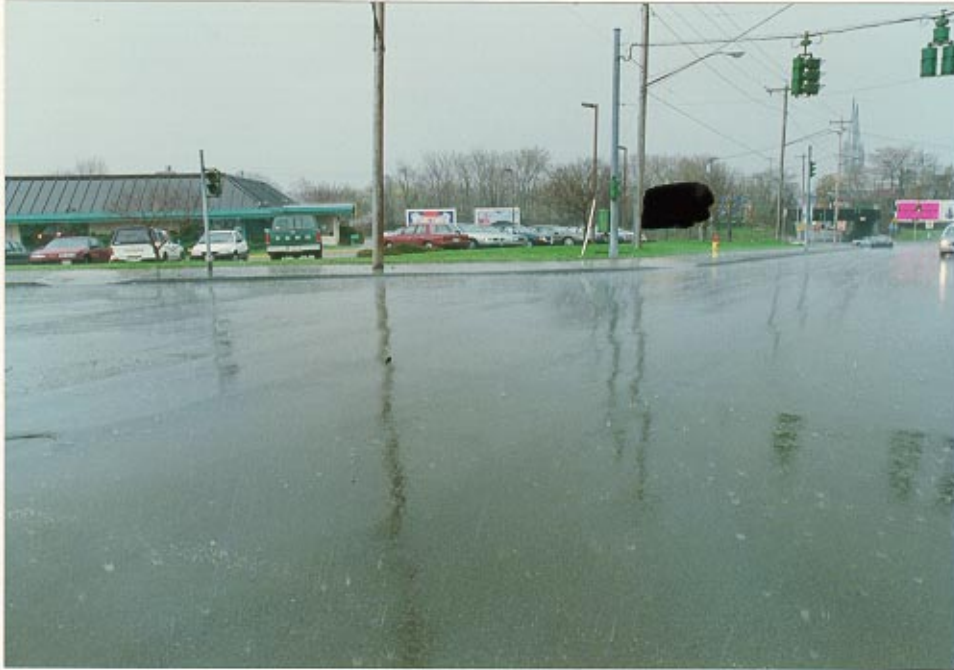
Vehicle #2 initiates a left turn at the four-leg oblique intersection

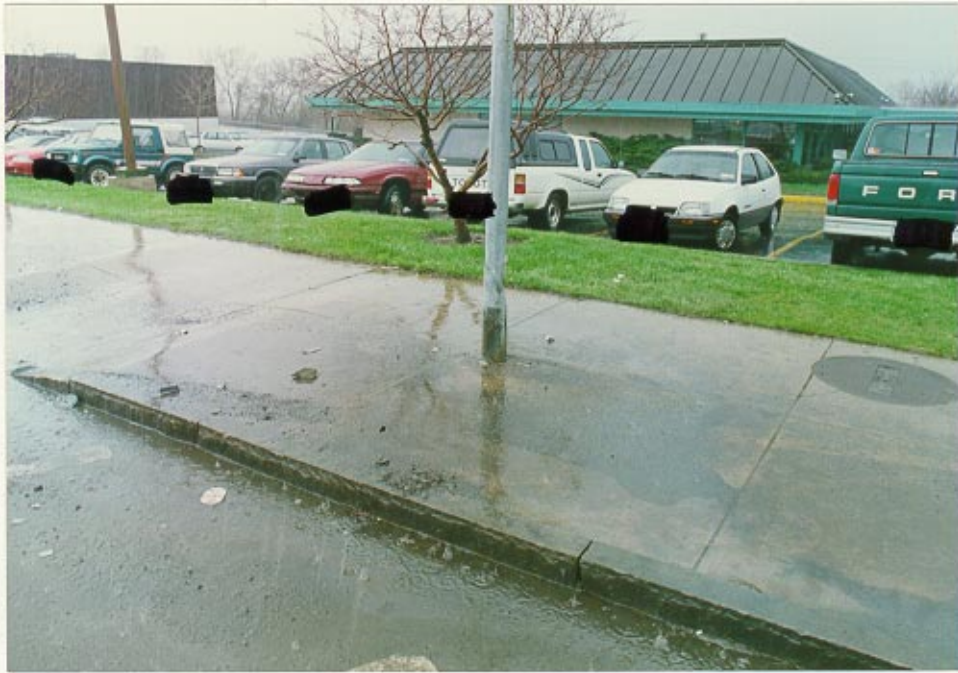
Struck pedestrian signal support pole

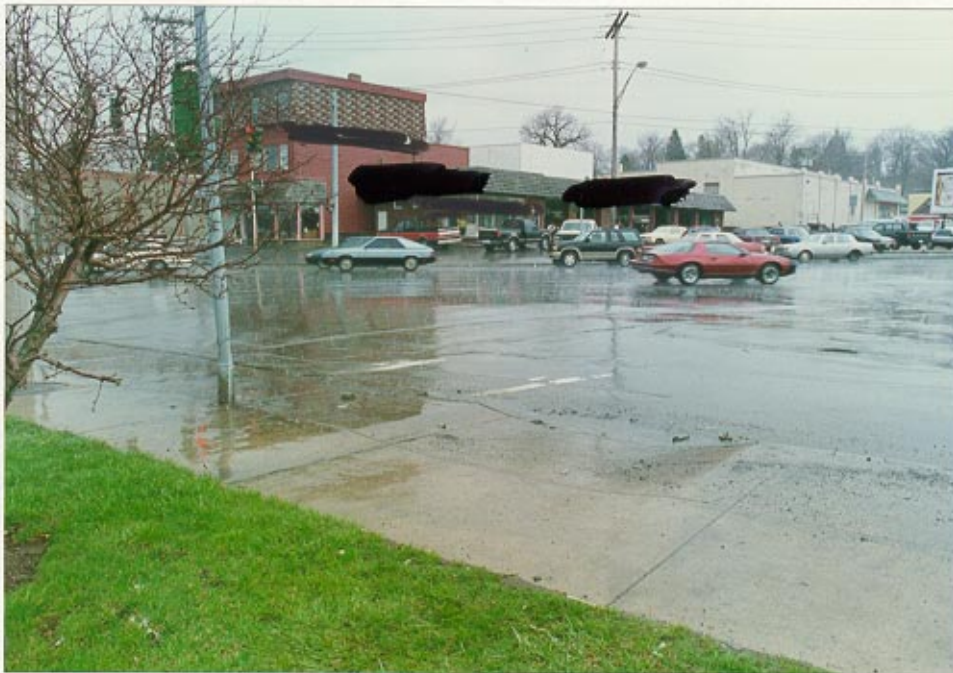
Lookback view of the vehicle's trajectories

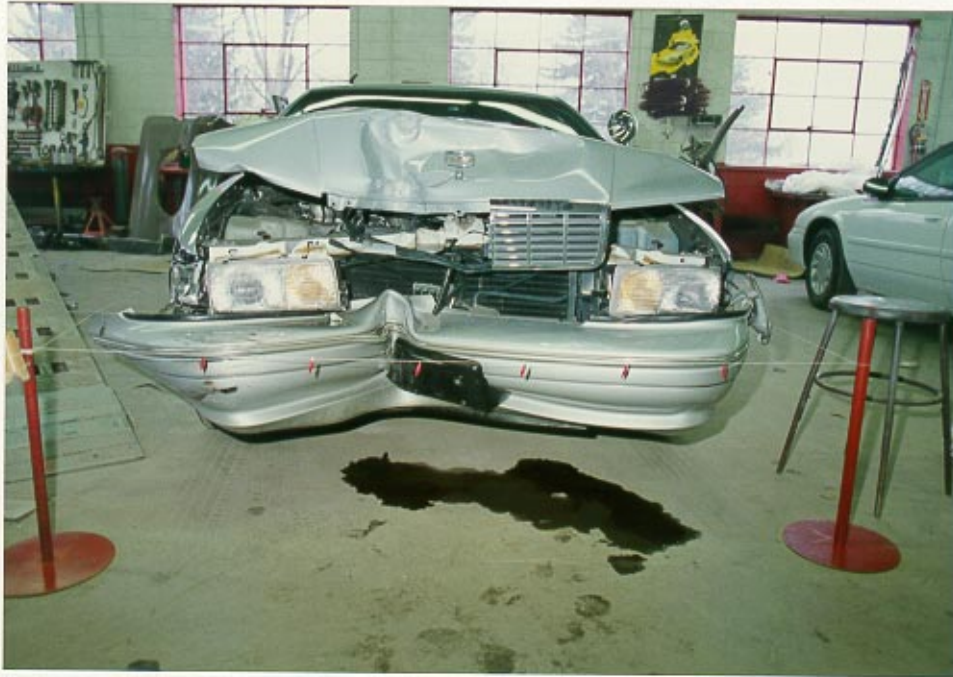
Frontal view of the Chevrolet Caprice

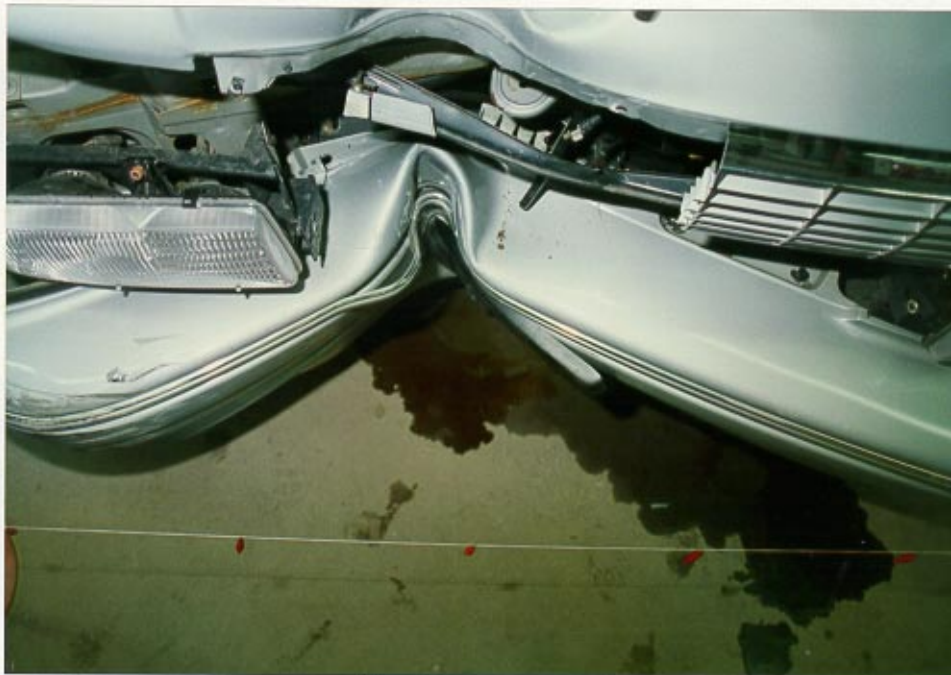
The pole impact damage began on the bumper fascia 5.7cm (2.25") right of center and extended 10.2cm (4") laterally to the right. The direct contact damage also extended vertically onto the hood face which began 7cm (2.75") right of center and extended 16cm (6.25") to the right. Maximum crush was 47.8cm (18.8") and was located on the bumper fascia 20cm (7.75") right of center and was inboard of the right frame rail. Crush values at bumper level were as follows: $C_1 = 0$, $C_2 = 4.6\text{cm}$ (1.8"), $C_3 = 20\text{cm}$ (7.75"), $C_4 = 35.6\text{cm}$ (14.0"), $C_5 = 17.8\text{cm}$ (7.0"), $C_6 = 0$. The Caprice underwent a CRASHPC generated velocity change of 23 KPH (14 mph) as a result of the 12 o'clock direction of force impact. The small diameter non-breakaway pole was dented and deflected slightly by the impact. The impact induced deceleration was below the required threshold of 26 KPH (16 mph) necessary for deployment of the SIR.

Pedestrian signal pole damage to the Caprice

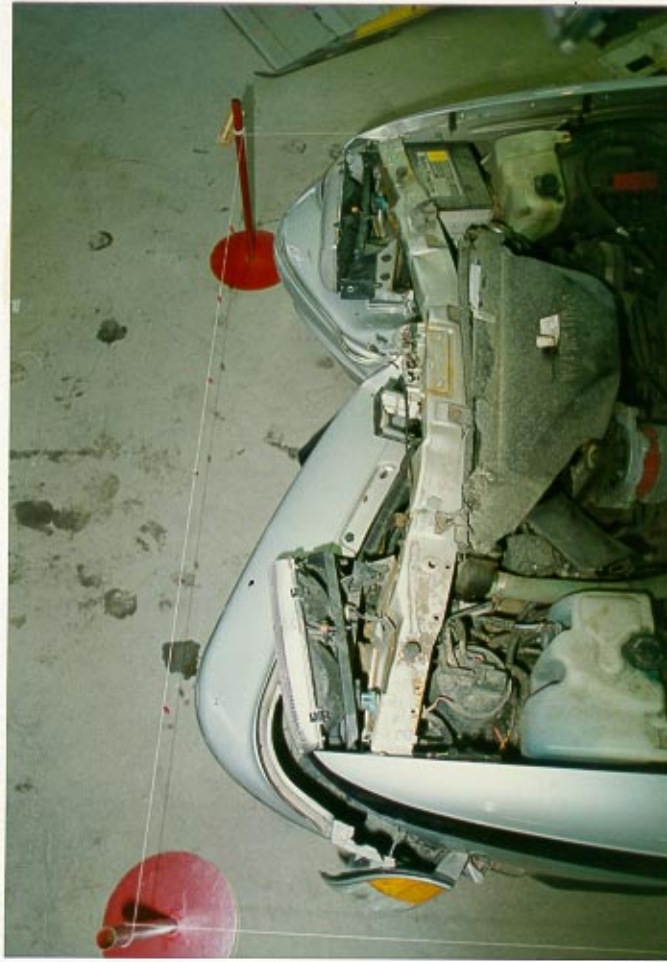
Overhead view of the pole impact damage to the bumper and radiator support panel

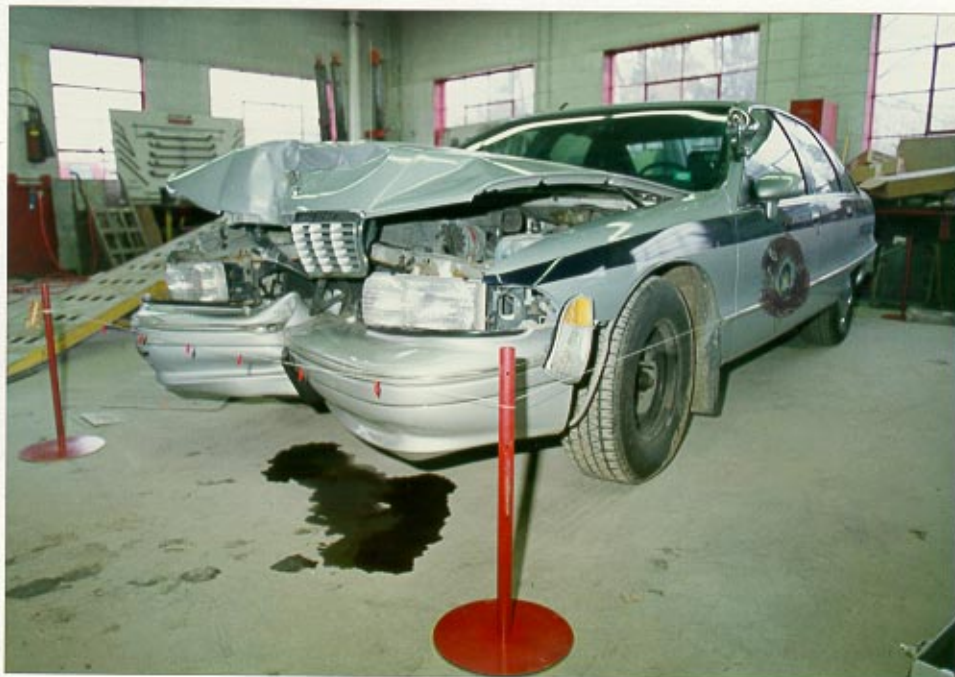
Left front three-quarter view

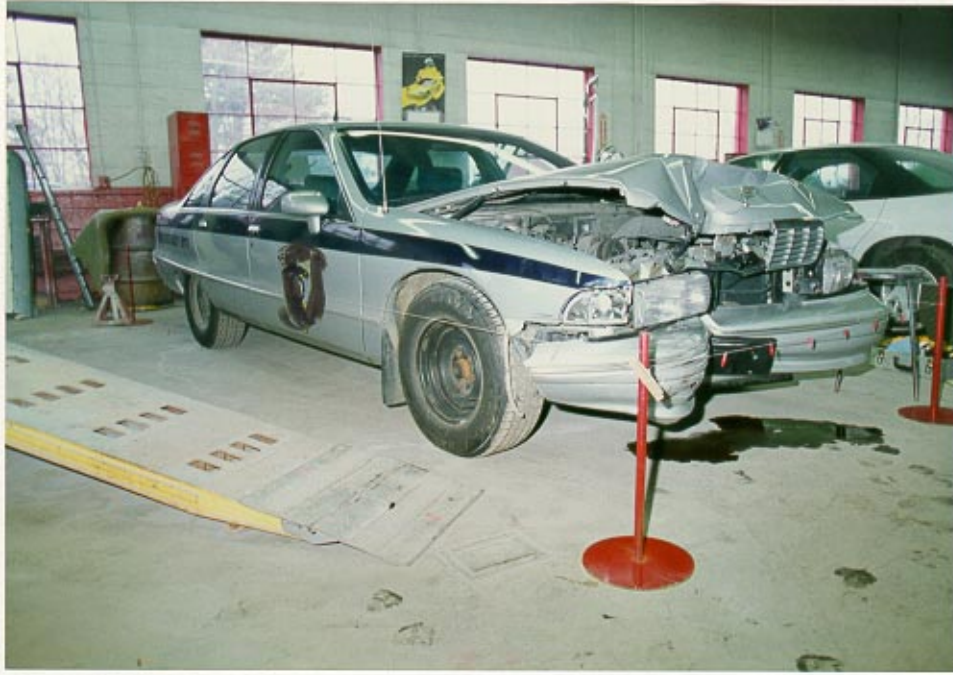
The right front corner area of the Chevrolet Caprice impacted the left side area of the Celebrity resulting in a sideswipe type collision. Direct contact damage on the Caprice began at the corner of the bumper fascia and extended 23.5cm (9.25") inboard. The direct contact damage also extended on the right side surface of bumper fascia and onto the right front fender ending at a point that was 32.4cm (12.75") rearward of the leading edge of the fender. The damage from the initial impact sequence with the Celebrity also extended vertically onto the leading edge of the hood. A small gouge was noted to the hood face that was located 10-15cm (4-6") inboard of the right edge. Although the subsequent pole impact deformed the entire frontal area of the Caprice, there was no residual crush to the bumper of the vehicle, therefore, the velocity change was minimal [\leq 8 KPH (5 mph)] and the SIR would not have deployed. The driver of the Caprice was not displaced or injured as a result of the vehicle-to-vehicle impact.

Right front three-quarter view and initial impact damage to the right front corner area

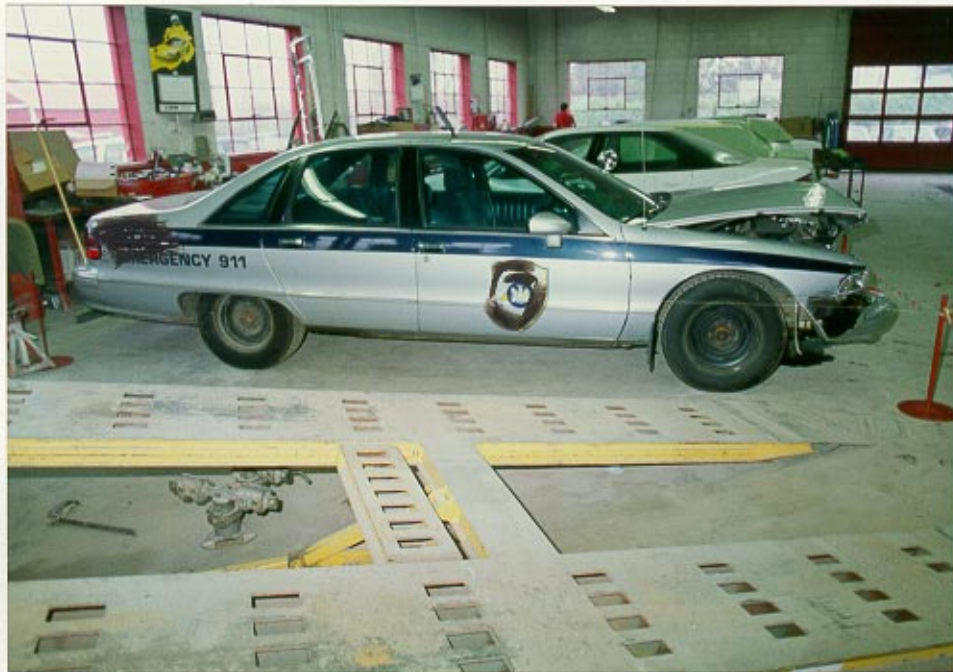
Right side view

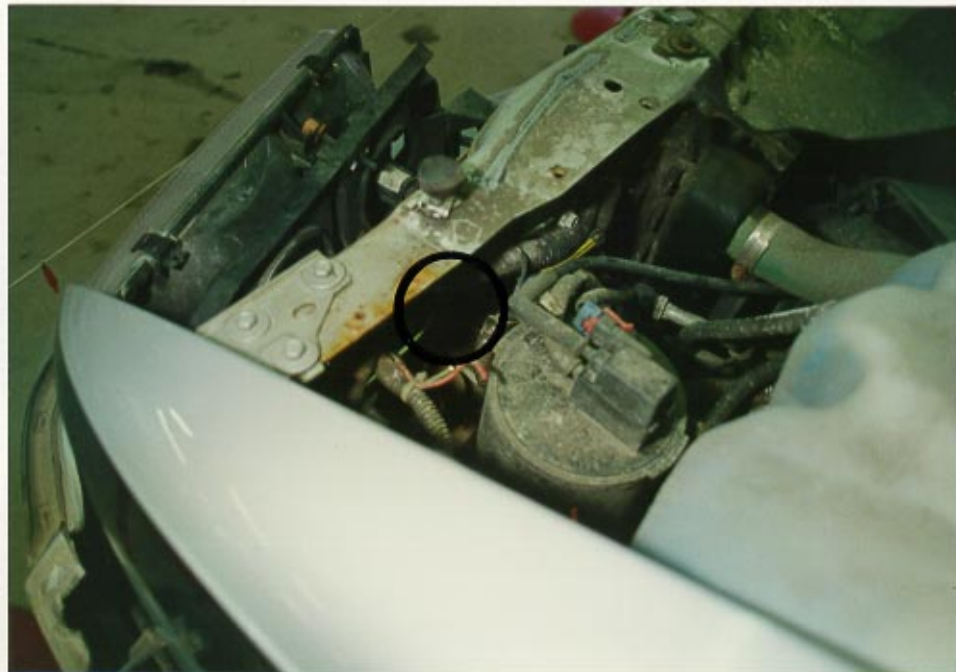
The front mounted discriminating crash sensors on the Caprice were visually inspected for damage. The sensors were found to be intact and free of damage and rotation from crash forces. The SIR diagnostic (DERM) were tested using the instrument panel mounted indicator lamp. Although the positive battery cable had been cut by emergency personnel at the crash scene, the cable was temporarily spliced to transmit power into the SIR. With the ignition switch turned to the run position, the SIR indicator lamp flashed a sequence of seven then remained out, indicating that the SIR system was operational. This sequence was repeated numerous times which yielded the same results.

Left front air bag crash sensor mounted to the radiator support panel behind the headlamp assembly

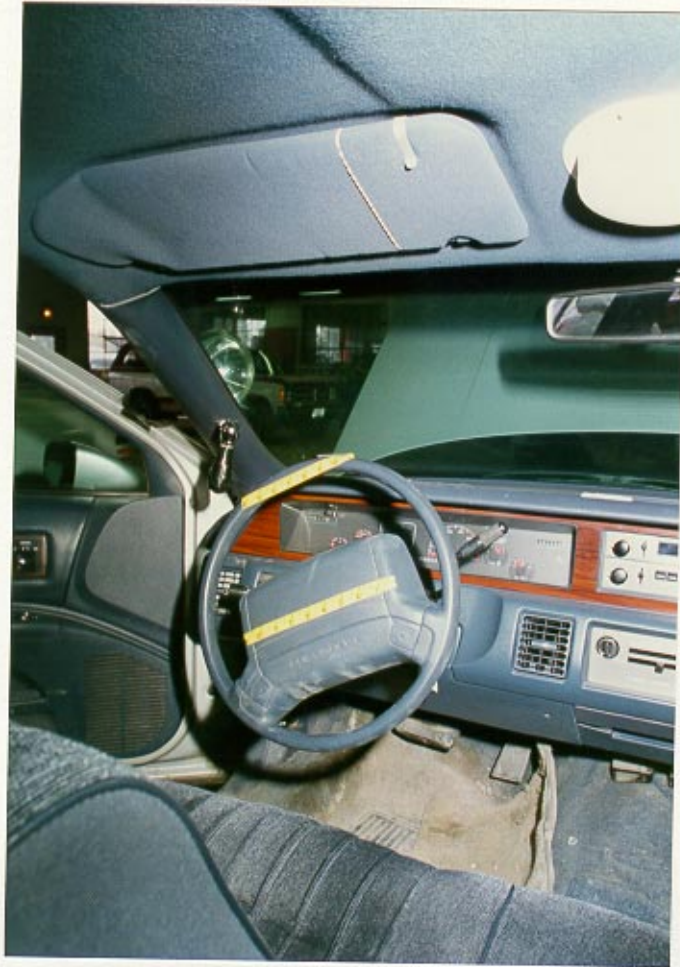
Overall view of the driver's seated position

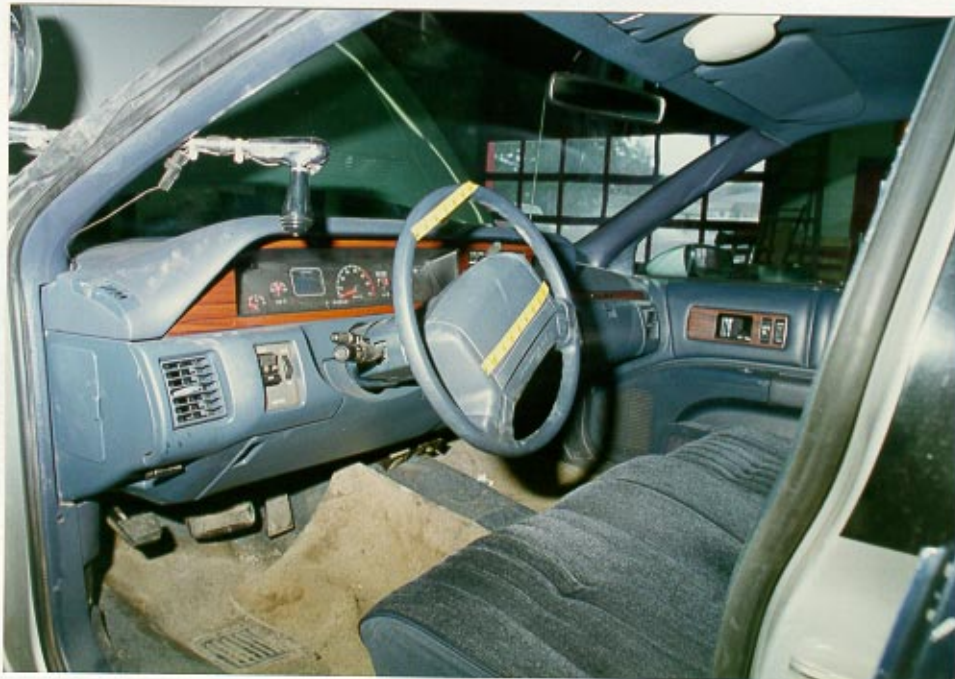
Steering and air bag module assembly

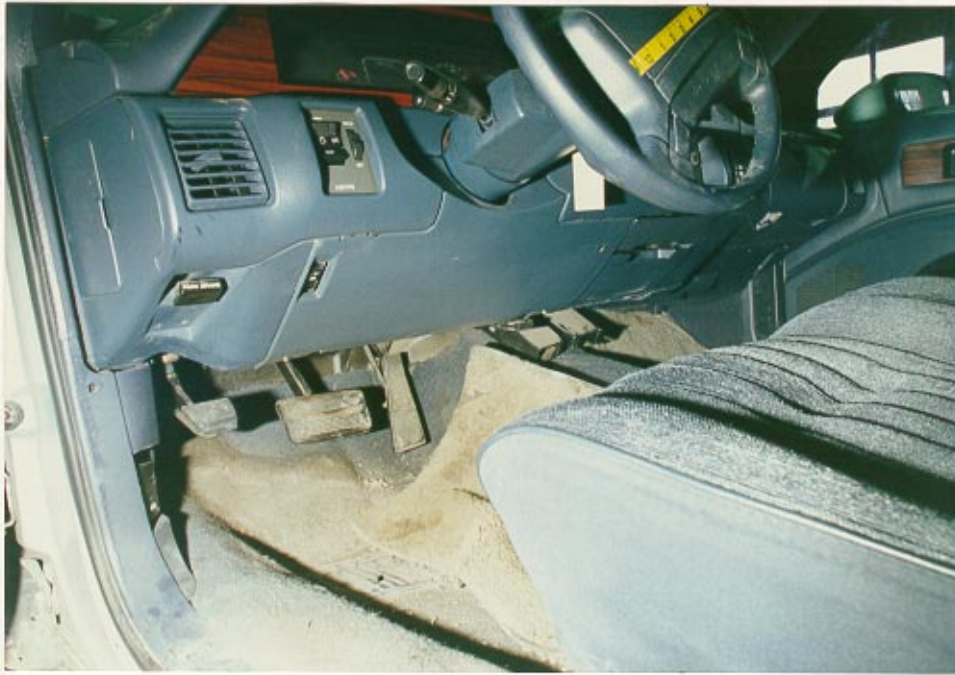
Knee bolster, no evidence of contact

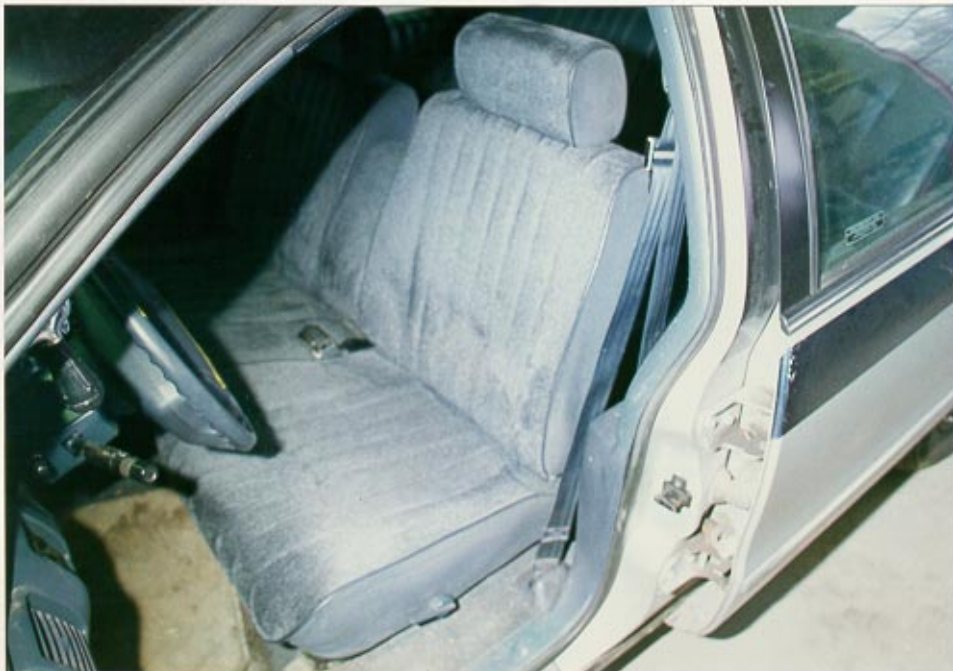
The driver of the Chevrolet Caprice was not wearing the manual 3-point lap and shoulder belt system in the patrol vehicle due to the poor fit around his equipment belt and his frequent exits from the vehicle. The driver stated that he drove the vehicle with the seat track adjusted to a rearward position and the seat back set to a near vertical position. In addition, the driver used a lumbar support cushion to prevent aggravation of a previous lower back injury. At impact with the pedestrian signal support pole, the unrestrained driver attempted to brace against the steering wheel and initiated a forward trajectory and loaded the steering assembly with his chest. As a result of the thoracic loading, he deformed the upper rim 6.4mm (0.25") forward. There was no compression of the energy absorbing steering column. His attempted bracing action and subsequent contact with the steering wheel produced soreness across both posterior shoulder areas. His head continued forward and impacted the windshield header area which resulted in a contusion to the anterior scalp, directly above the hairline (AIS-1). The impact force and head contact also produced a minor whiplash to the lower cervical spine area (AIS-1). The driver stated that he had a history of neck and lower back injuries and that the crash aggravated both areas. He rebounded into the left front seat back where he came to rest.

Driver's seat and manual 3-point lap and shoulder belt system (not worn)

The driver of the Chevrolet Caprice sustained minor injuries as a result of this moderate severity crush. These injuries could have been mitigated had the driver worn the manual 3-point lap and shoulder belt system.

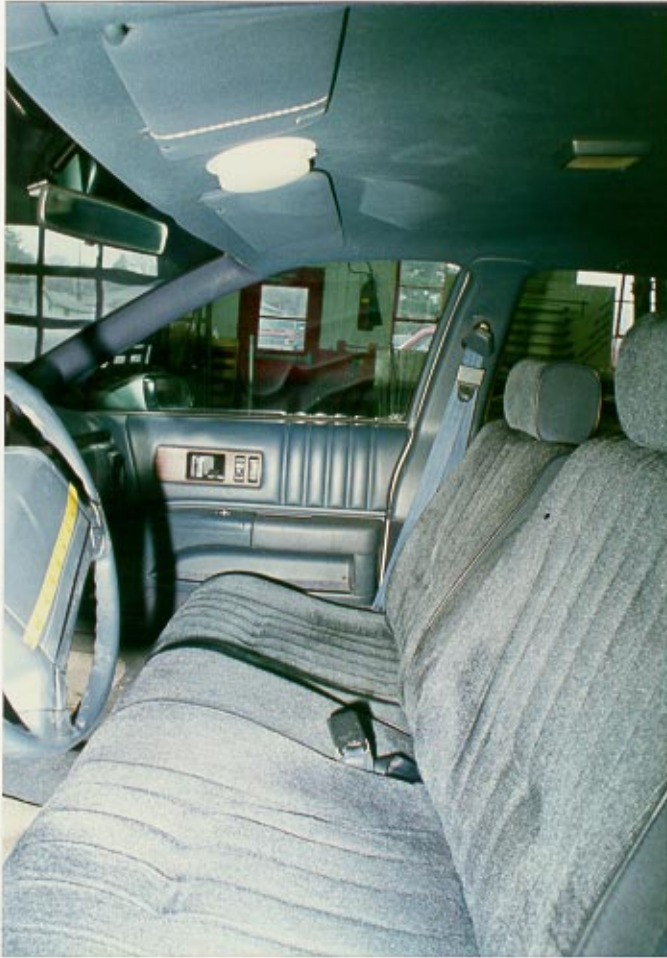
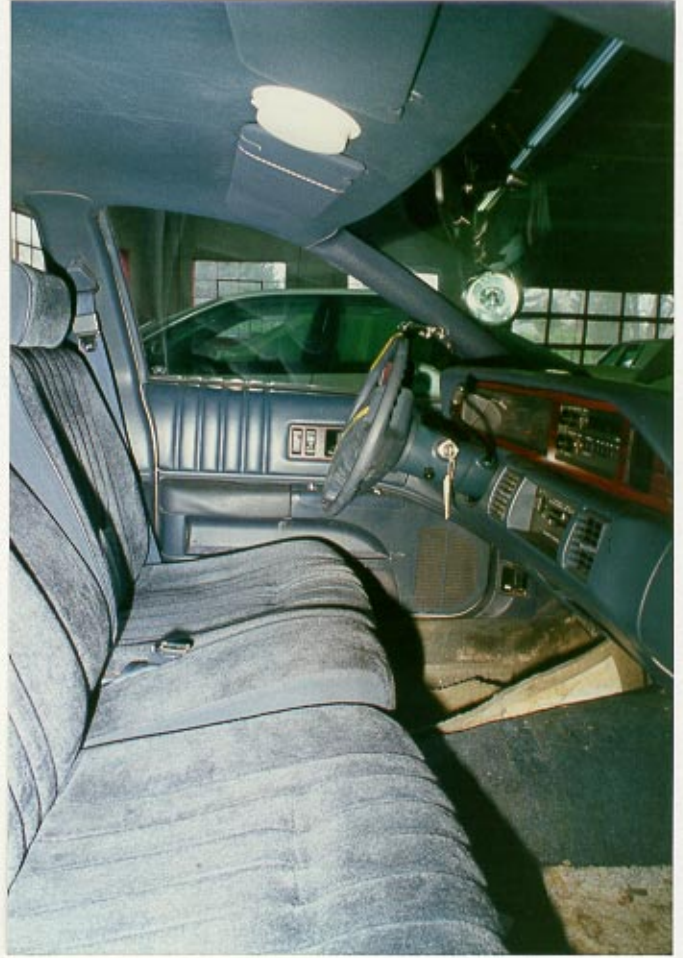
Perpendicular views across the interior of the Chevrolet Caprice

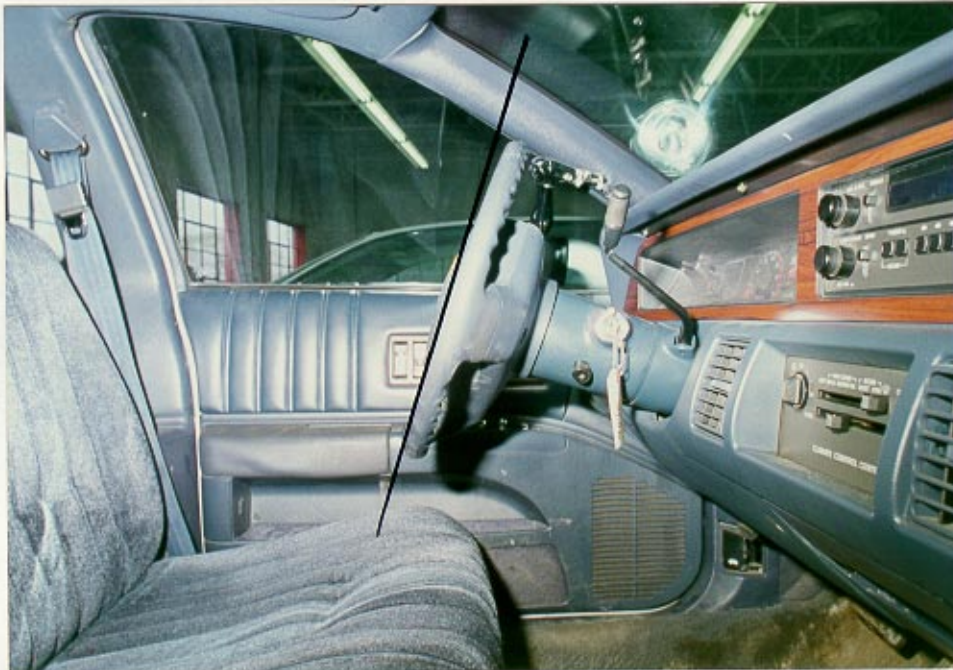
Perpendicular view of the steering wheel rim, 6.4mm (0.25") of upper rim displacement

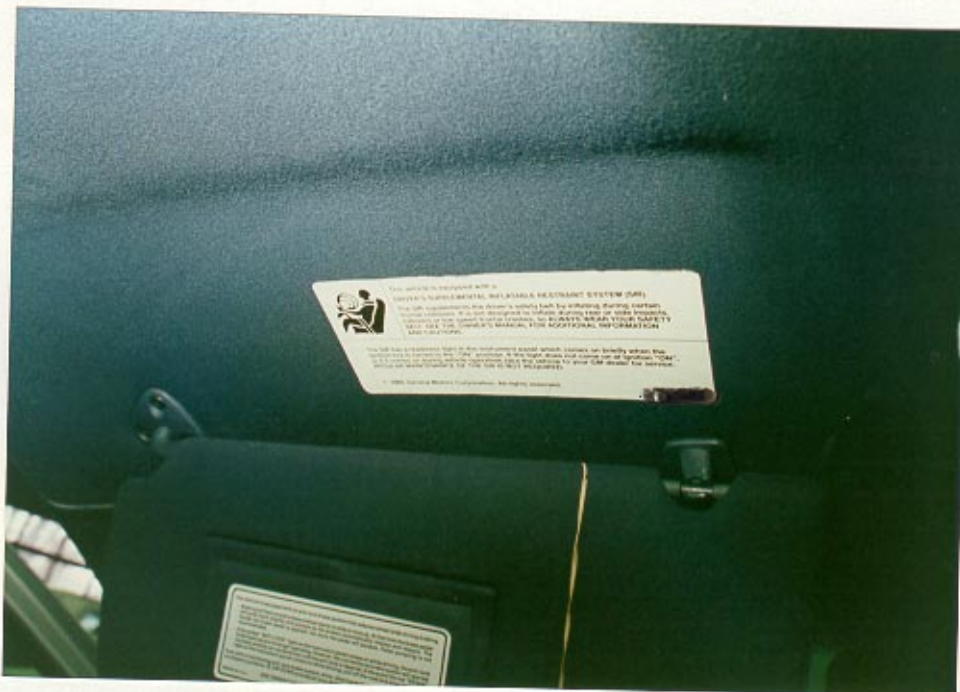
SIR information label on left sunvisor
