DYNAMIC SCIENCE, INC.
In-Depth Accident Investigation

Case DSI-93-AB-012

TECHNICAL SUMMARY

CONTRACTOR: Dynamic Science, Inc.
CASE NUMBER: DSI-93-AB-012

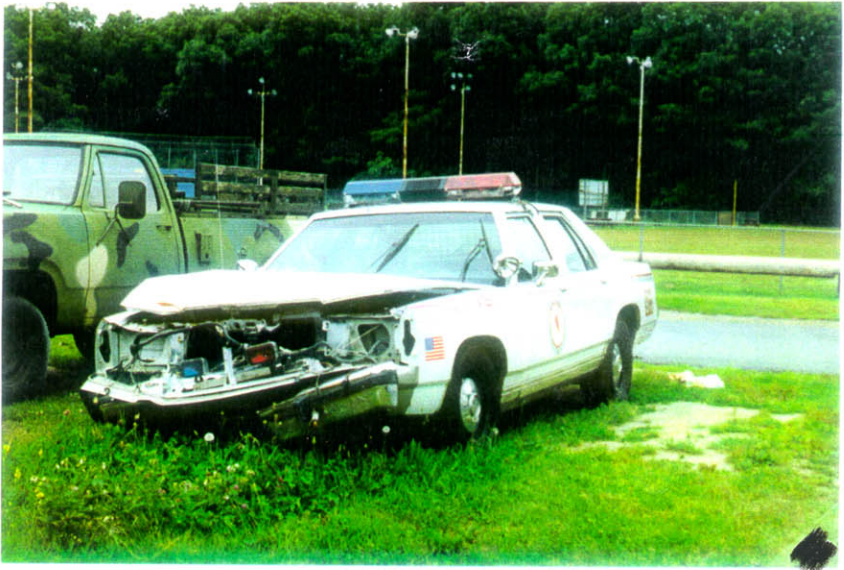
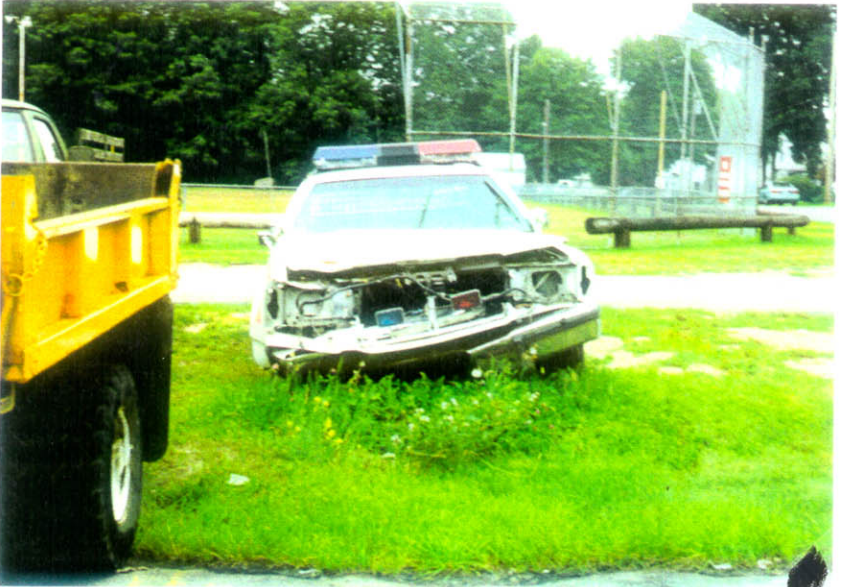
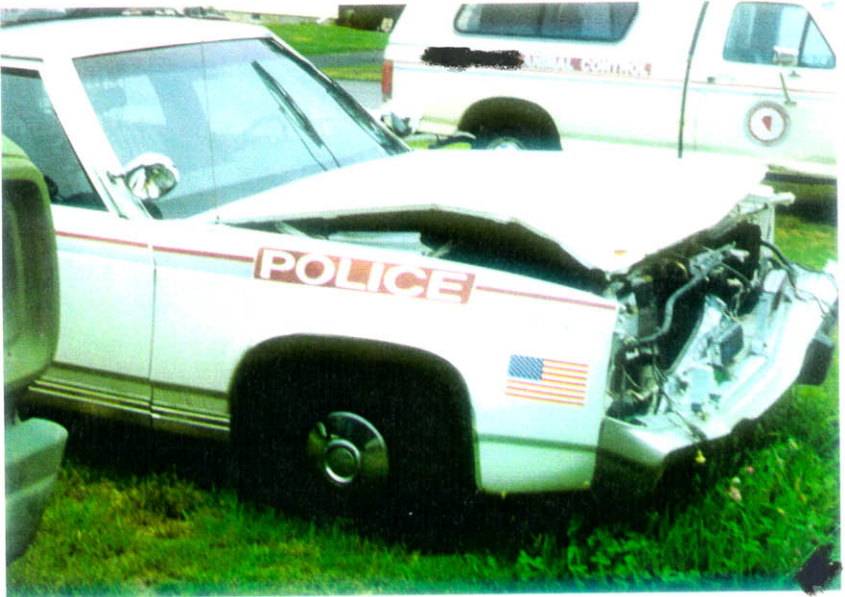
PHOTO #	VEHICLE #	DIRECTION OF PICTURE	SUBJECT MATTER
1-3	1	NA	Exterior of Vehicle 1.

Vehicle 1 sustained moderate damage and was towed from the scene.
