REPORT NUMBER: 201U-CAL-06-04

**SAFETY COMPLIANCE TESTING FOR FMVSS 201
OCCUPANT PROTECTION IN INTERIOR IMPACT
UPPER INTERIOR HEAD IMPACT PROTECTION**

**HONDA OF AMERICA
2006 HONDA CIVIC 4 DOOR LX**

NHTSA NUMBER: C65302

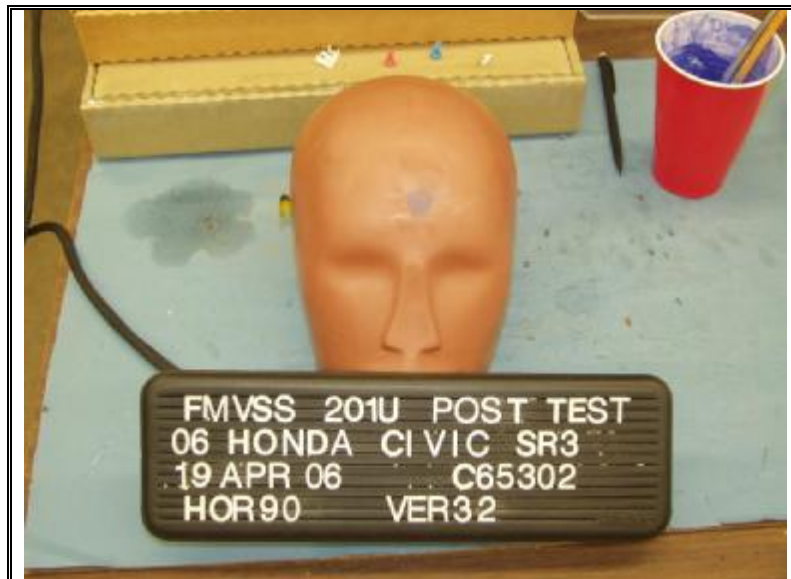
POST-IMPACT SR3 HEADFORM

Impact Point Description (from lower midpoint on midsagittal line)			
On Centerline	5	mm right	x mm left
On Centerline	14	mm up

Free Motion HIC	315.8
HIC(d)	404.6
Impact Velocity (kph)	18.45
HIC T1 (msec)	3.0
HIC T2 (msec)	9.3

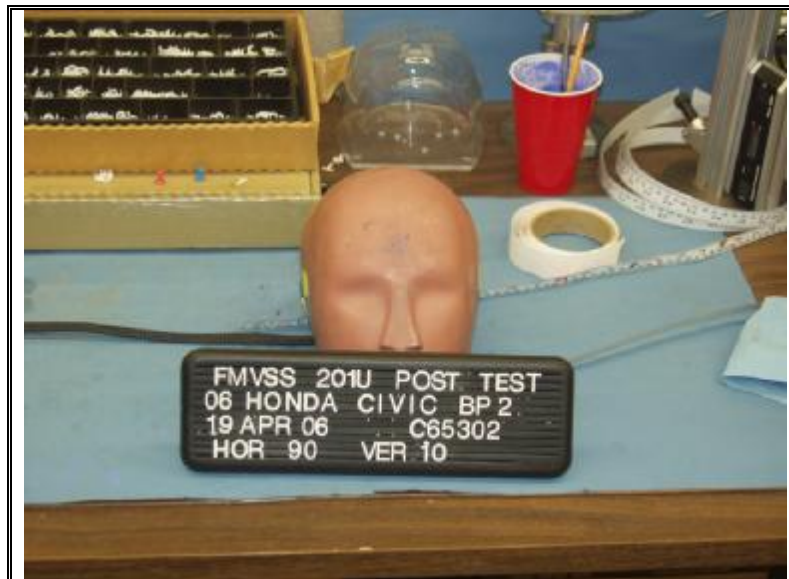
POST-IMPACT BP2 HEADFORM

Impact Point Description (from lower midpoint on midsagittal line)			
On Centerline	0	<input type="checkbox"/>	mm right <input type="checkbox"/> mm left
On Centerline	7		mm up

Free Motion HIC	665.7
HIC(d)	668.6
Impact Velocity (kph)	23.4
HIC T1 (msec)	2.2
HIC T2 (msec)	10.1

Note : BP2 target location – Seat belt anchorage

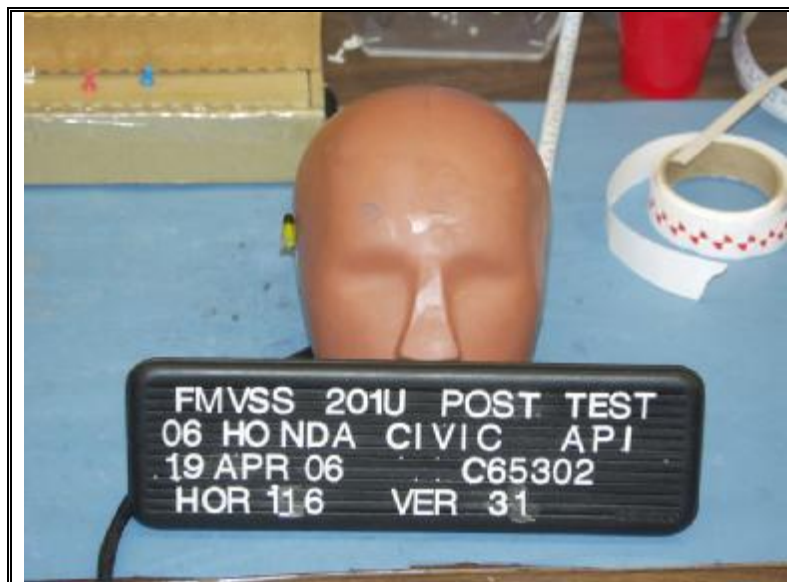
POST-IMPACT AP1 HEADFORM

Impact Point Description (from lower midpoint on midsagittal line)				
On Centerline	33	x	mm right	mm left
On Centerline	9		mm up

Free Motion HIC	355.5
HIC(d)	434.6
Impact Velocity (kph)	18.67
HIC T1 (msec)	2.2
HIC T2 (msec)	7.2

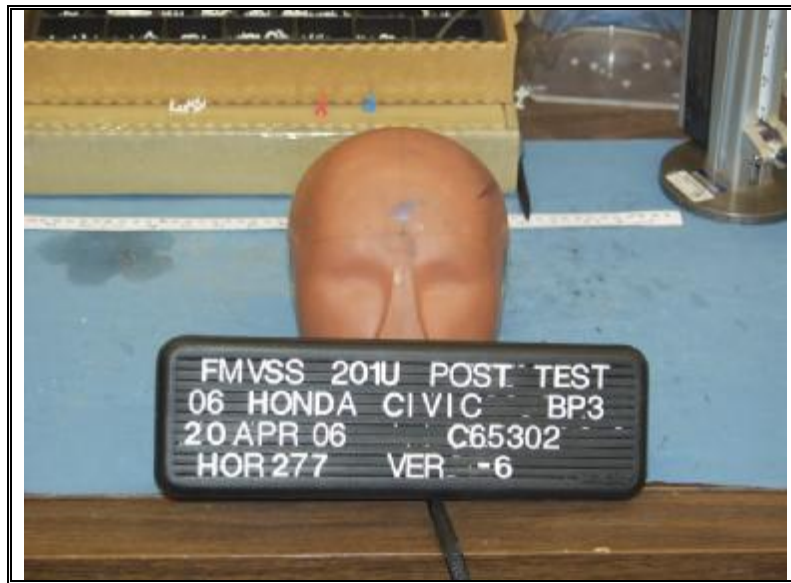
POST-IMPACT BP3 HEADFORM

Impact Point Description (from lower midpoint on midsagittal line)			
On Centerline	0	mm right	mm left
On Centerline	14	mm up

Free Motion HIC	618.9
HIC(d)	633.4
Impact Velocity (kph)	23.84
HIC T1 (msec)	2.7
HIC T2 (msec)	9.3

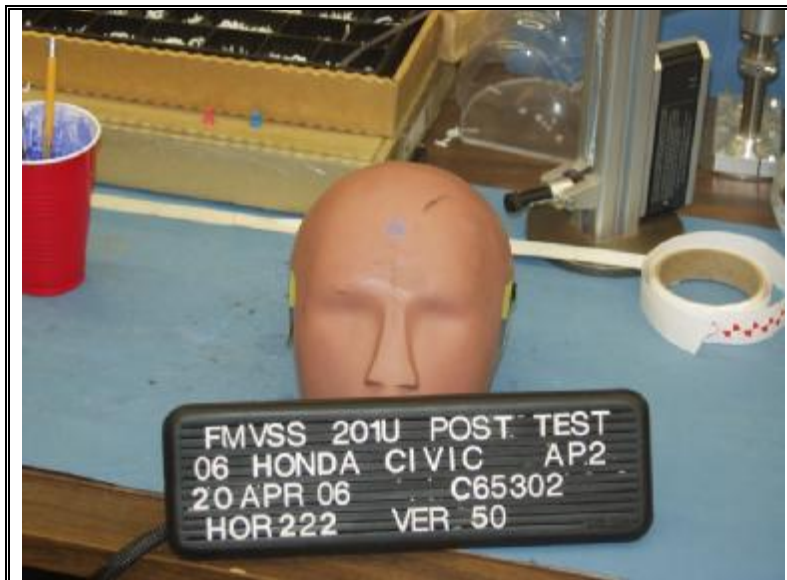
POST-IMPACT AP2 HEADFORM

Impact Point Description (from lower midpoint on midsagittal line)					
On Centerline	0	<input type="checkbox"/>	mm right	<input type="checkbox"/>	mm left
On Centerline	27				mm up

Free Motion HIC	649.8
HIC(d)	656.6
Impact Velocity (kph)	18.83
HIC T1 (msec)	4.5
HIC T2 (msec)	7.7

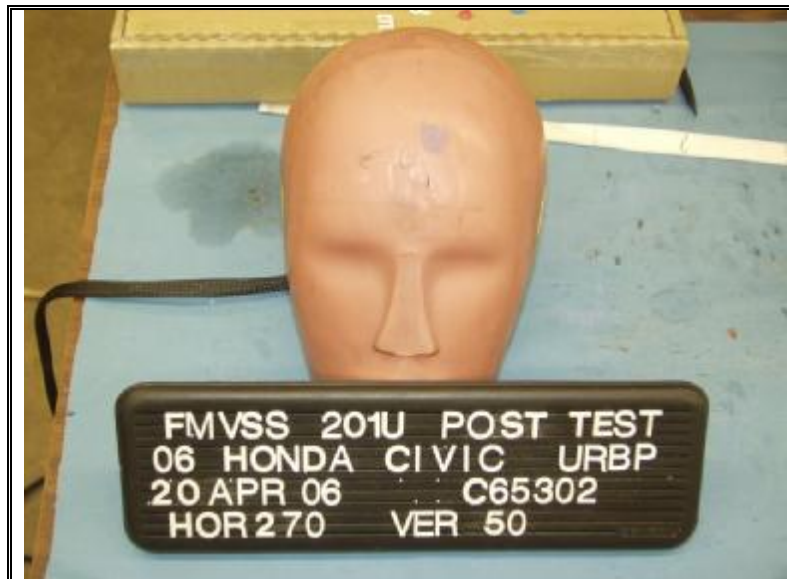
POST-IMPACT URBP Driver HEADFORM

Impact Point Description (from lower midpoint on midsagittal line)			
On Centerline	7	mm right	x mm left
On Centerline	33	mm up

Free Motion HIC	890.8
HIC(d)	838.5
Impact Velocity (kph)	23.48
HIC T1 (msec)	3.6
HIC T2 (msec)	9.3
