REPORT NUMBER: 201U-CAL-06-07

**SAFETY COMPLIANCE TESTING FOR FMVSS 201
OCCUPANT PROTECTION IN INTERIOR IMPACT
UPPER INTERIOR HEAD IMPACT PROTECTION**

**FUJI HEAVY INDUSTRIES LTD.
2006 SUBARU B9 TRIBECA**

CALSPAN TEST NUMBER: 8754-FMH-14

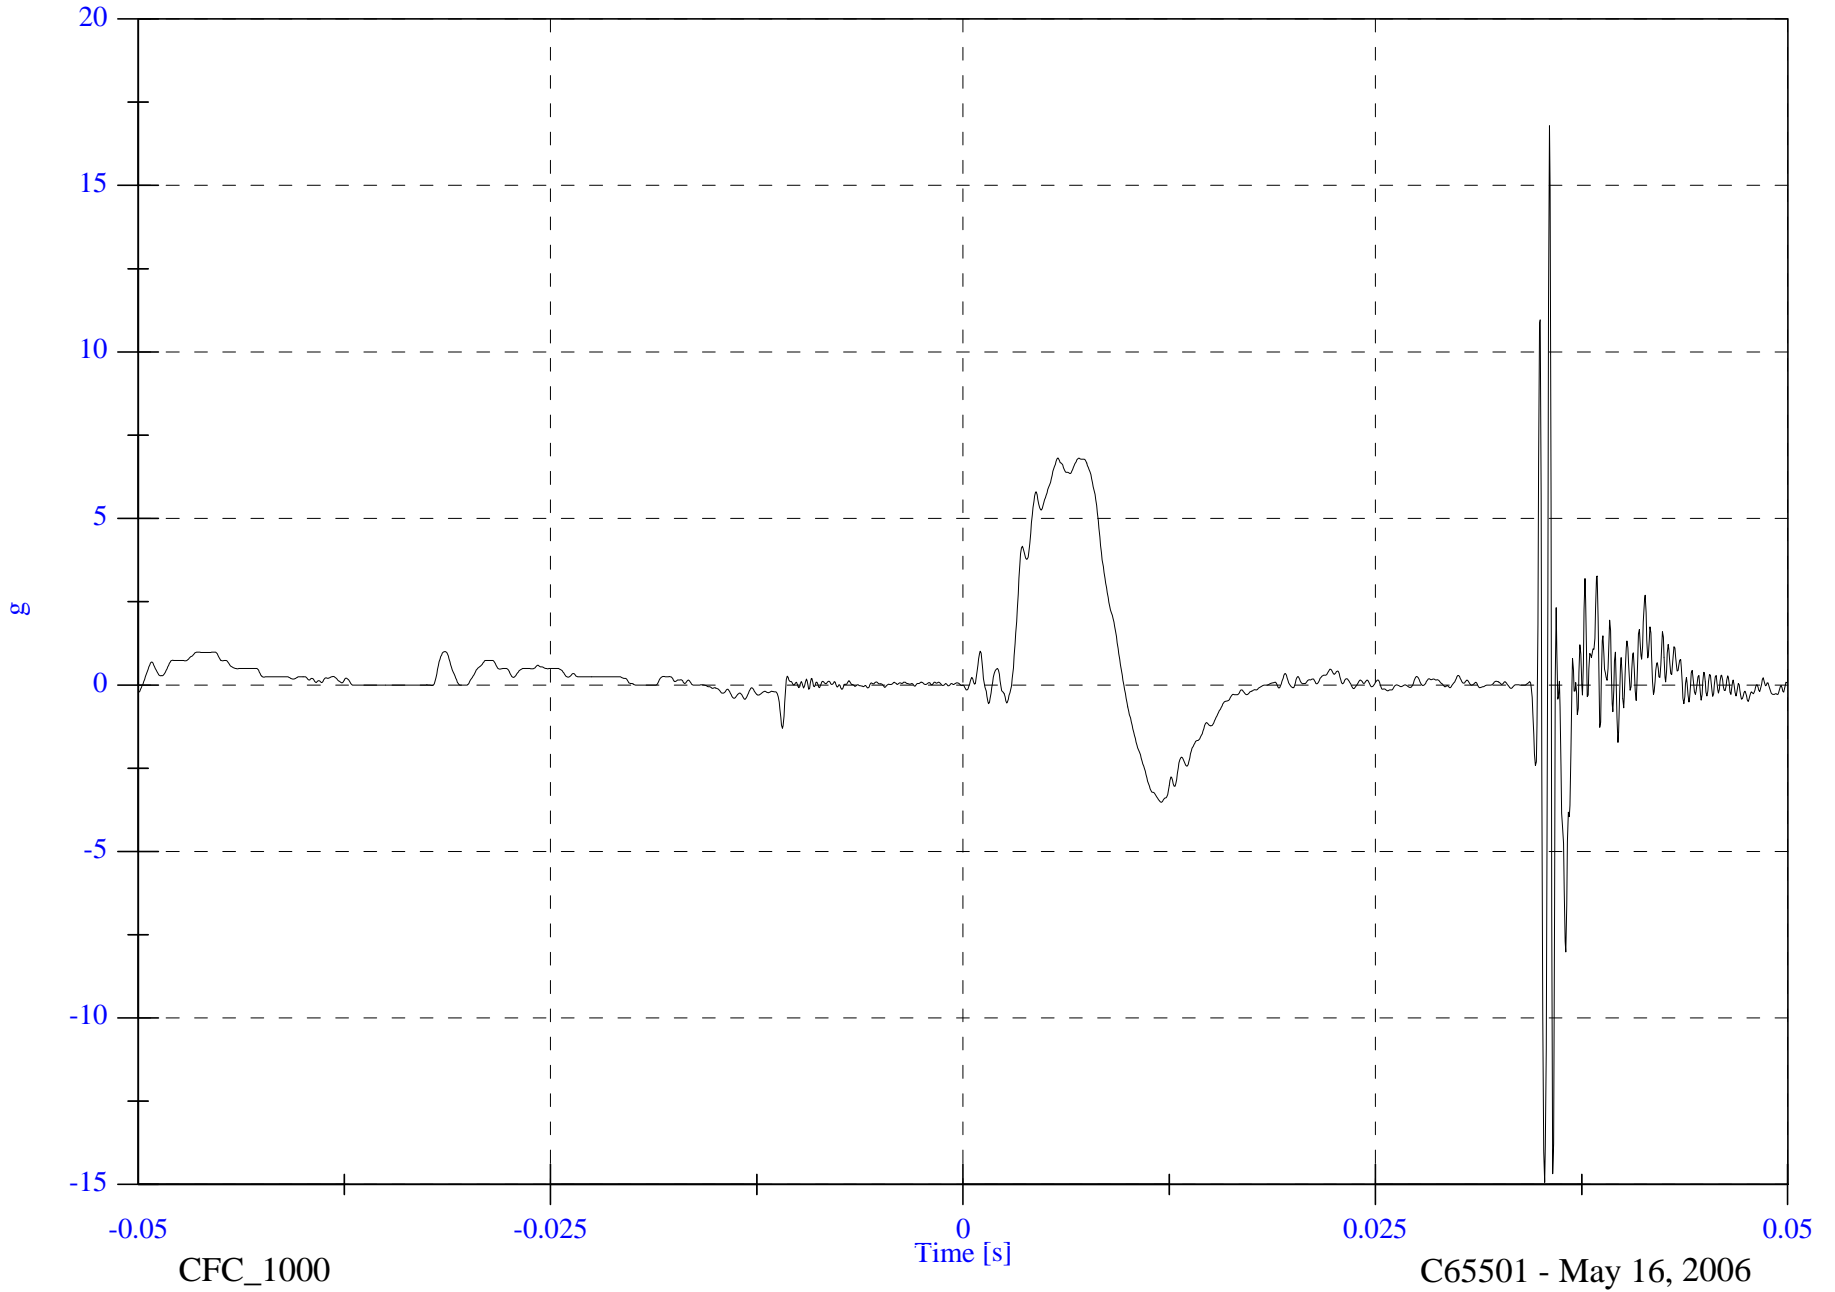
C65501 PASSENGER SIDE OP1 IMPACT PLOT #2

Headform Z Acceleration

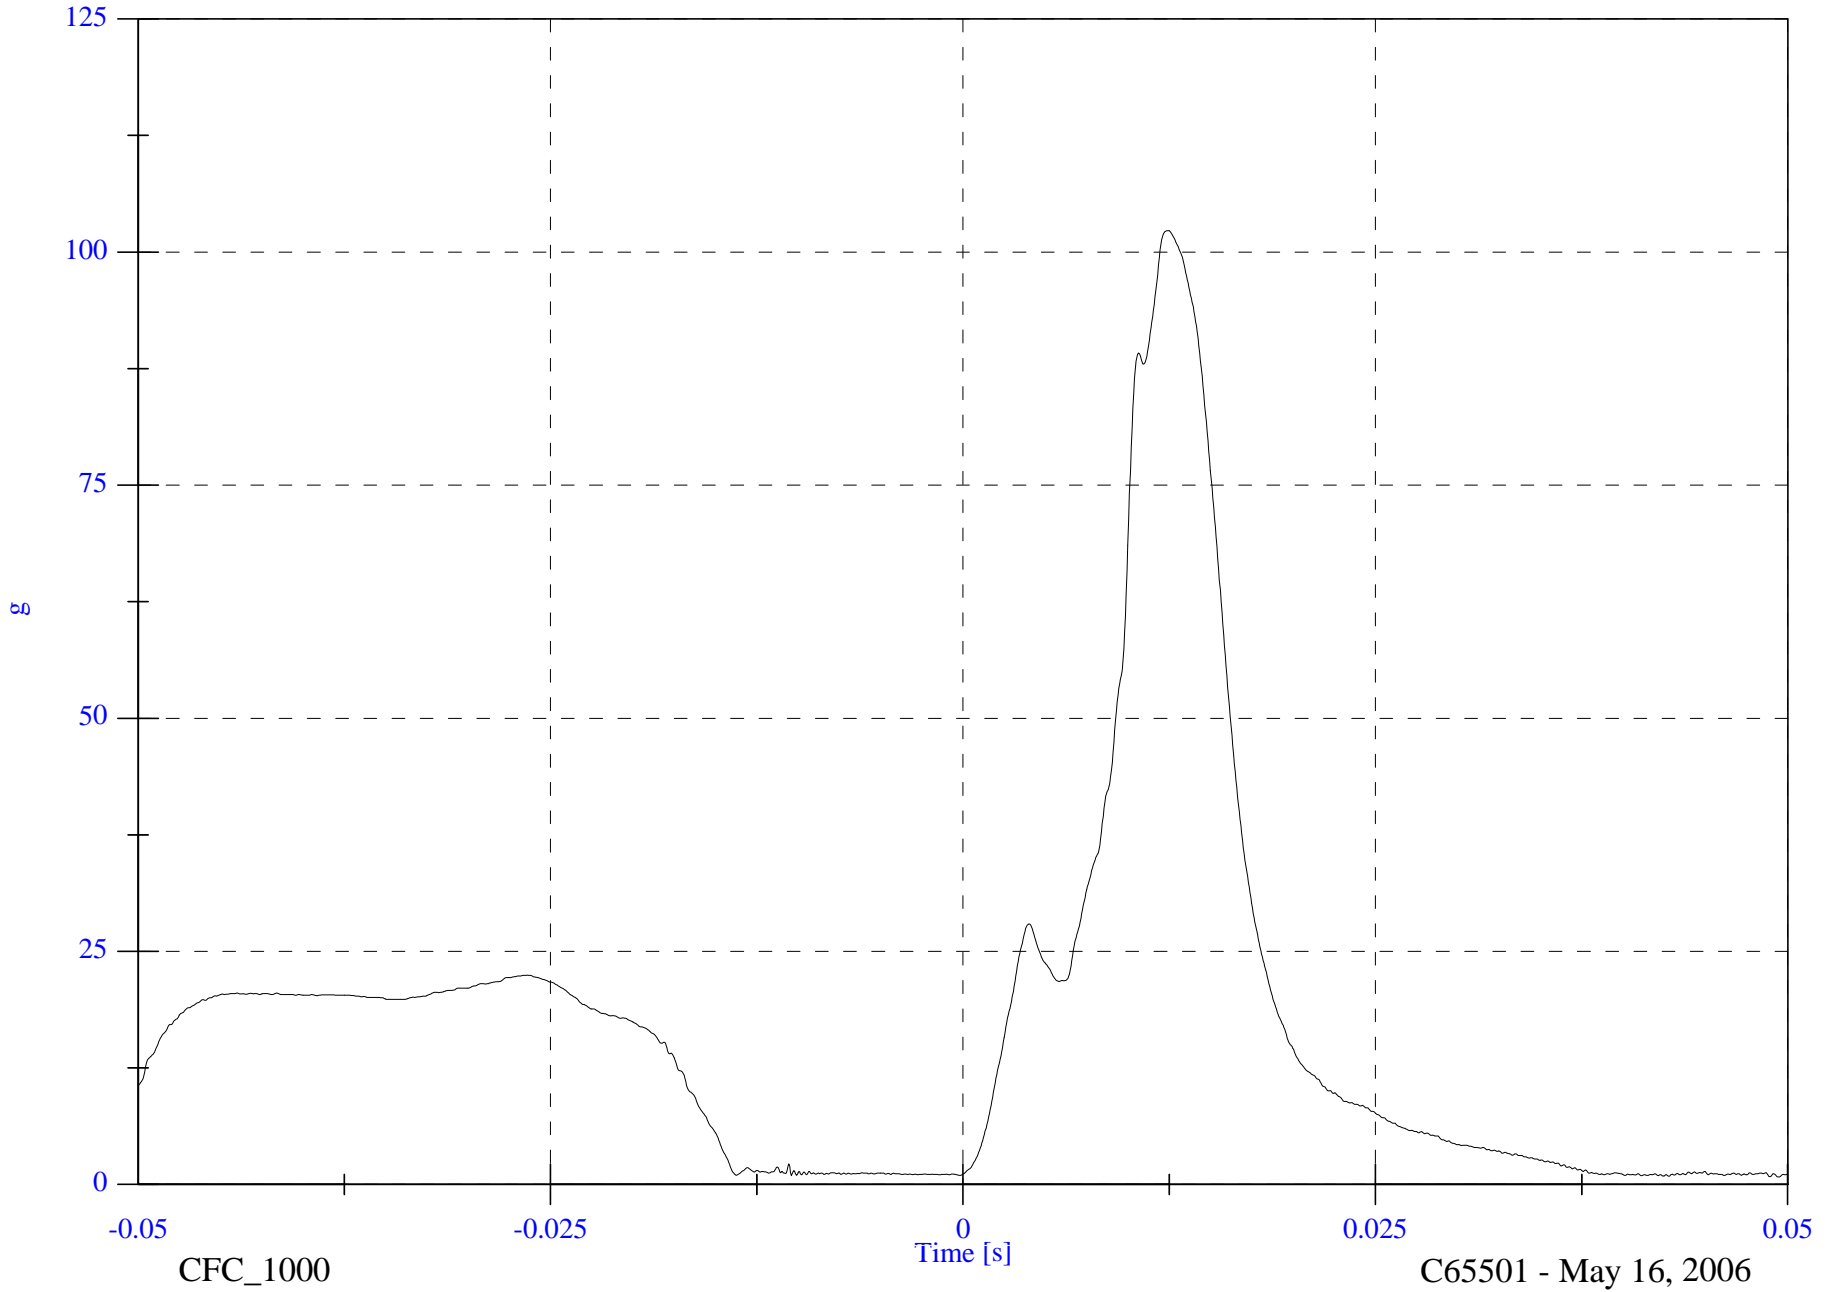
C65501 PASSENGER SIDE UROP IMPACT PLOT #4

Headform Velocity

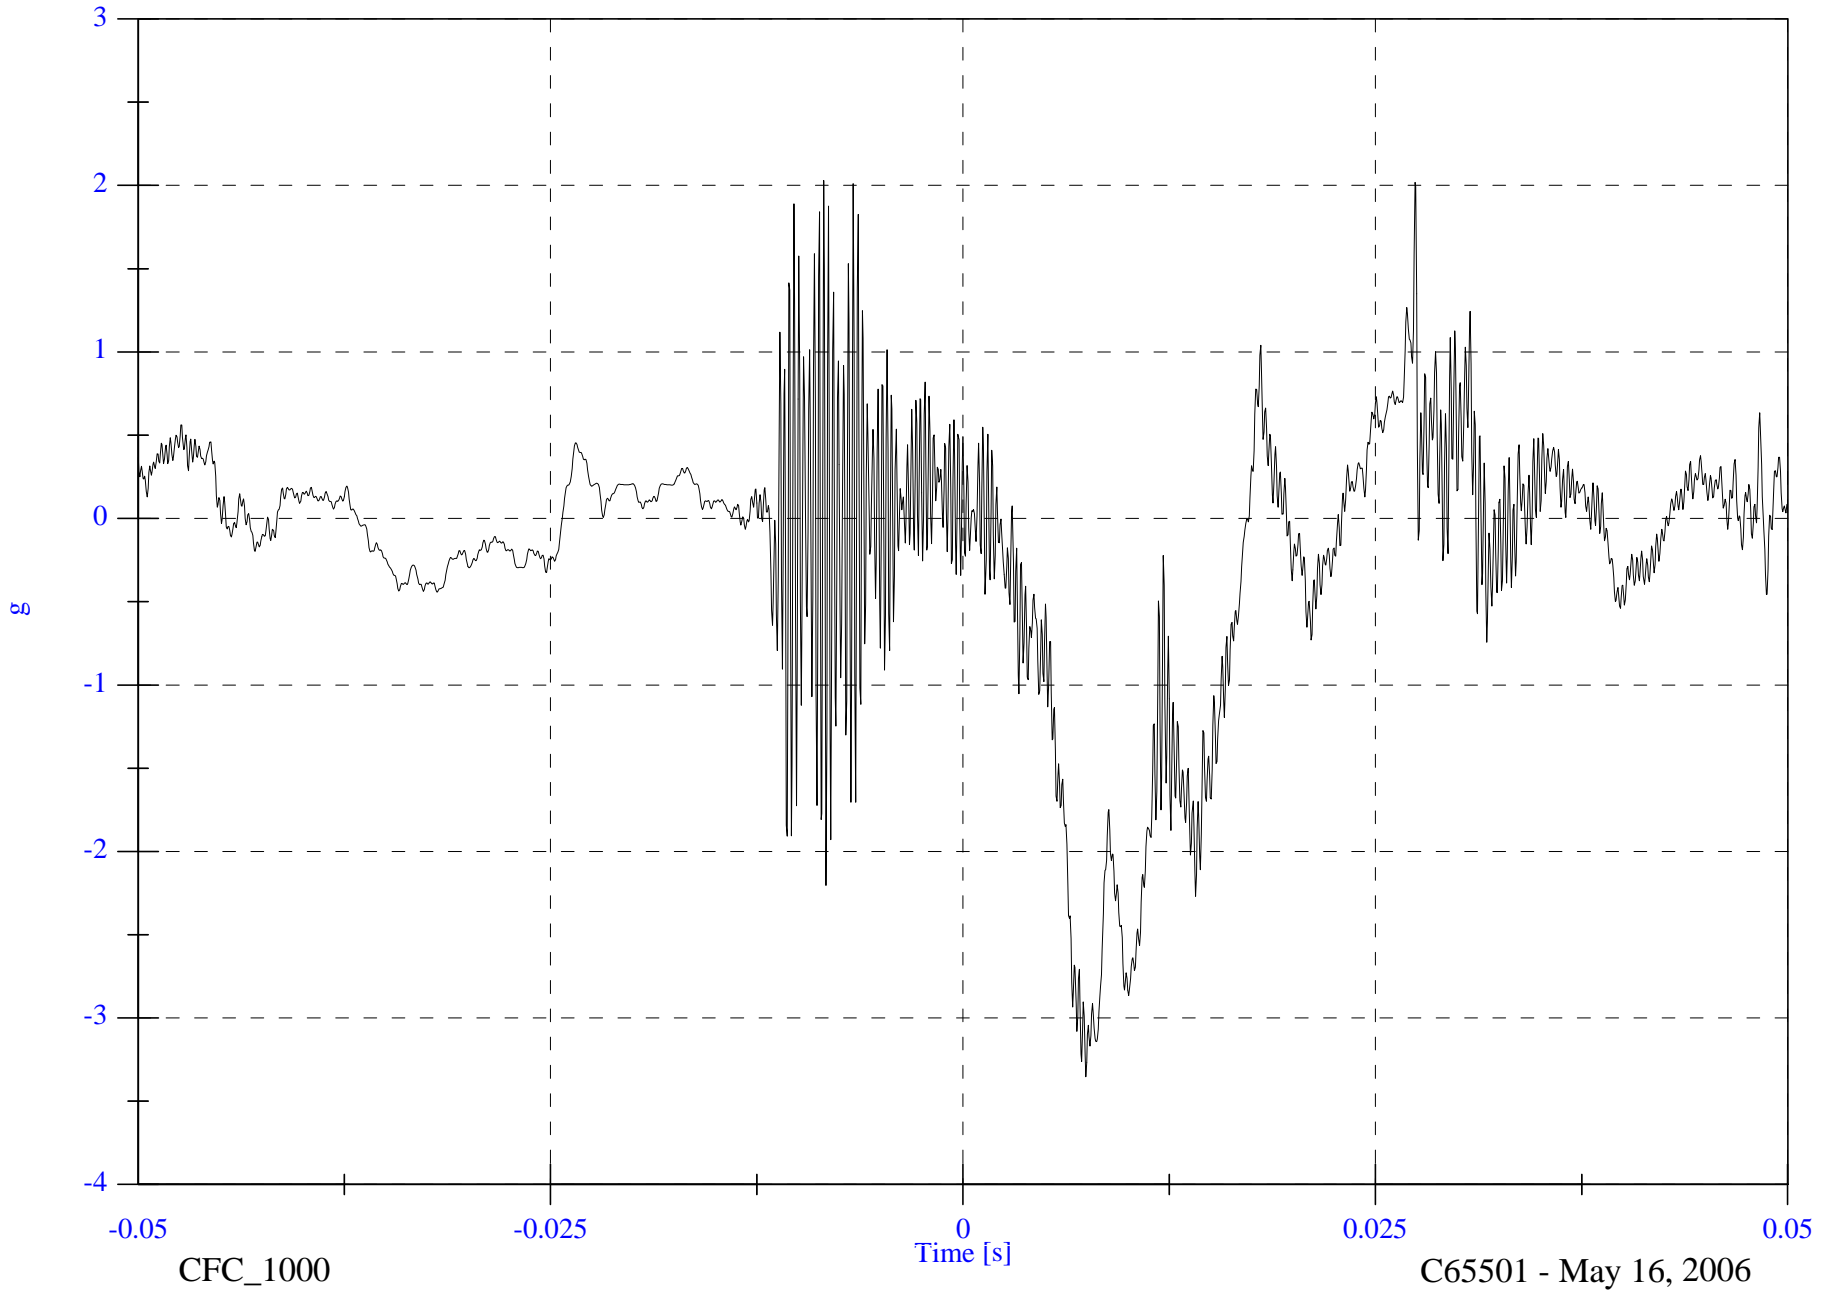
C65501 PASSENGER SIDE URBP IMPACT PLOT #2

Headform Z Acceleration

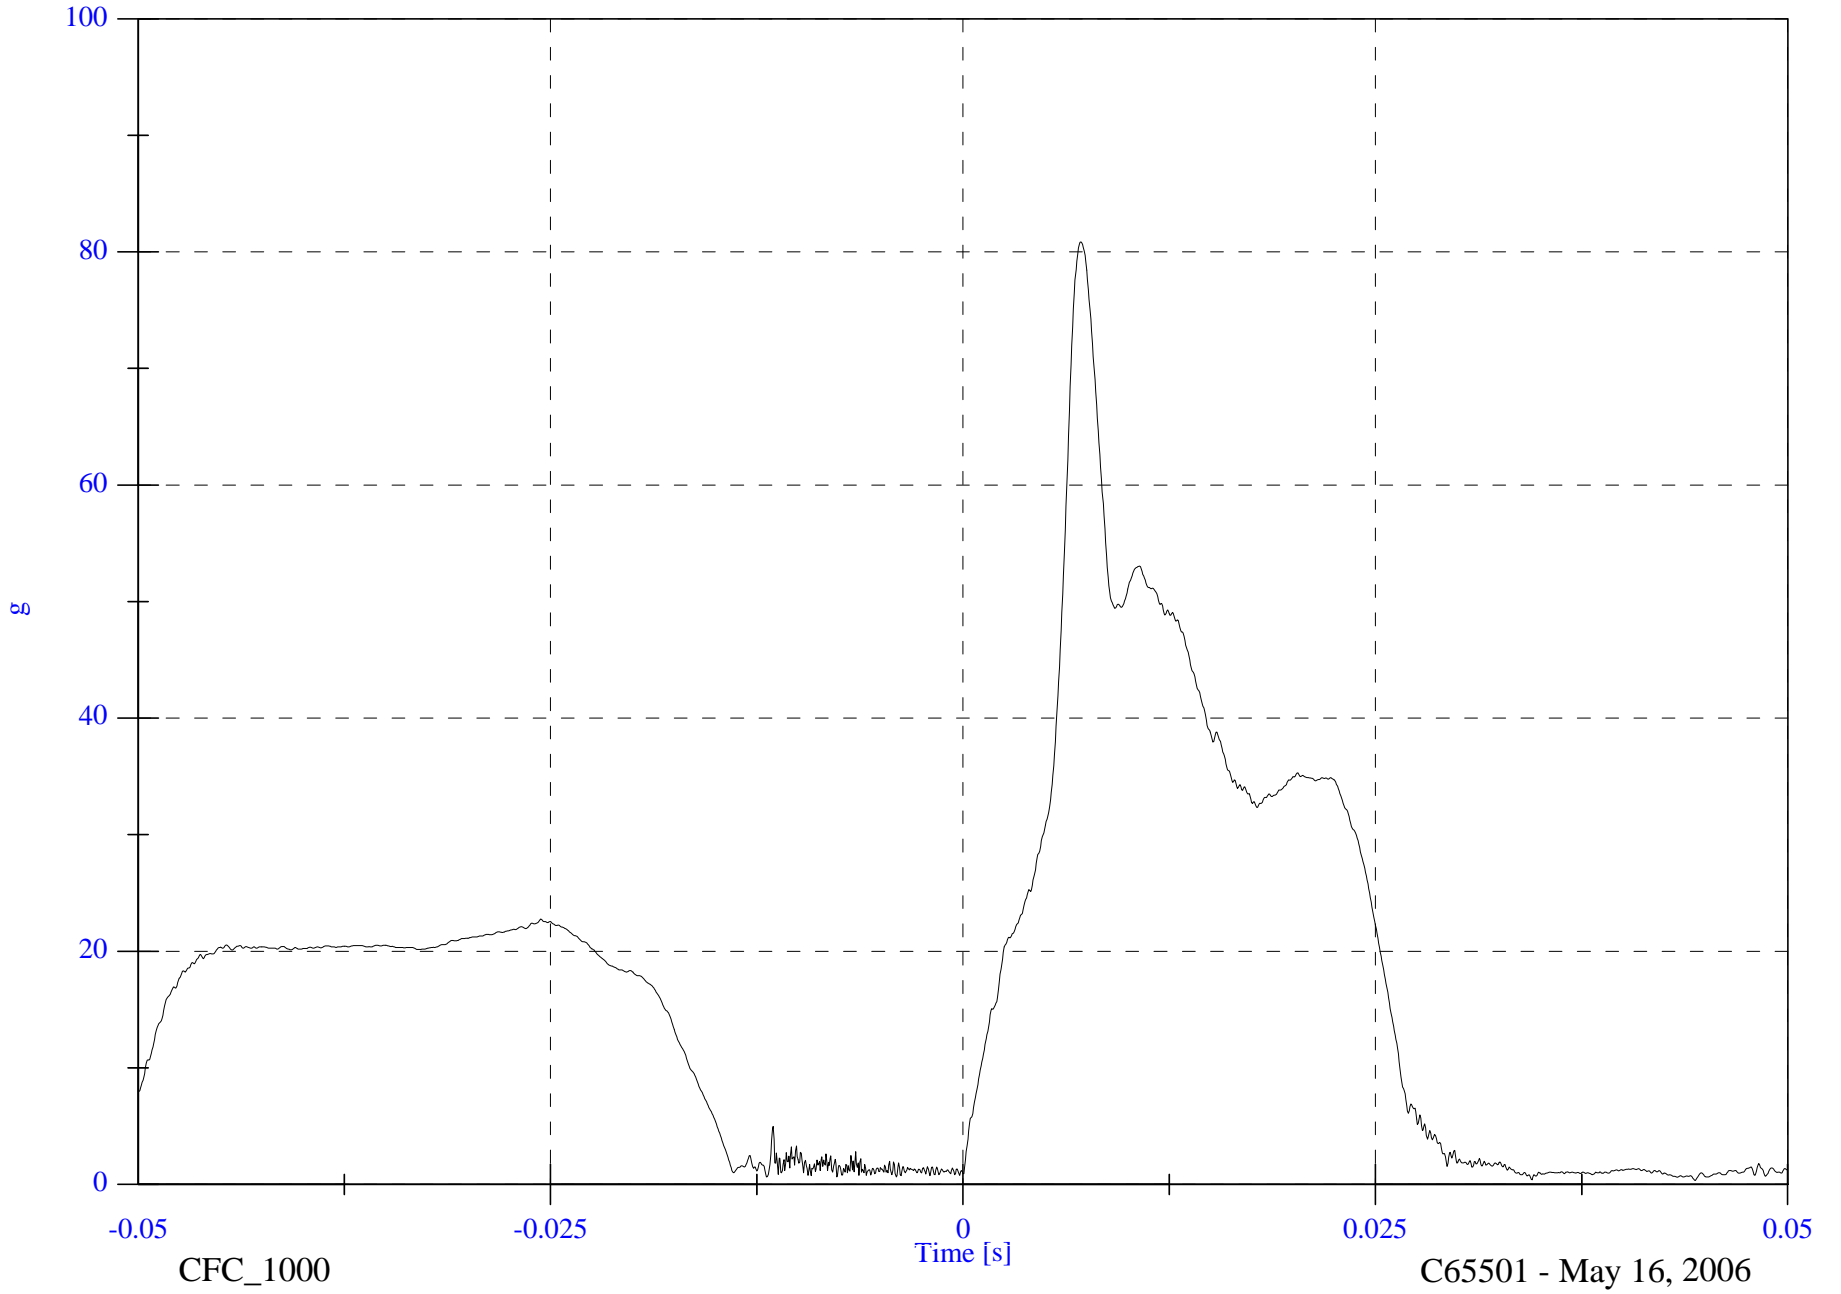
C65501 PASSENGER SIDE URBP IMPACT PLOT #4

Headform Velocity

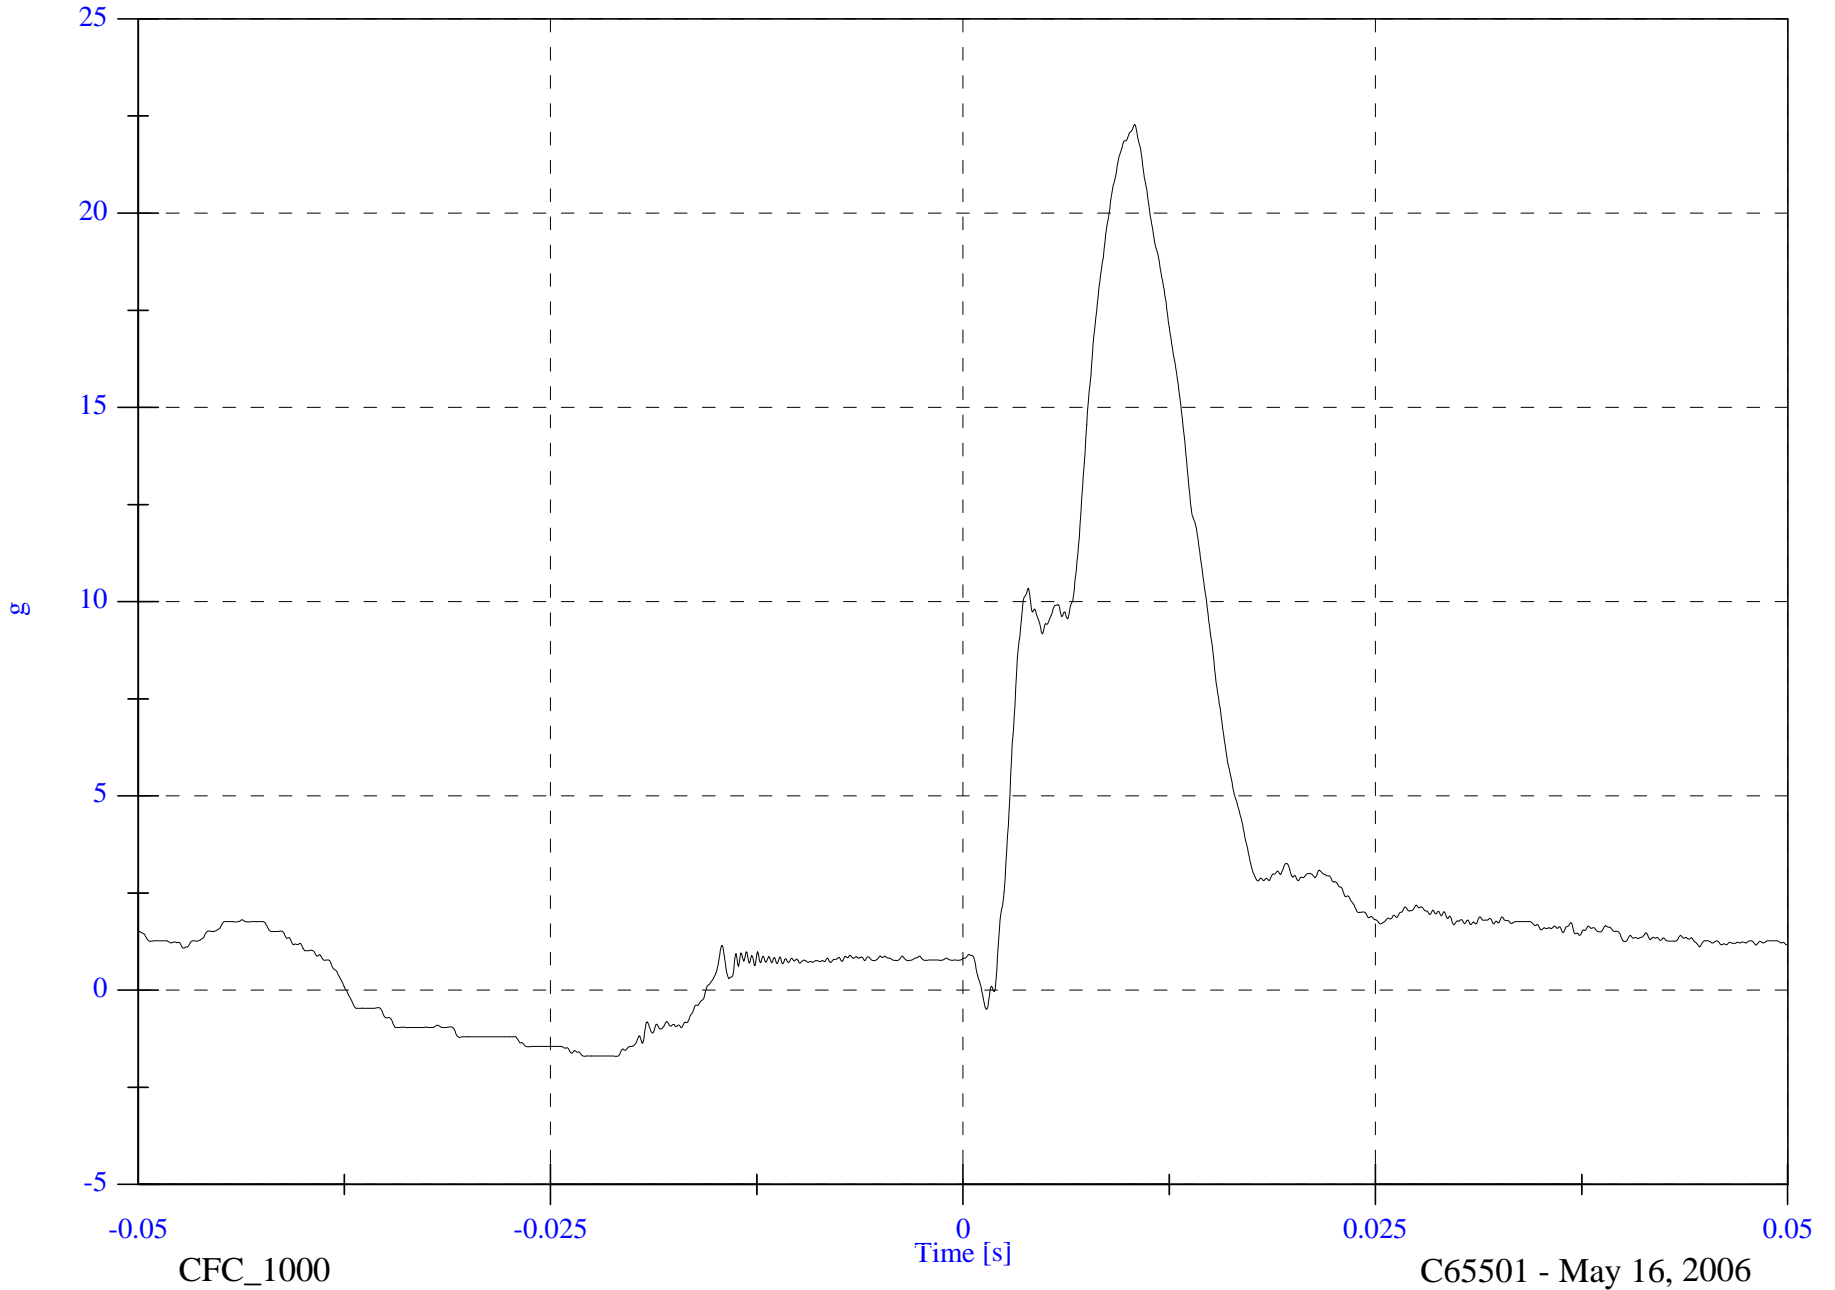
C65501 PASSENGER SIDE SR2A IMPACT PLOT #3

Headform Resultant

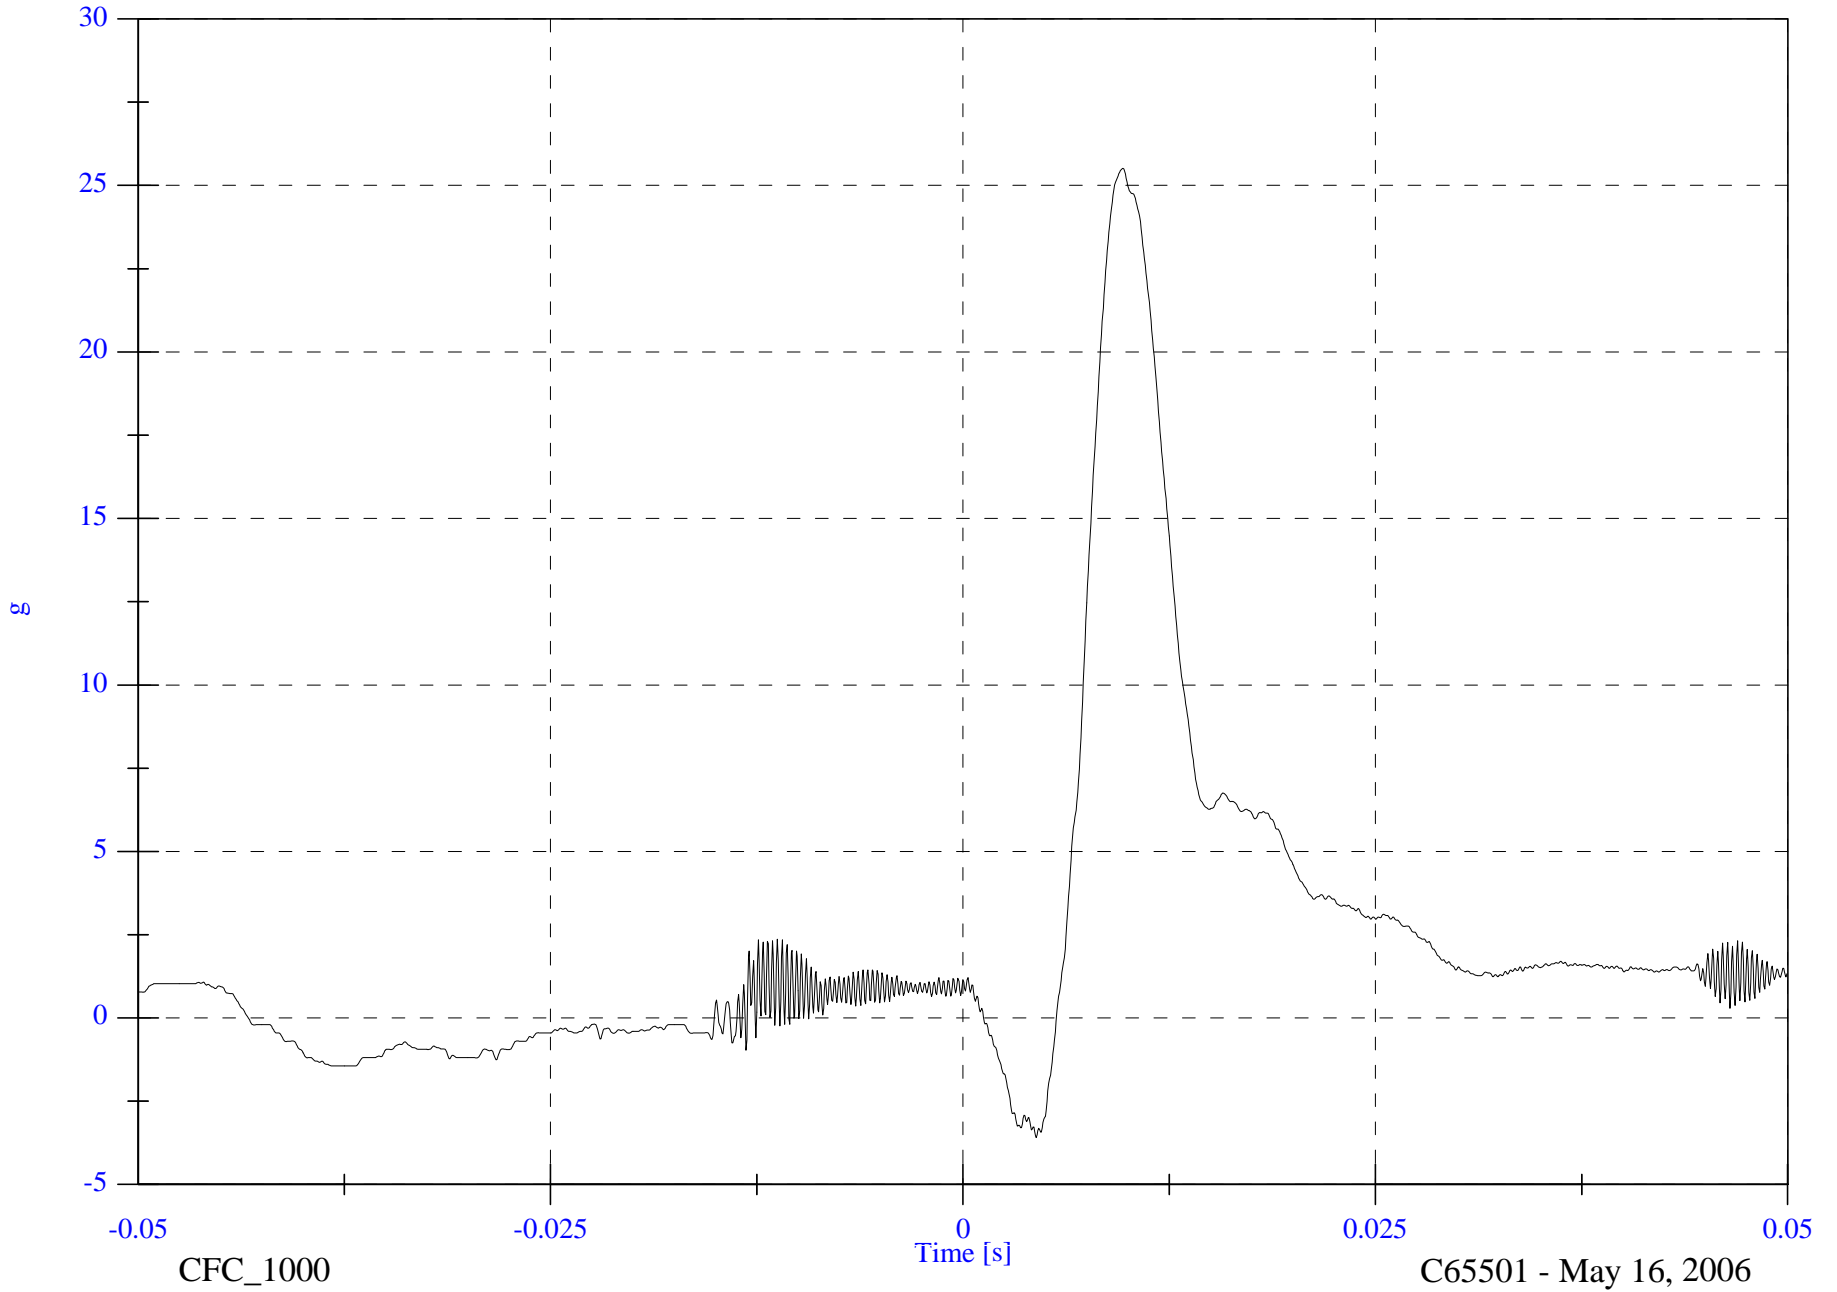
C65501 PASSENGER SIDE AP1 IMPACT PLOT #3

Headform Resultant

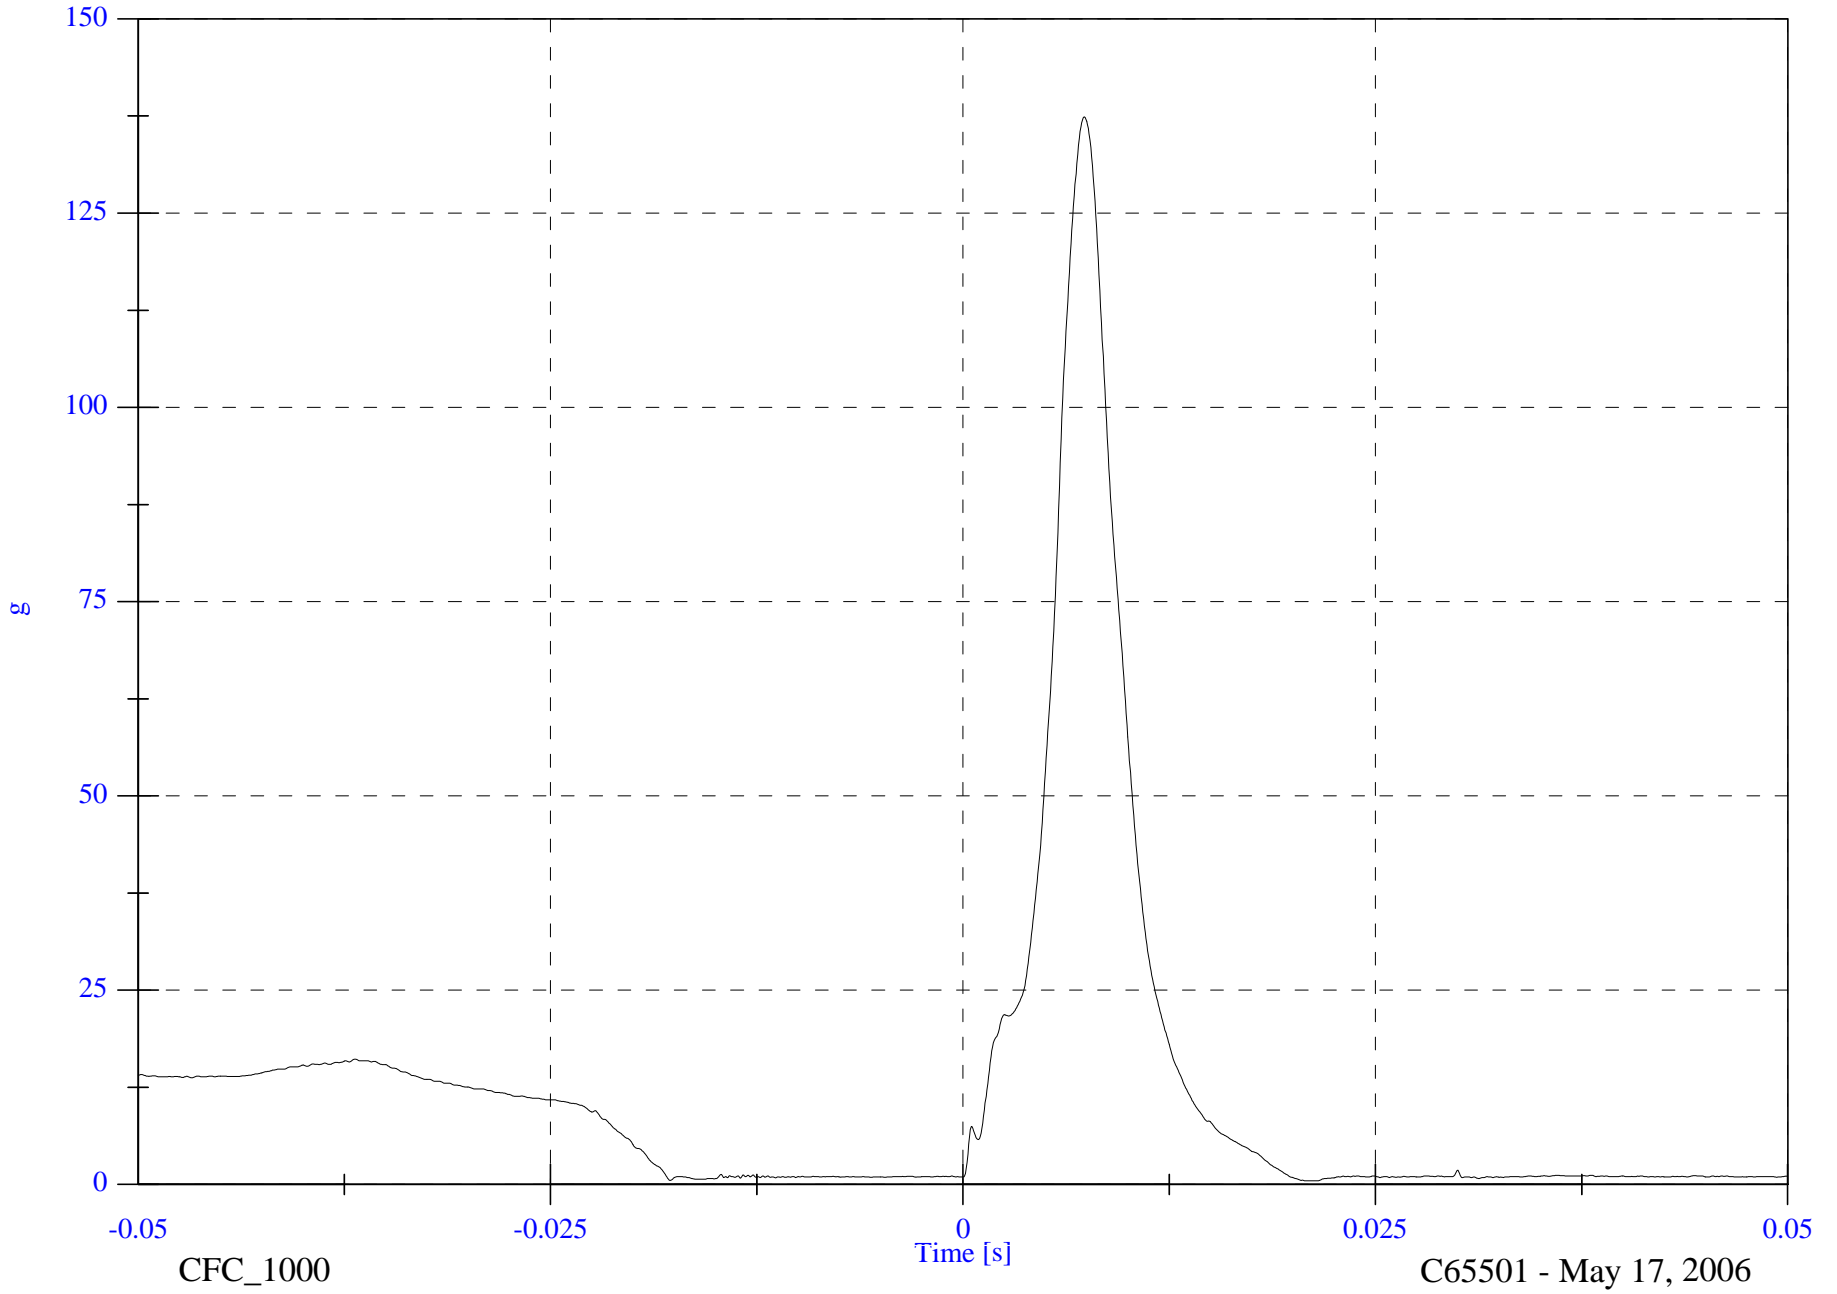
C65501 DRIVER SIDE AP2 IMPACT PLOT #4

Headform Velocity

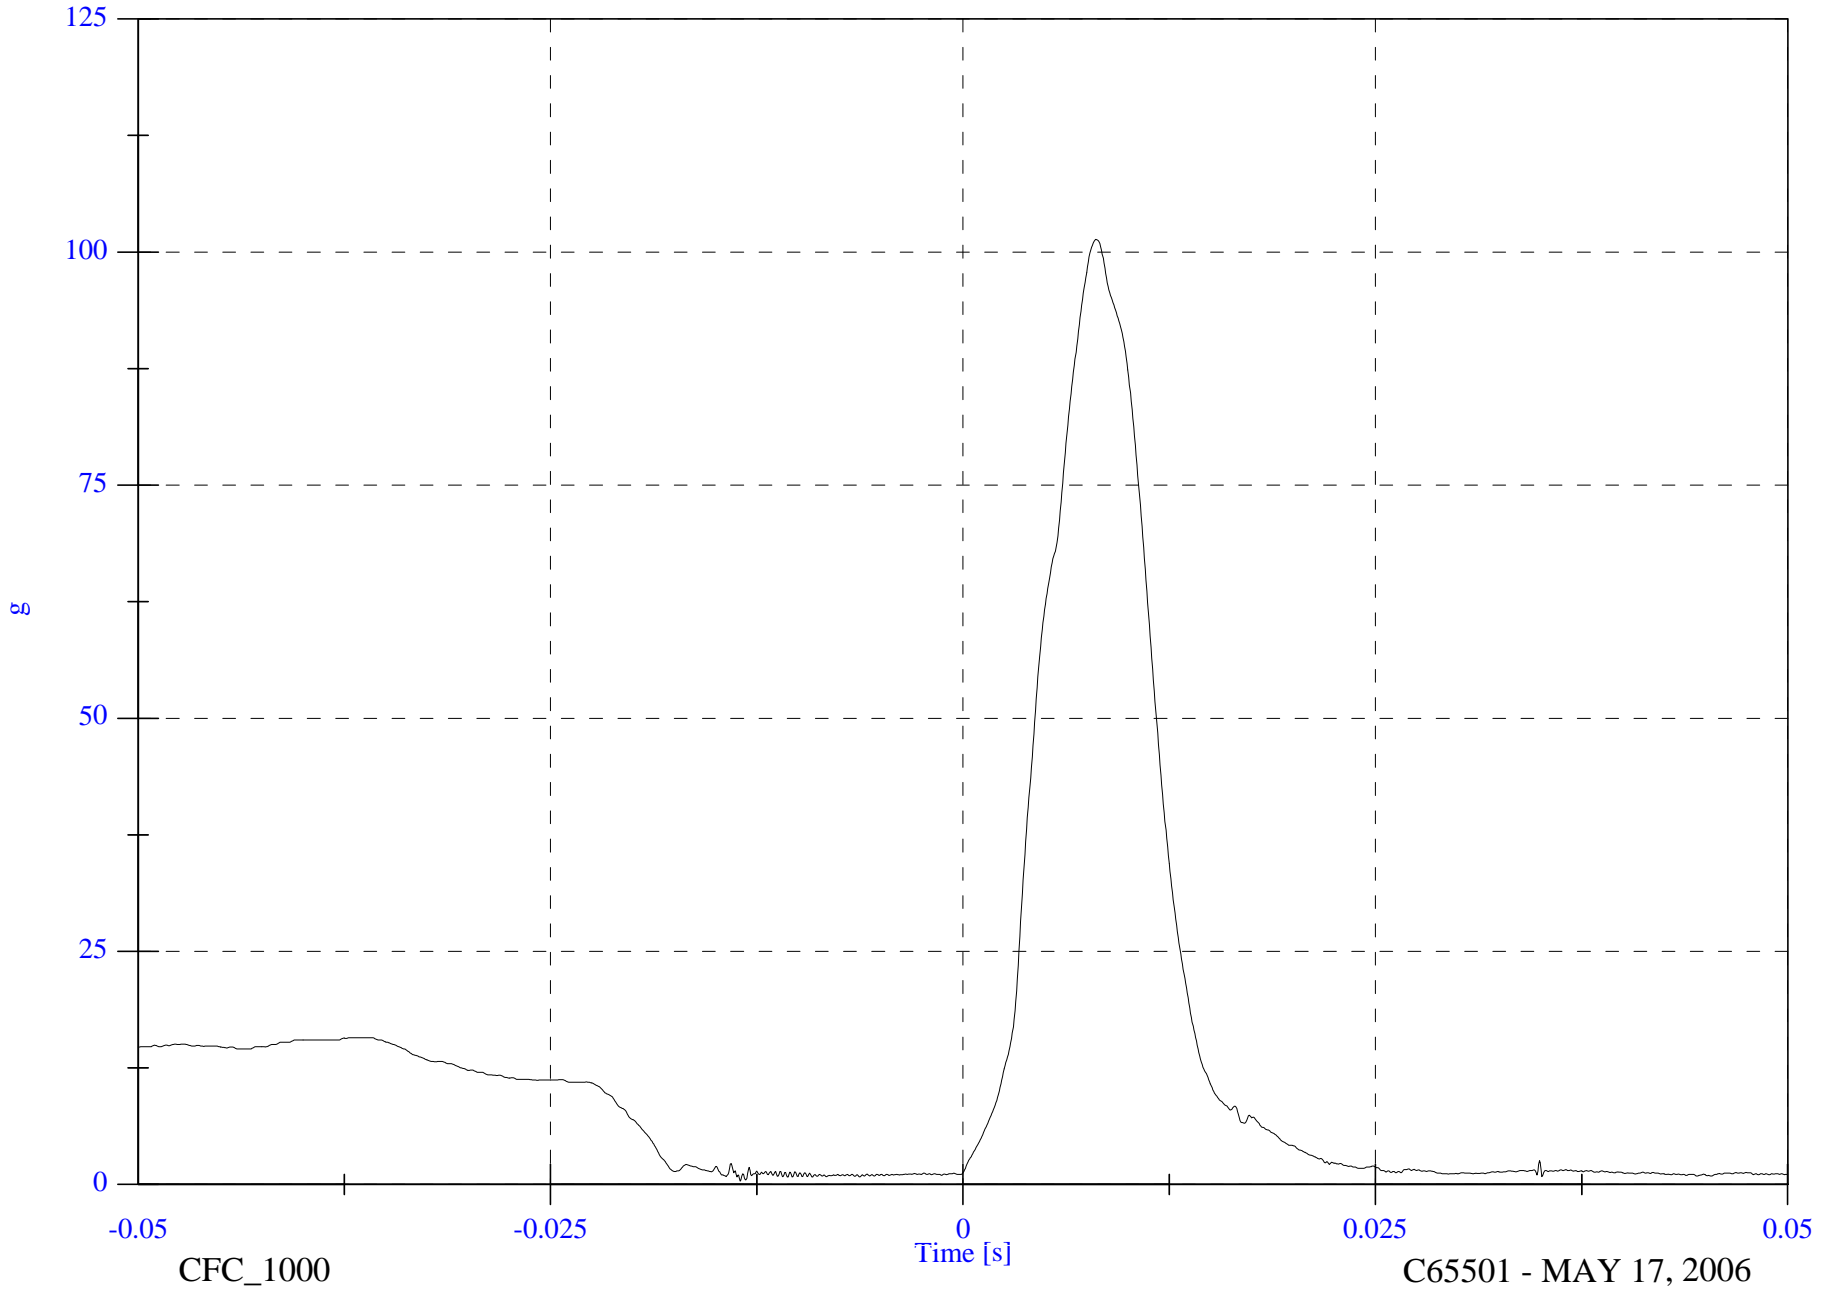
C65501 DRIVER SIDE SR1 IMPACT PLOT #4

Headform Velocity
