REPORT NUMBER: 111SB-MGA-2007-002

**SAFETY COMPLIANCE TESTING FOR
FMVSS NO. 111
SCHOOL BUS REARVIEW MIRRORS**

**U.S. Bus Corporation
2006 US BUS School Bus
NHTSA No. C60900**

**PREPARED BY:
MGA RESEARCH CORPORATION
5000 WARREN ROAD
BURLINGTON, WI 53105**

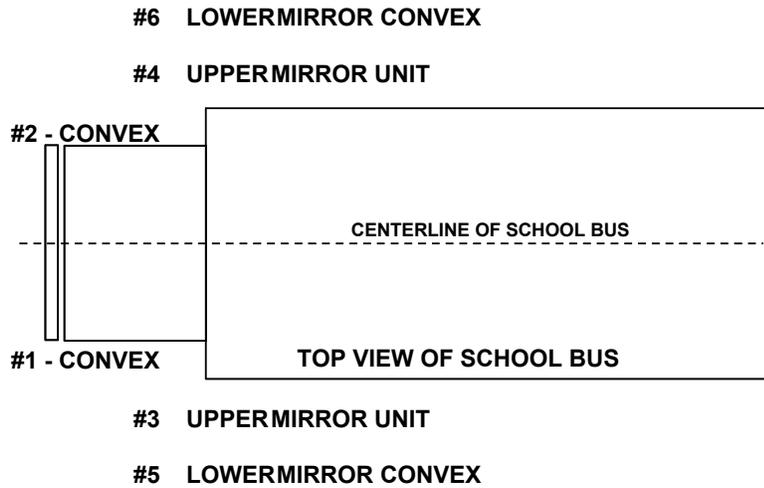
MIRROR DIAGRAM

MIRROR NO.	TYPE	MIRROR SYSTEM	CYLINDERS VIEWED (entire top surface)
1	CROSS VIEW/CONVEX	B	B,C,E,F,H,I,J,L,M
2	CROSS VIEW/CONVEX	B	A,D,E,G,H,I,K,N,O,P
3	UNIT MAGNIFICATION	A	61 Meter INDICATOR
4	UNIT MAGNIFICATION	A	61 Meter INDICATOR
5	CONVEX	A	L,M
6	CONVEX	A	N,O

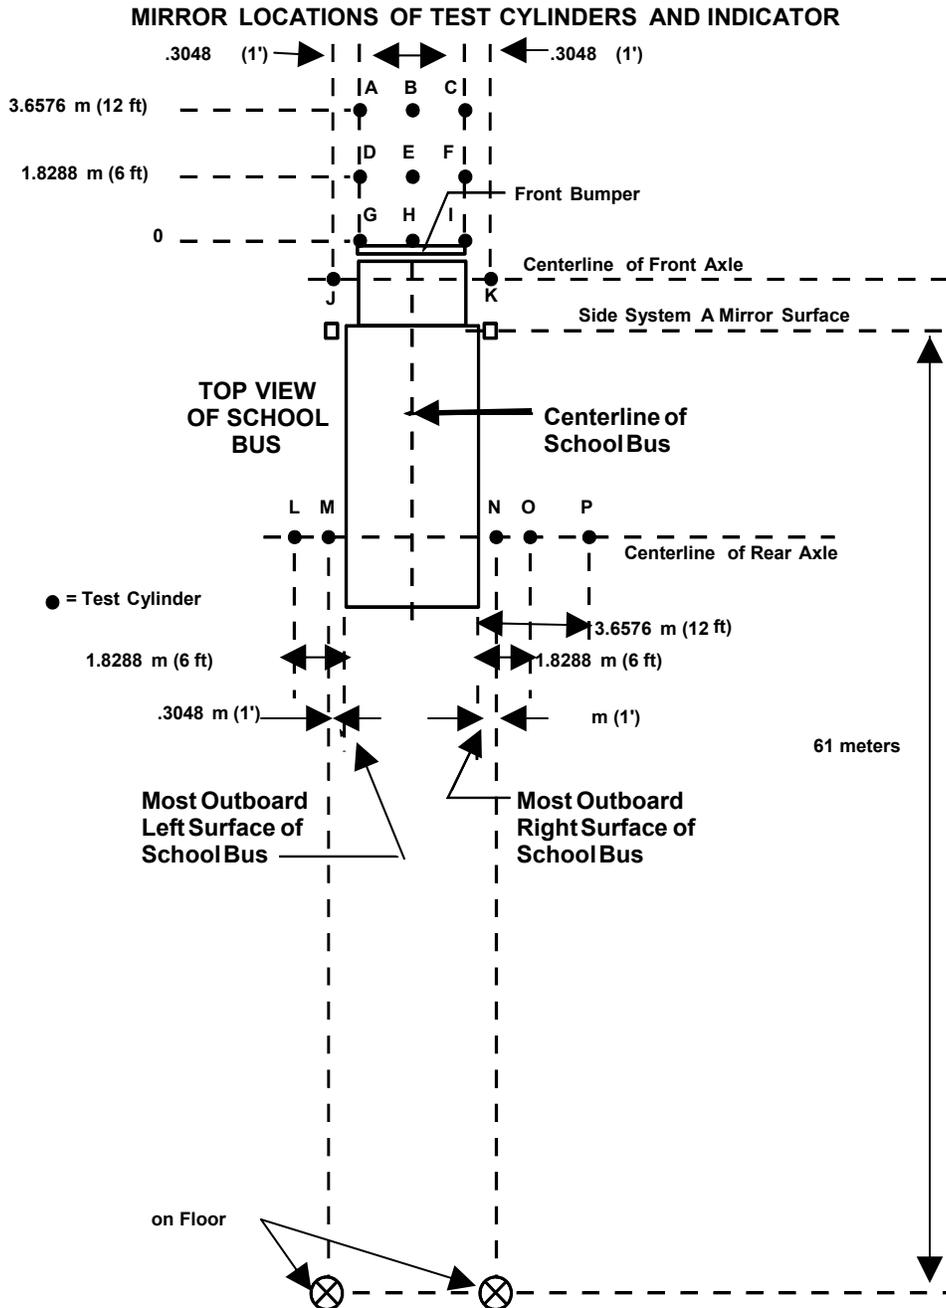
FMVSS 111SB – DATA SHEET 2...continued
MIRROR LOCATION AND FIELD OF VIEW

- NOTES:
1. The cylinders shall be a color which provides a high contrast with the surface on which the bus is parked (S13.1).
 2. The cylinders are 0.3048 m high and 0.3048 m in diameter, except for cylinder P which is 0.9144 m high and 0.3048 m in diameter.

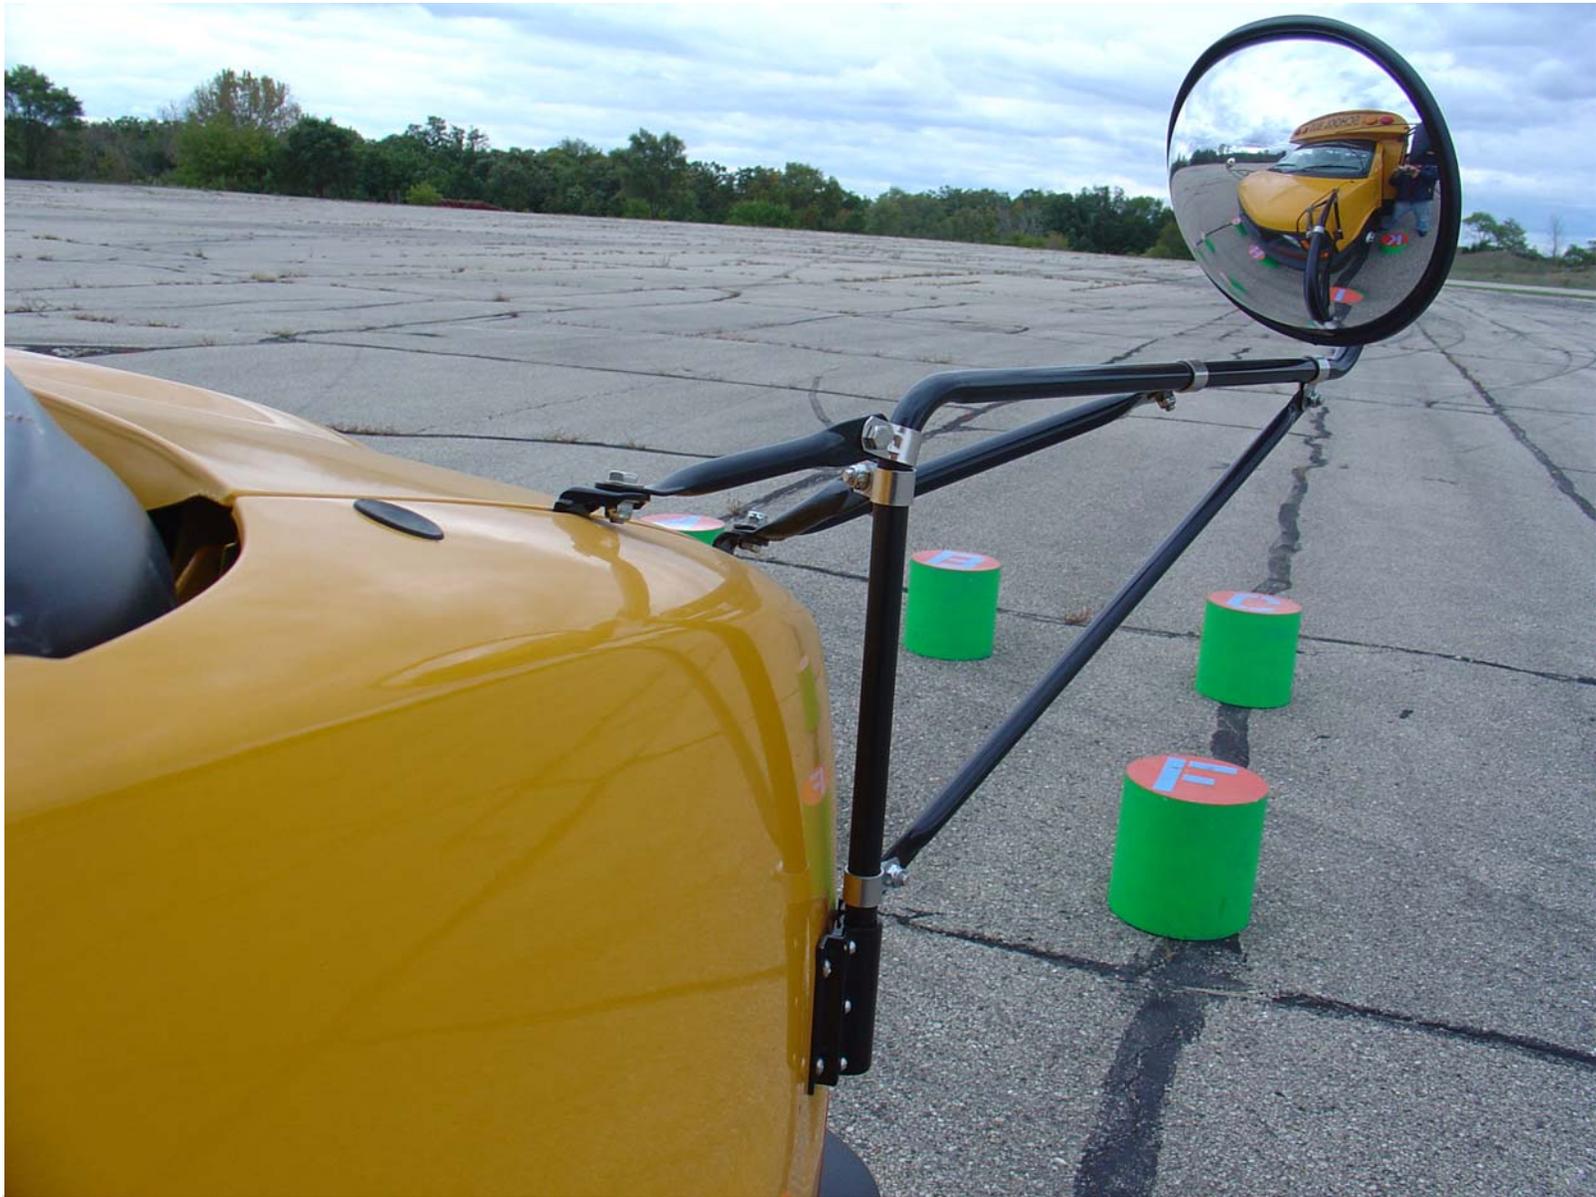
Photo 5 - Right Front Cross View Mirror and Mounting

Pass/Fail	Comments
Mounting	PASS	--
Field of View	PASS	--
Overlap with System A	PASS	--
Distance to Eye Point	PASS	--
No Surface Discontinuities	PASS	--
Surface Area	PASS	--
If Convex – Radius of Curvature	PASS	--
Radius of Curvature Label	FAIL	Label is not visible to the driver.
Arc Separation	PASS	--
Reflectance	PASS	--

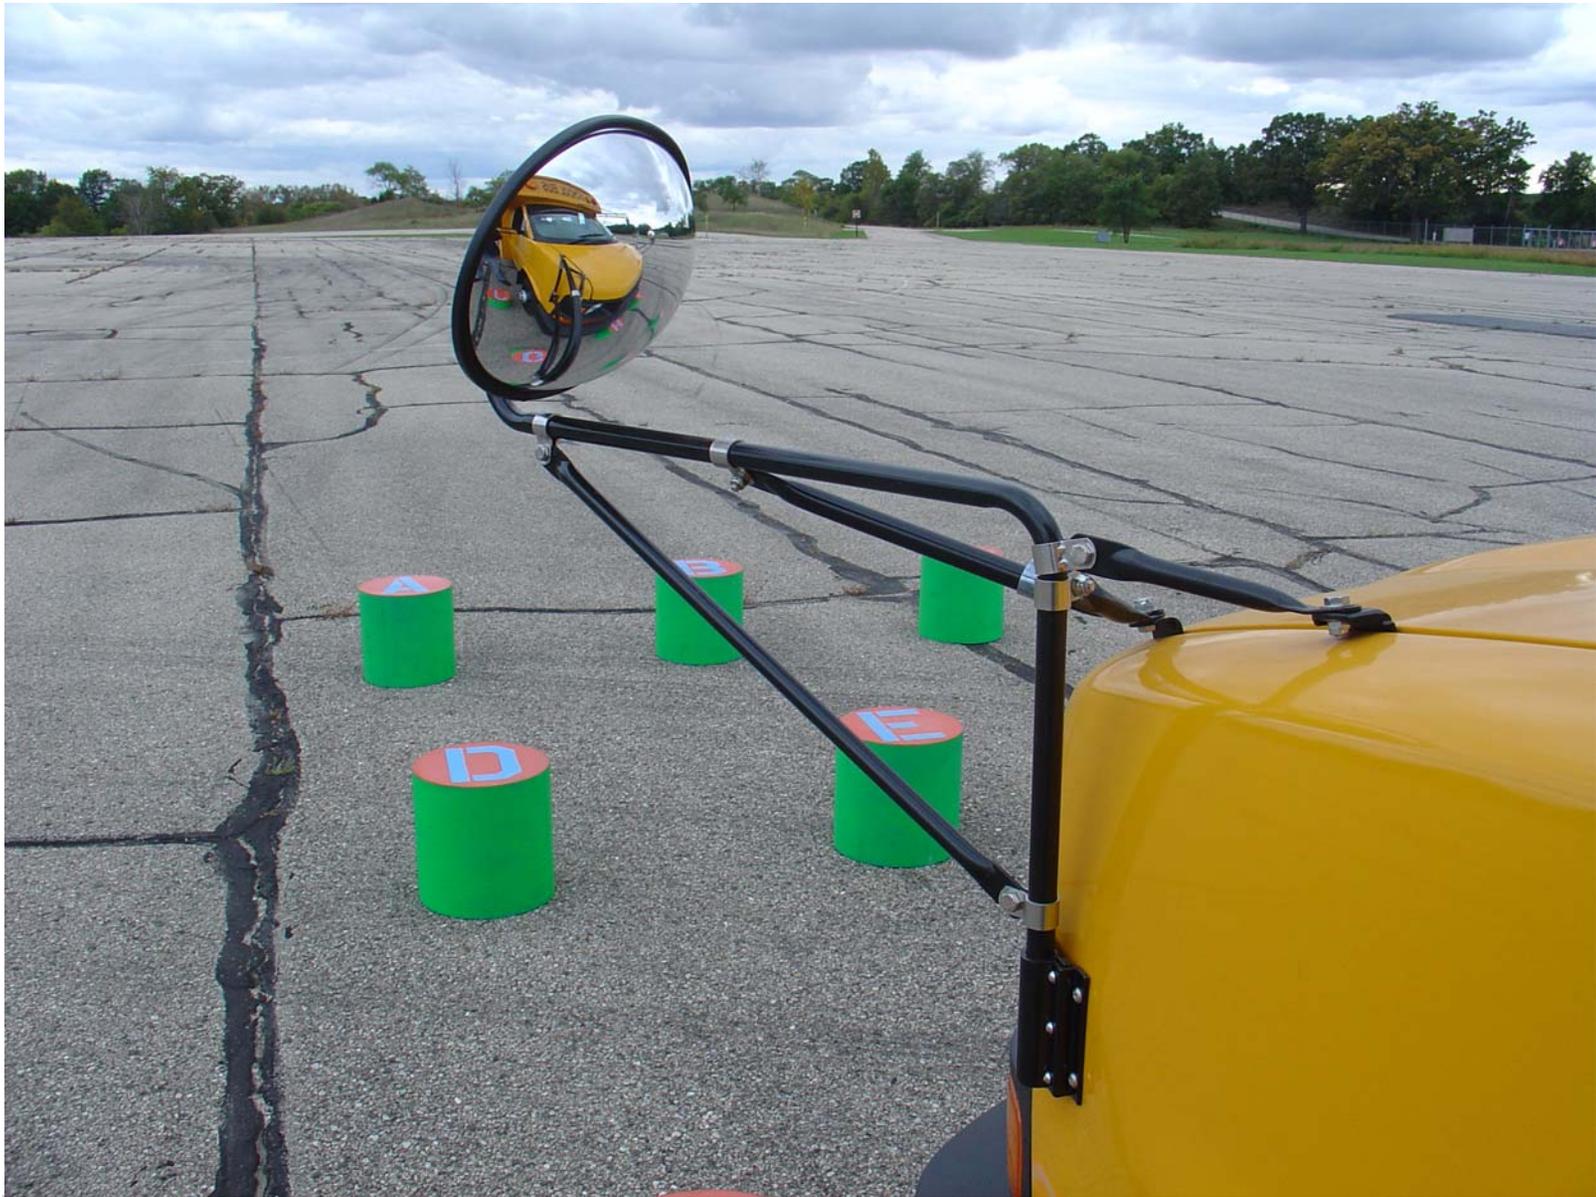
Photo 8 - Left Front Cross View Mirror and Mounting

Pass/Fail	Comments
Mounting	PASS	--
Field of View	PASS	--
Overlap with System A	PASS	--
Distance to Eye Point	PASS	--
No Surface Discontinuities	PASS	--
Surface Area	PASS	--
If Convex – Radius of Curvature	PASS	--
Radius of Curvature Label	FAIL	Label is not visible to the driver.
Arc Separation	PASS	--
Reflectance	PASS	--

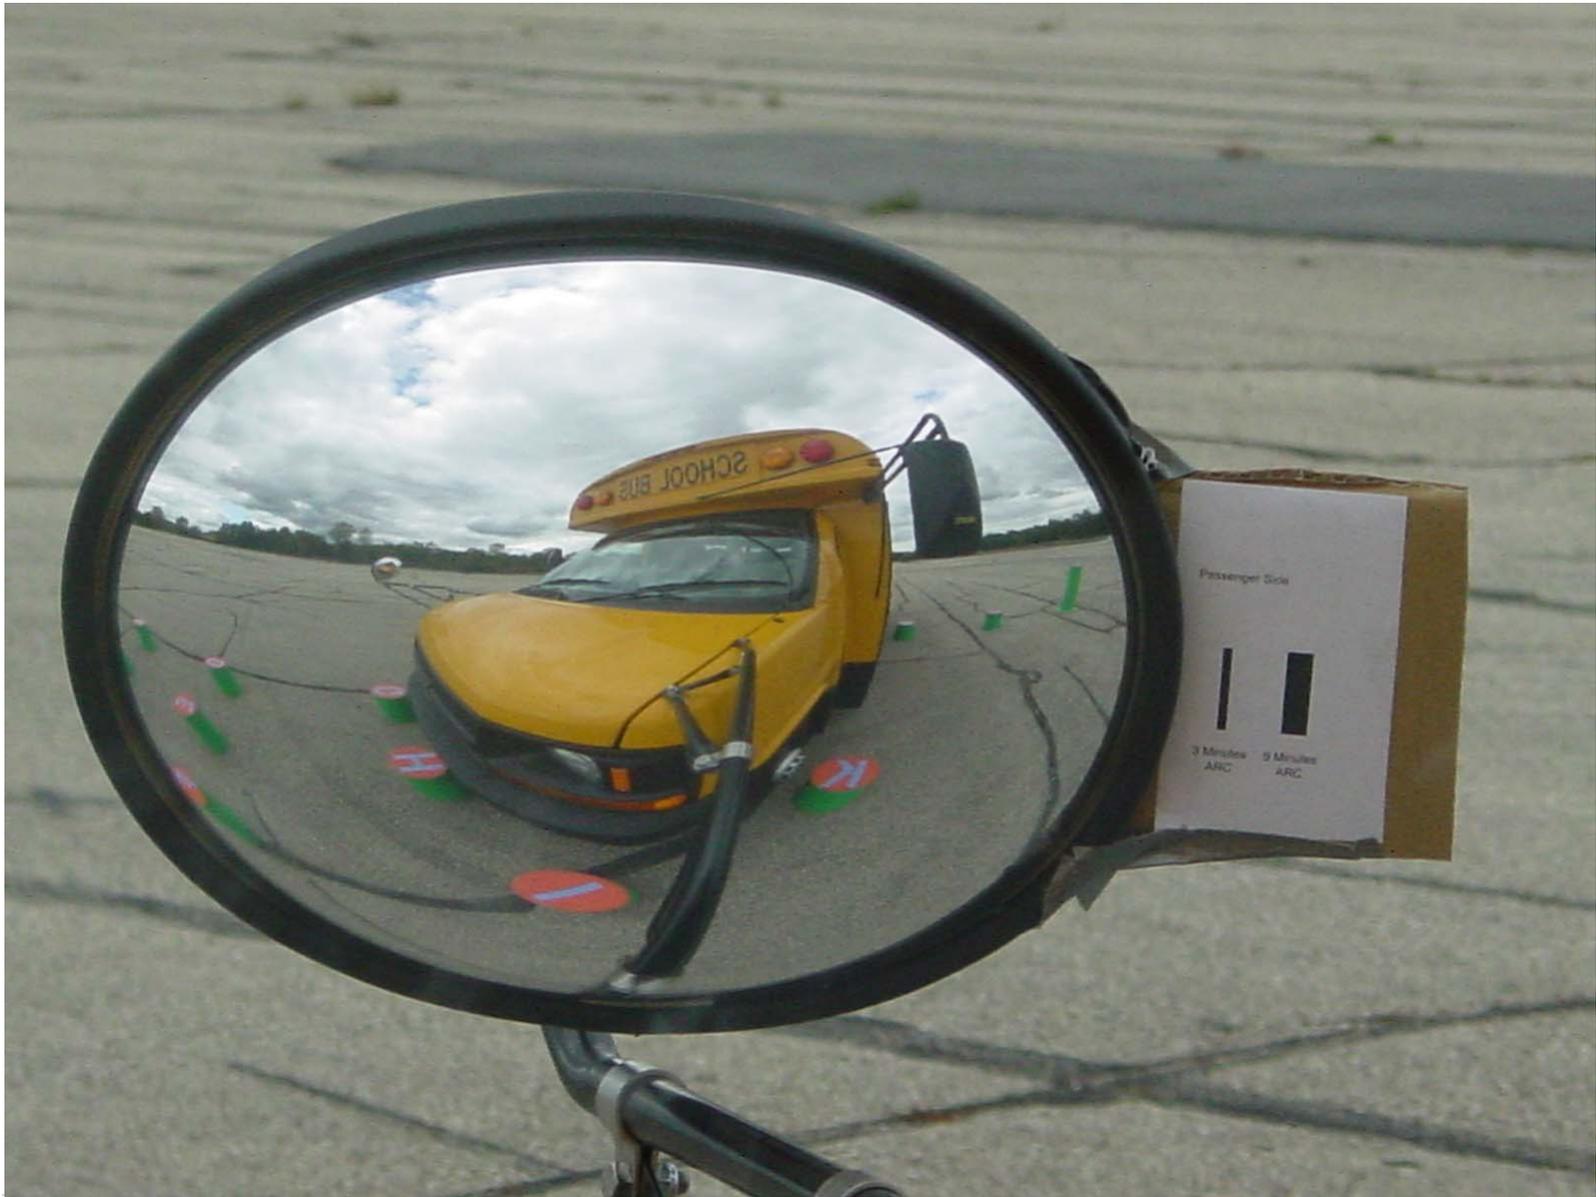
Photo 12 - Mirror #2 System B Field of View

Pass/Fail
All test cylinders with entire top surface not directly visible from the driver's semi-circle eye location are able to be viewed with System B mirrors from the driver's semi-circle location:		PASS
All test cylinders with entire top surface not directly visible from the driver's semi-circle eye location but the image can be viewed with System B mirrors. The image is separated from the edge of the effective mirror surface of the mirror providing that image by a distance of not less than 3 minutes of arc:		PASS
If the entire top surface of test cylinder P is not directly visible from the driver's semi-circle eye location, the image can be viewed with System B mirrors from the driver's semi-circle eye location, where the angular size of the shortest dimension of that cylinder's image is not less than 3 minutes of arc, and the angular size of the longest dimension of that cylinder's image is not less than 9 minutes of arc:		PASS

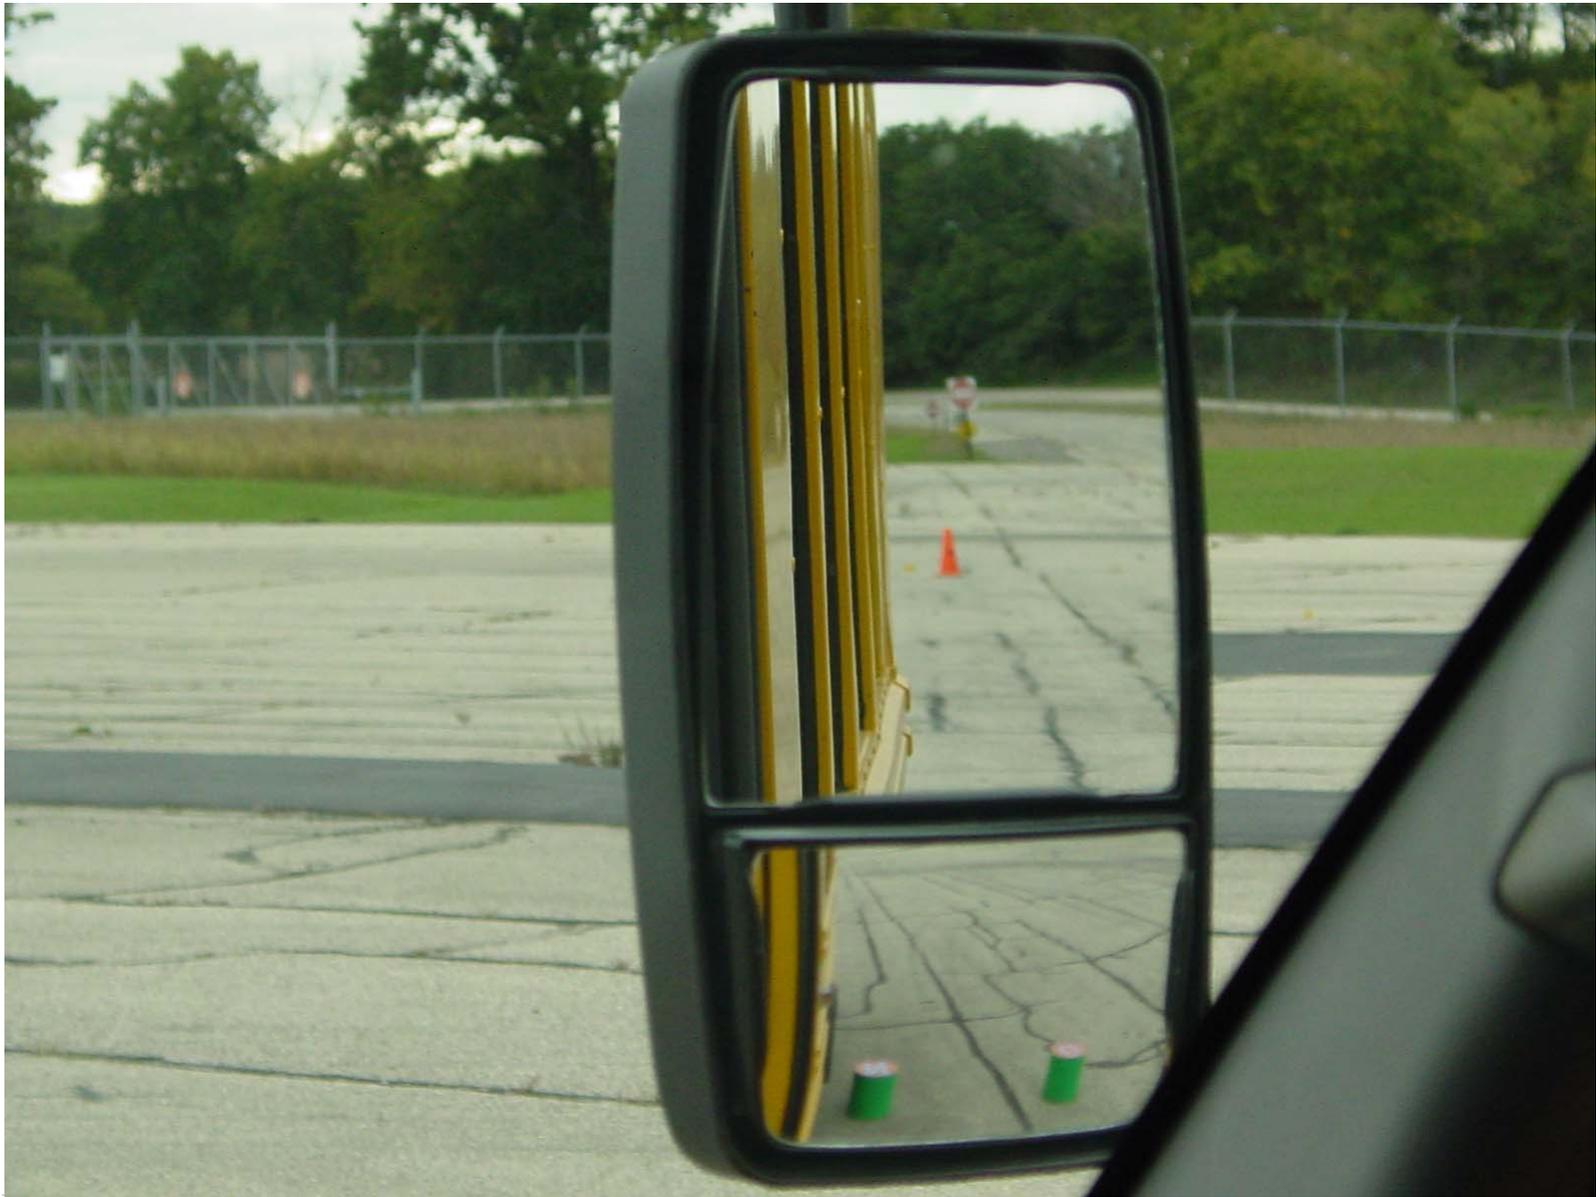
Photo 14 - Mirror #4 and #6 System A Field of View

System A Mirrors	Pass/Fail
Entire top surface of cylinder N and the indicator 61 meters (200 feet) rearward of the mirror surface be viewed in the photograph	PASS
Entire top surface of cylinder M and indicator 61 meters (200 feet) rearward of the mirror surface be viewed in the photograph	PASS
Which test cylinders A through P can not be photographed directly from the driver's eye location within the semi-circle viewing area using no mirror system:	D,E,F,G,H, I,J,K,L,M,N,O,P

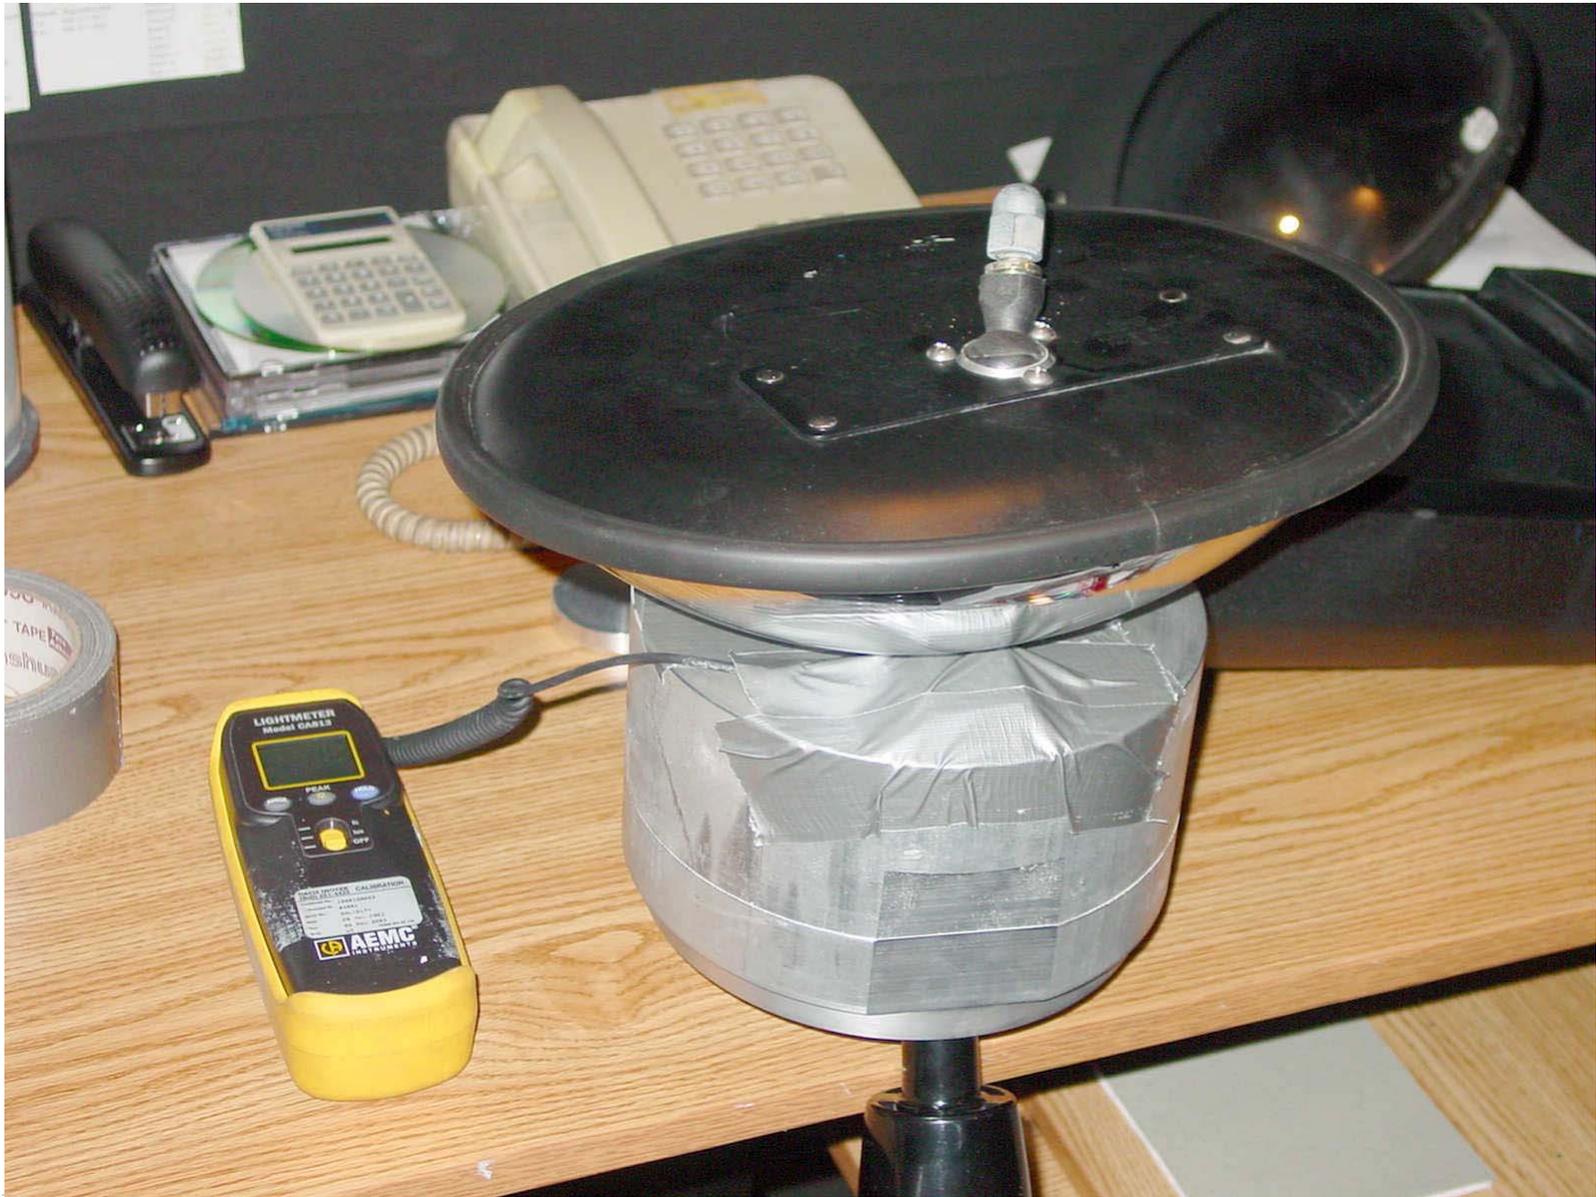
Photo 19 - Reflectance Test Set-up

Mirror No.	Type	Light meter reading from calibration (FC)	Light meter reading from light reflected by mirror (FC)	Pass/Fail	Observations
1	Crossview/Convex	119	72.67	PASS	
2	Crossview/Convex	115.67	71.67	PASS	
3	Unit	116.67	59.33	PASS	
4	Unit	115.33	63.33	PASS	
5	Convex	115	63.33	PASS	
6	Convex	114.33	63	PASS

Mirror No.	Type	Reflectance	Requirement
1	Crossview/Convex	61%	>35%
2	Crossview/Convex	62%	>35%
3	Unit	51%	>35%
4	Unit	55%	>35%
5	Convex	55%	>35%
6	Convex	55%	>35%

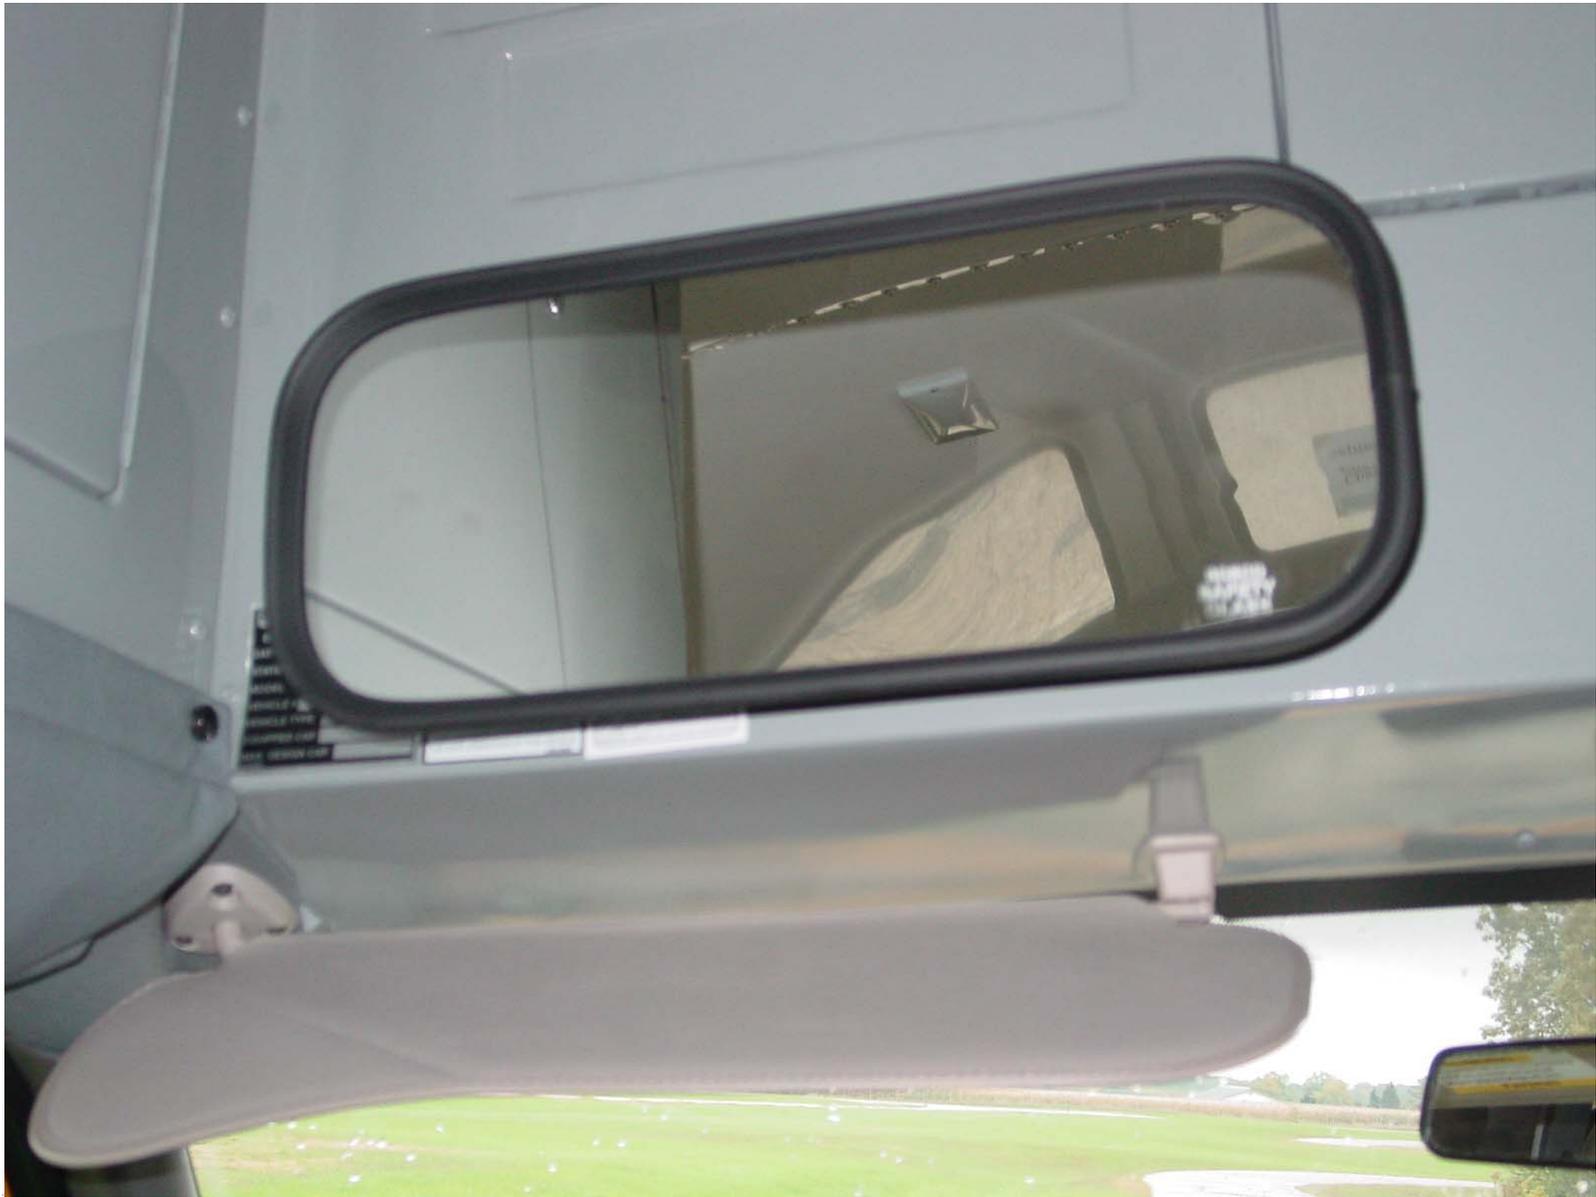
Photo 21 - Rearview Mirror blocking Driver's sight of Cross View Mirror Warning

The required label indicating that the cross view mirrors are not to be used while driving is not visible to the seated driver.

Note: The required label indicating that the cross view mirrors are not to be used while driving is not visible to the seated driver.

The required label indicating that the cross view mirrors are not to be used while driving is placed behind the rearview mirror in such a way that it is not visible to the seated driver.
