REPORT NUMBER 138-STF-06-006

# SAFETY COMPLIANCE TESTING FOR FMVSS NO. 138 TIRE PRESSURE MONITORING SYSTEMS

MAZDA MOTOR CORPORATION  
2006 RX-8 FOUR-DOOR  
PASSENGER CAR  
NHTSA NO. C65403

FINAL REPORT

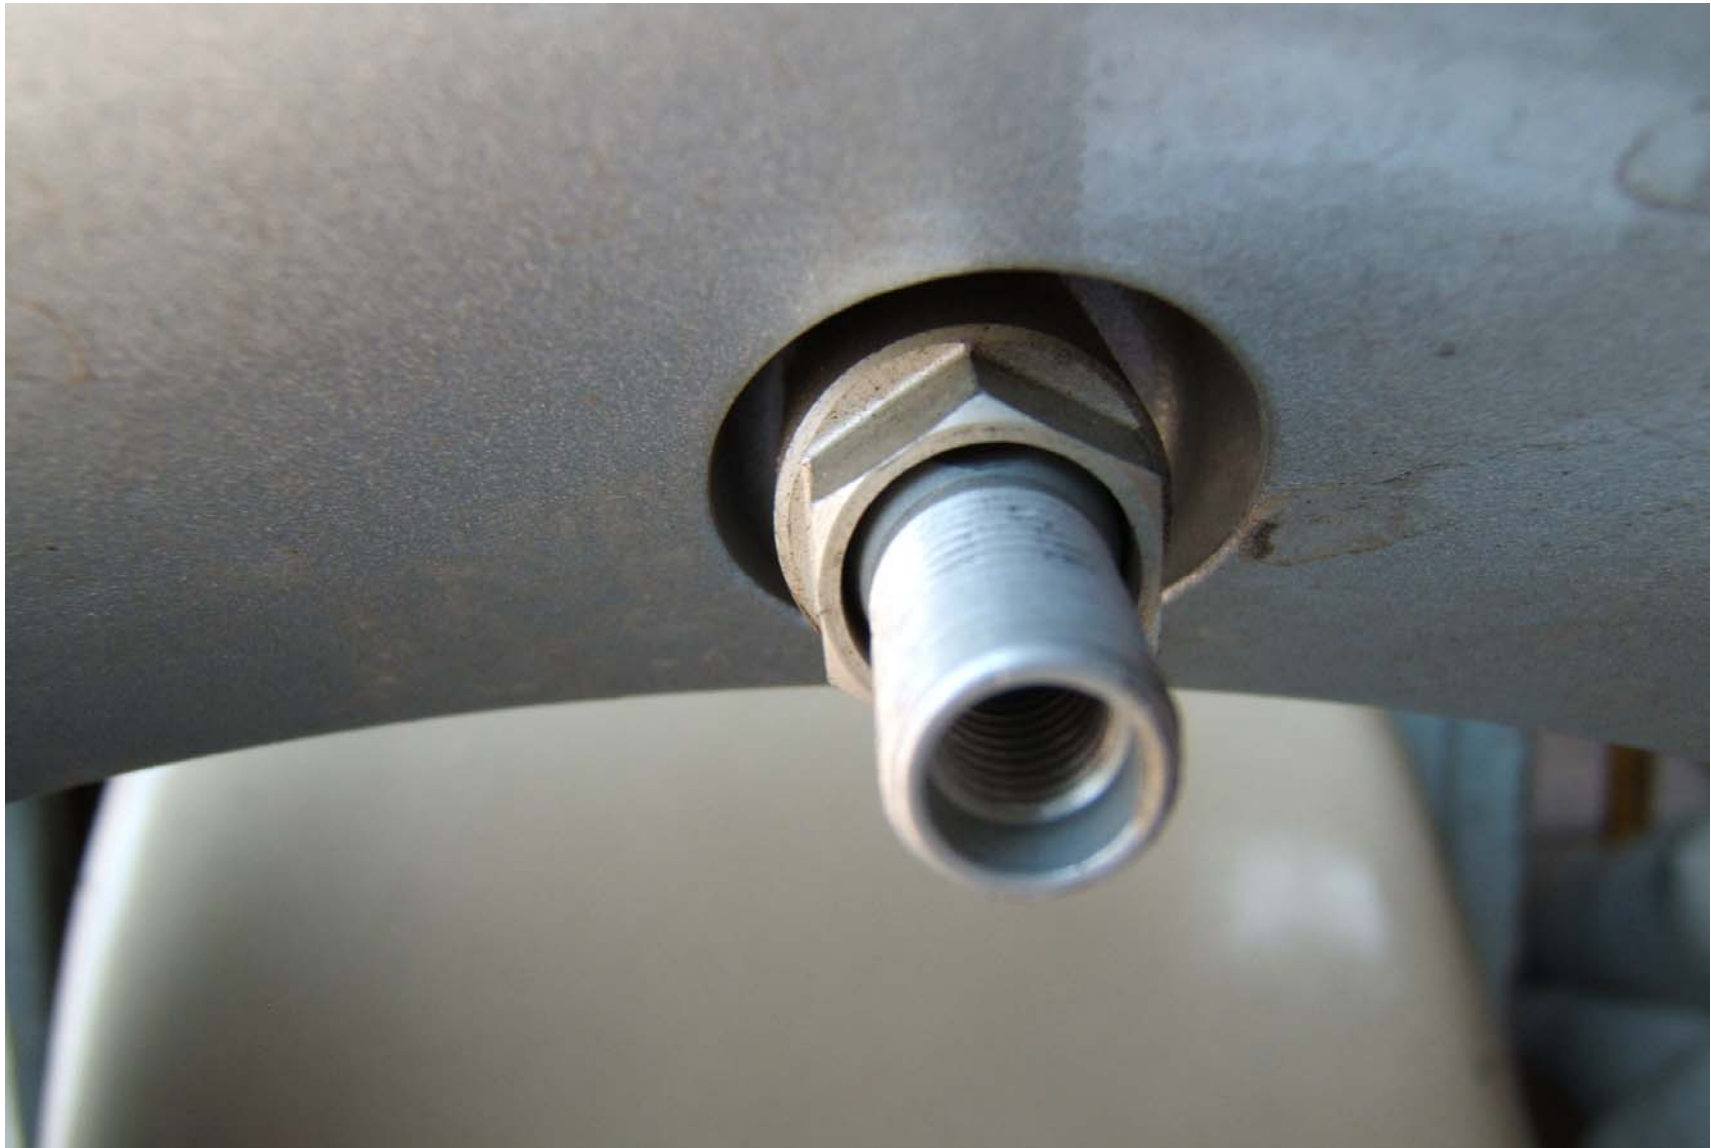
FIGURE 5.10  
RIM SHOWING VALVE STEM

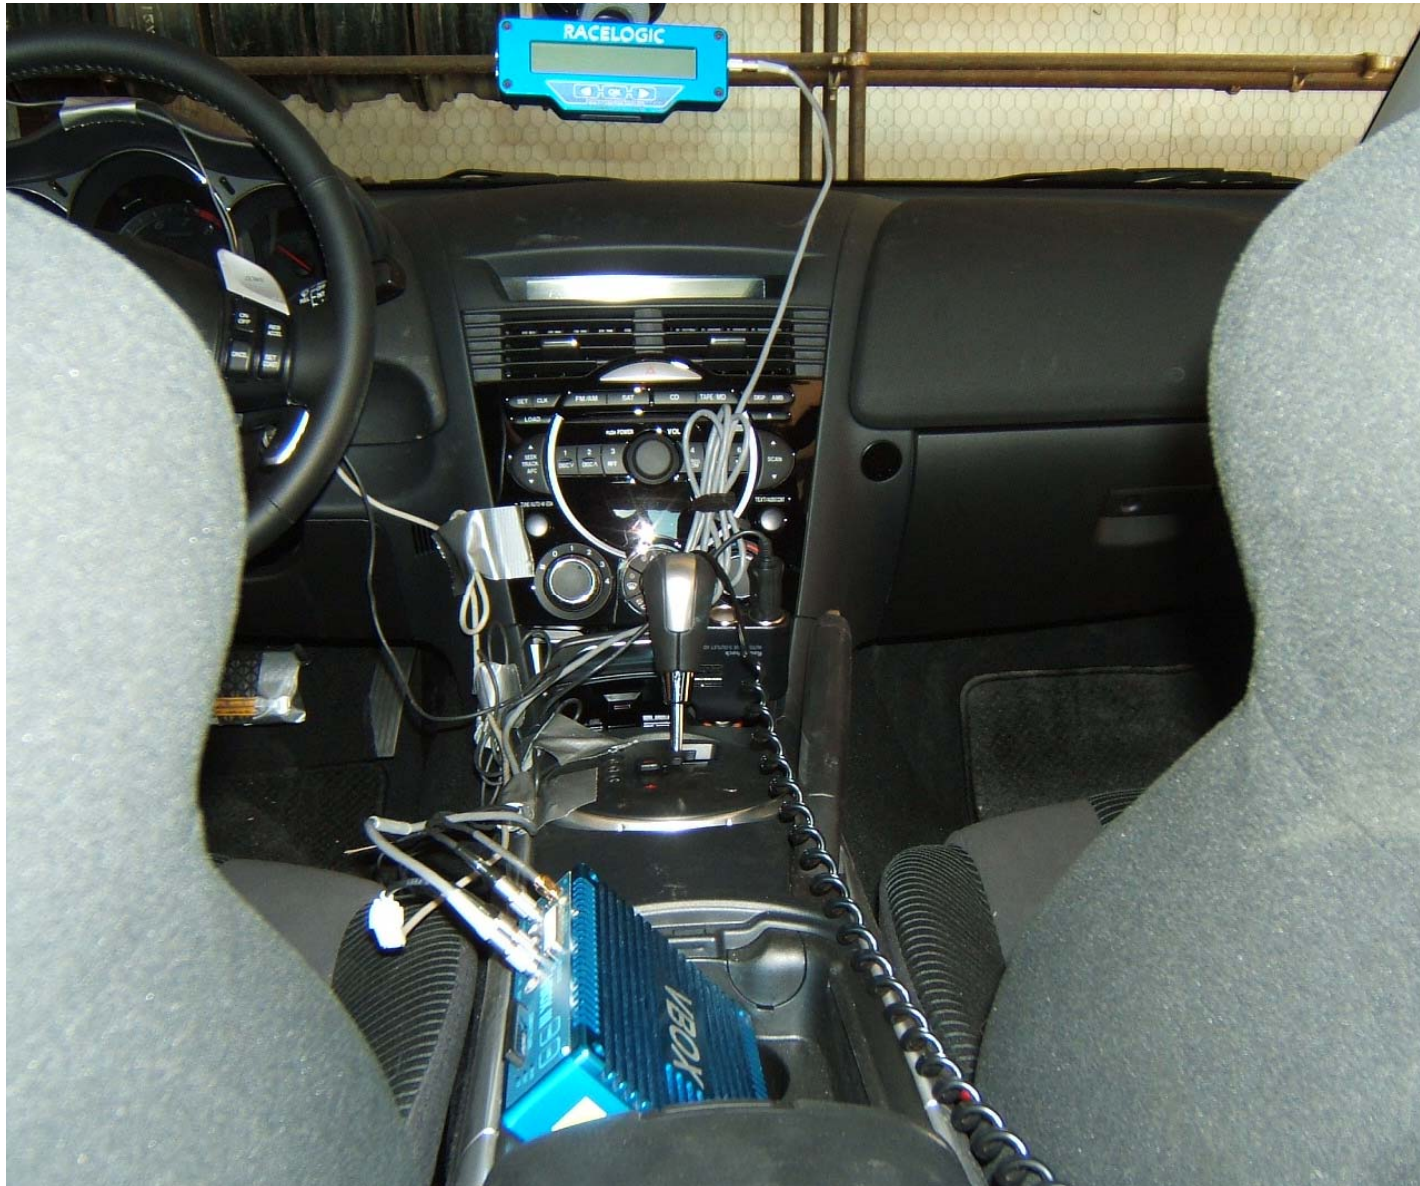
FIGURE 5.12  
TEST INSTRUMENTATION MOUNTED ON VEHICLE

The vehicle was instrumented with a Racelogic VBOX III 100 Hz GPS Data Logger and brake pedal trigger. The VBOX uses GPS to measure vehicle speed, time, and distance. Test data were recorded to a compact flash card. During the test, a stopwatch was used to determine the approximate "cumulative driving time" during each test phase. Cumulative driving time does not include time during the brake application or when the vehicle speed was below 50 km/h or above 100 km/h. Upon completion of a tire deflation test, graph(s) were generated by VBOX software showing vehicle speed versus time during the test procedure calibration phase and detection phase. The graphs furnish a second-by-second analysis of each test phase. The cumulative driving time for each test was calculated by post processing the VBOX graph data and is reported in Section 3 (Test Data) as 'Total Driving Time'.

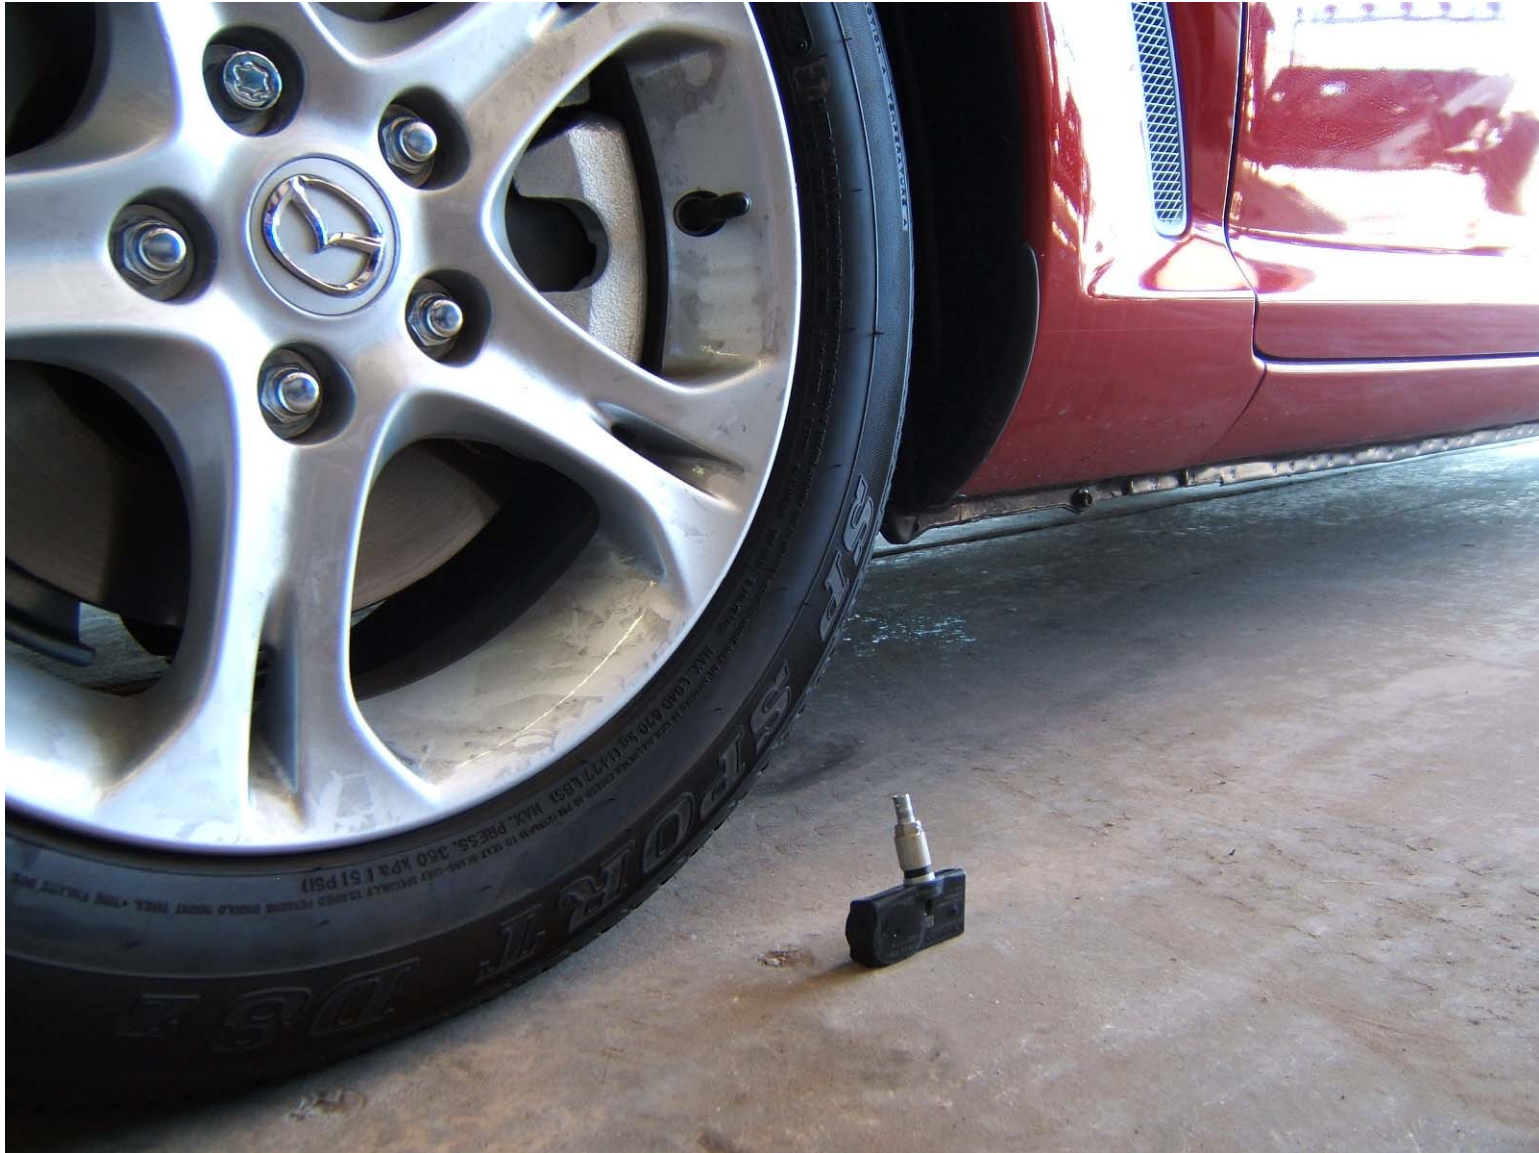
FIGURE 5.16  
LEFT FRONT WHEEL SHOWING TPMS SENSOR REPLACED WITH  
REGULAR VALVE STEM FOR MALFUNCTION DETECTION TEST

Describe method of malfunction simulation: TPMS sensor was removed from left front  
tire/wheel assembly and replaced with non-TPMS valve stem.

TPMS sensor was removed from left front tire/wheel assembly and replaced with non-TPMS valve stem at GVWR.

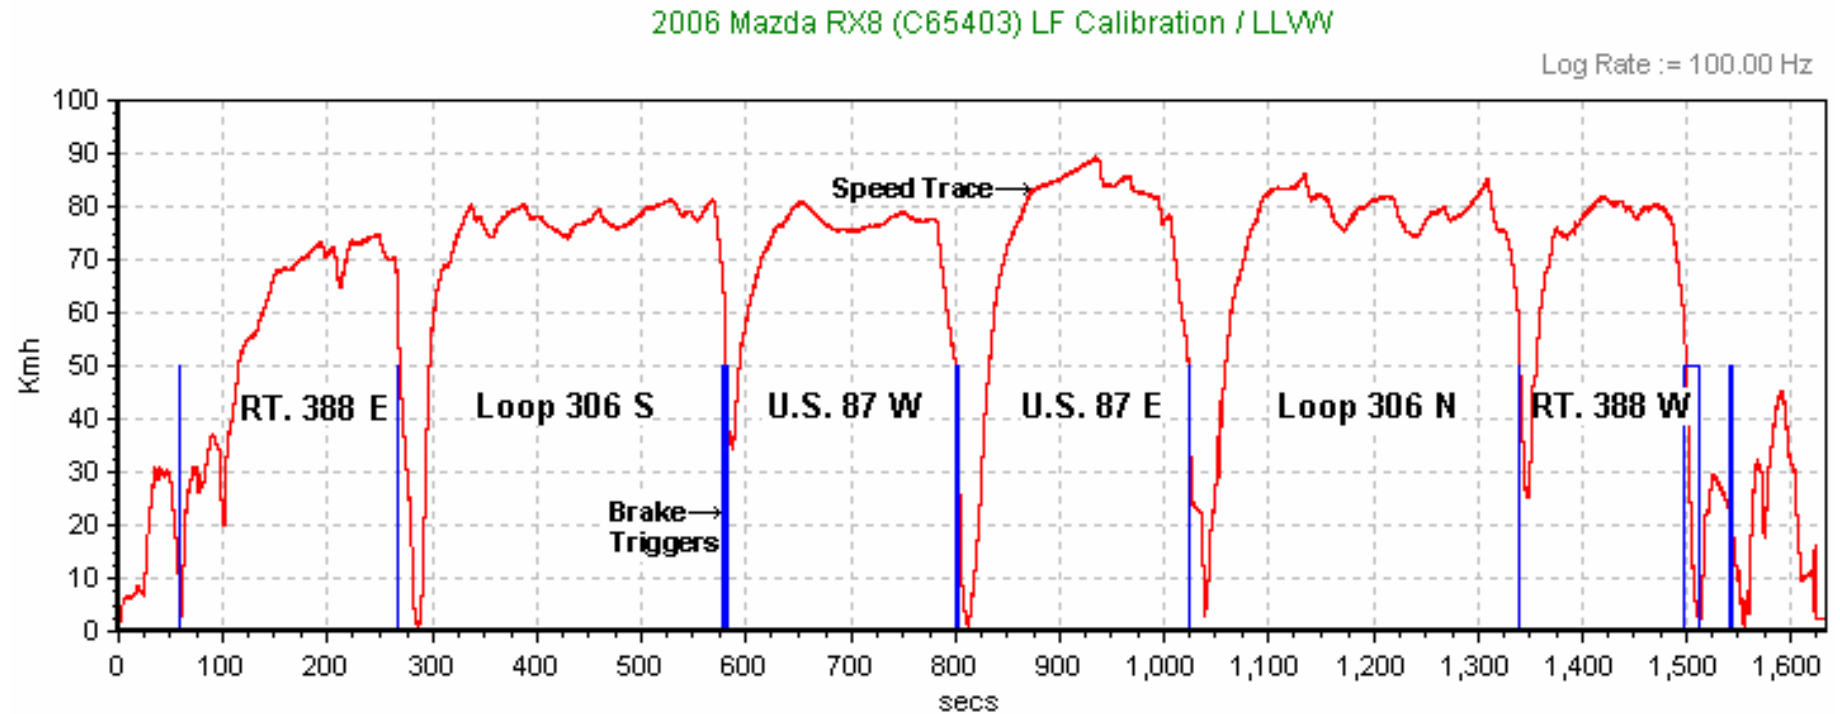
Calibration Phase

Scenario A: Left Front Tire  
Test Date: 9/19/06  
Data File Time: 27:13 minutes  
Cumulative Driving Time: 20:51 minutes  
Start Point: SATF shop

LF Detection Phase: Telltale illuminated upon ignition activation. Driving was not required.

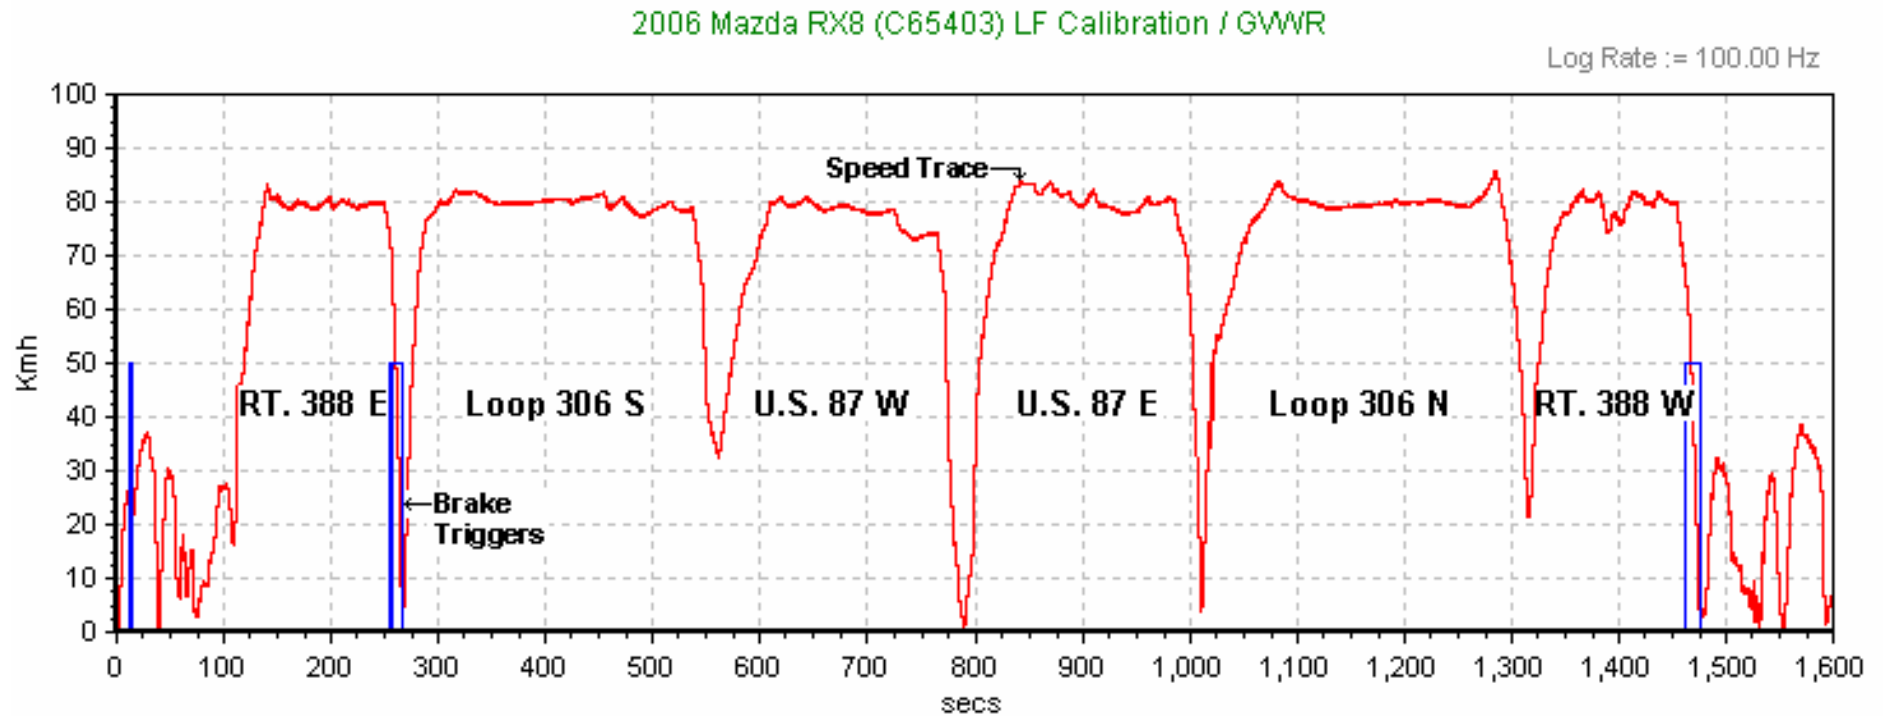
Calibration Phase

Scenario G: Left Front Tires  
Test Date: 11/7/06  
Data File Time: 27:01 minutes  
Cumulative Driving Time: 20:29 minutes  
Start Point: SATF shop

LF Detection Phase: Telltale illuminated upon ignition activation. Driving was not required.

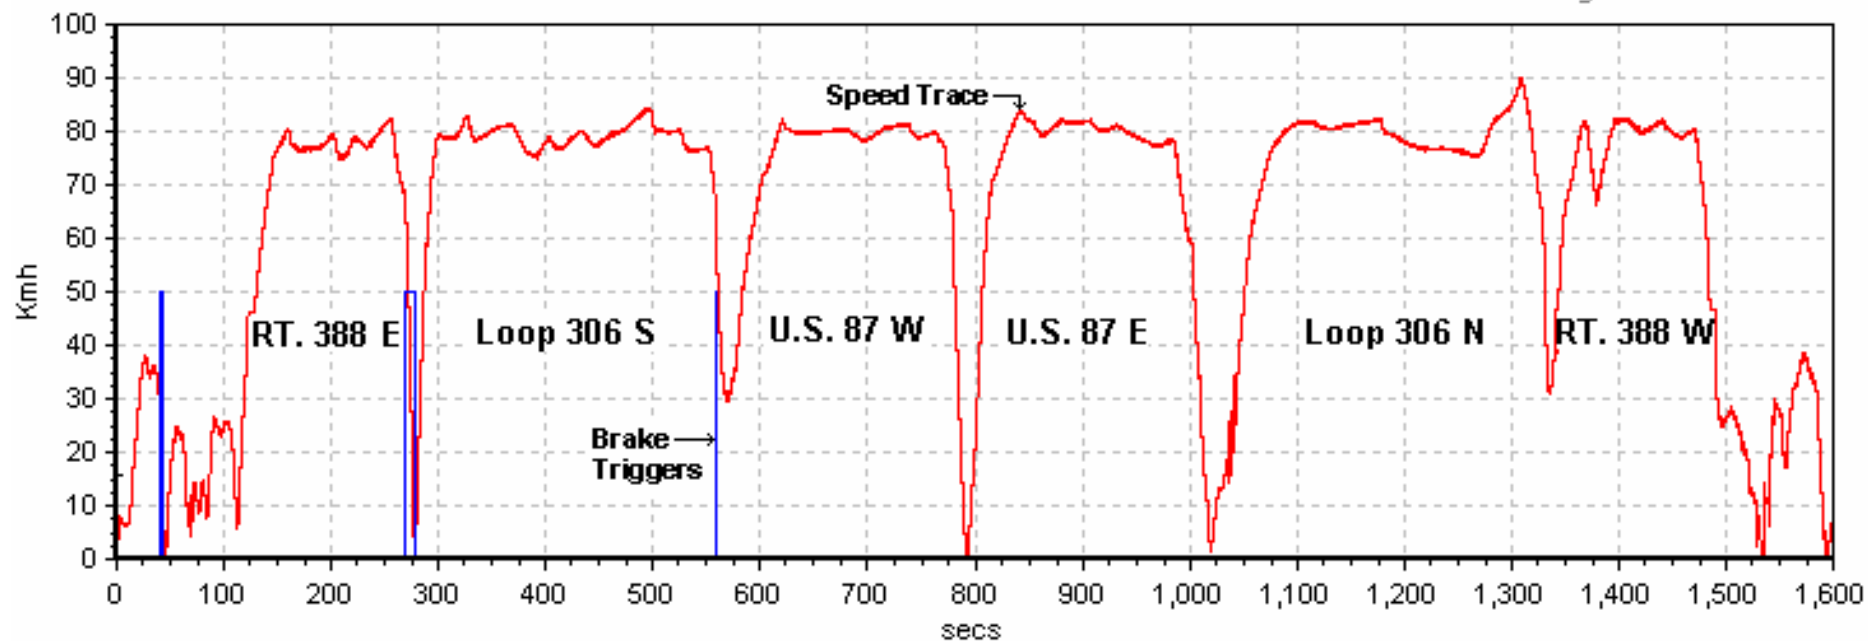
2006 Mazda RX8 (C65403) RR Calibration / GWWR

Scenario H: Right Rear Tire  
Test Date: 11/7/06  
Data File Time: 27:01 minutes  
Cumulative Driving Time: 20:25 minutes  
Start Point: SATF shop

RR Detection Phase: Telltale illuminated upon ignition activation. Driving was not required.

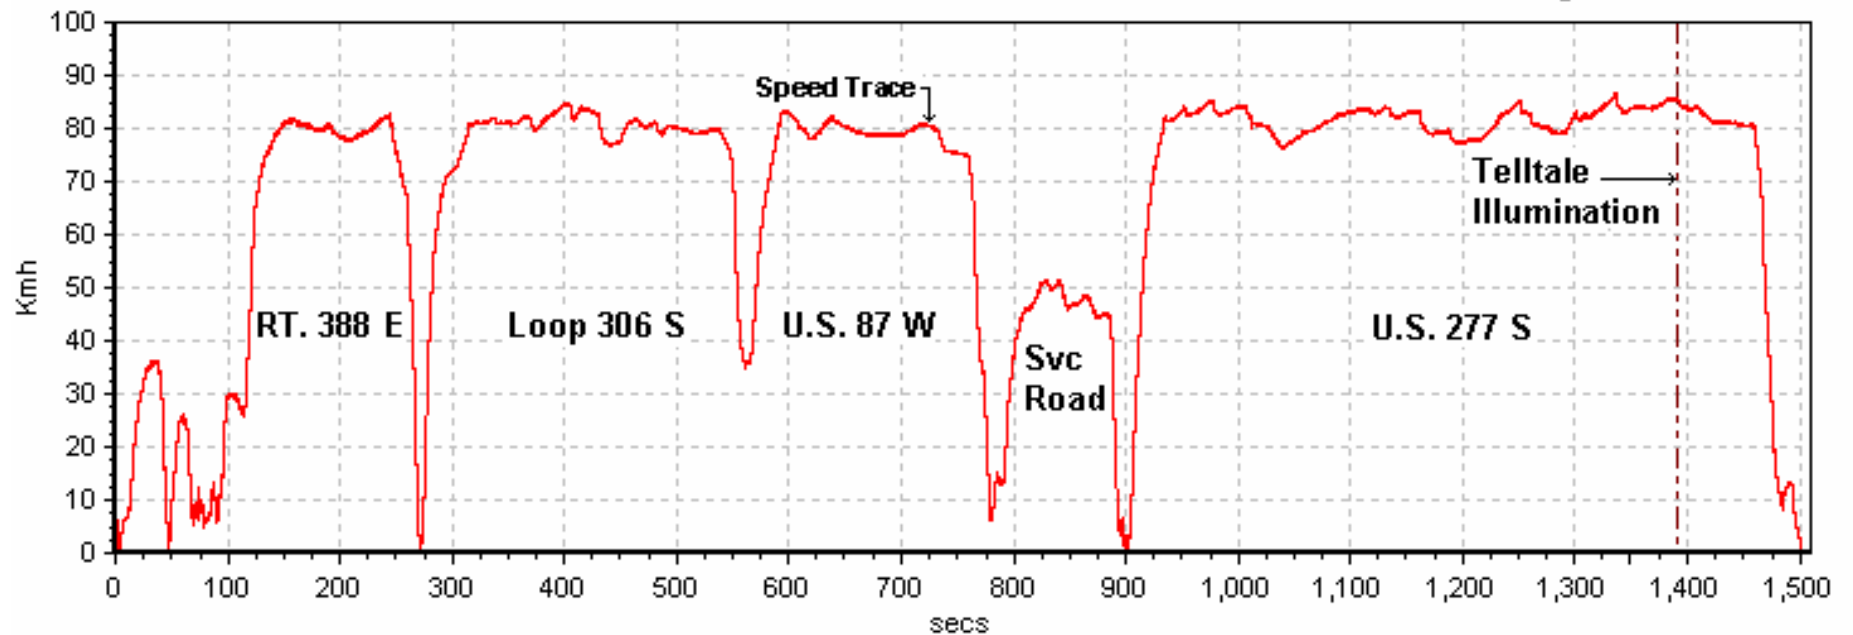
2006 Mazda RX8 (C65403) LF Combination Low Tire / Malfunction Telltale Illumination / GWR

Scenario K: Sensor from Left Front Wheel Replaced with Non-TPMS Valve Stem  
Test Date: 11/8/06  
Data File Time: 25:02 minutes  
Illumination: 16:36 minutes  
Start Point: SATF shop

LF Malfunction Telltale: Indicant test only.
