REPORT NUMBER: 221-MGA-2007-001

**SAFETY COMPLIANCE TESTING FOR
FMVSS NO. 221
SCHOOL BUS BODY JOINT STRENGTH**

**THOMAS BUILT BUSES INC.
2007 THOMAS SAF-T-LINER C2
NHTSA NO.: C70900**

**PREPARED BY:
MGA RESEARCH CORPORATION
5000 WARREN ROAD
BURLINGTON, WI 53105**

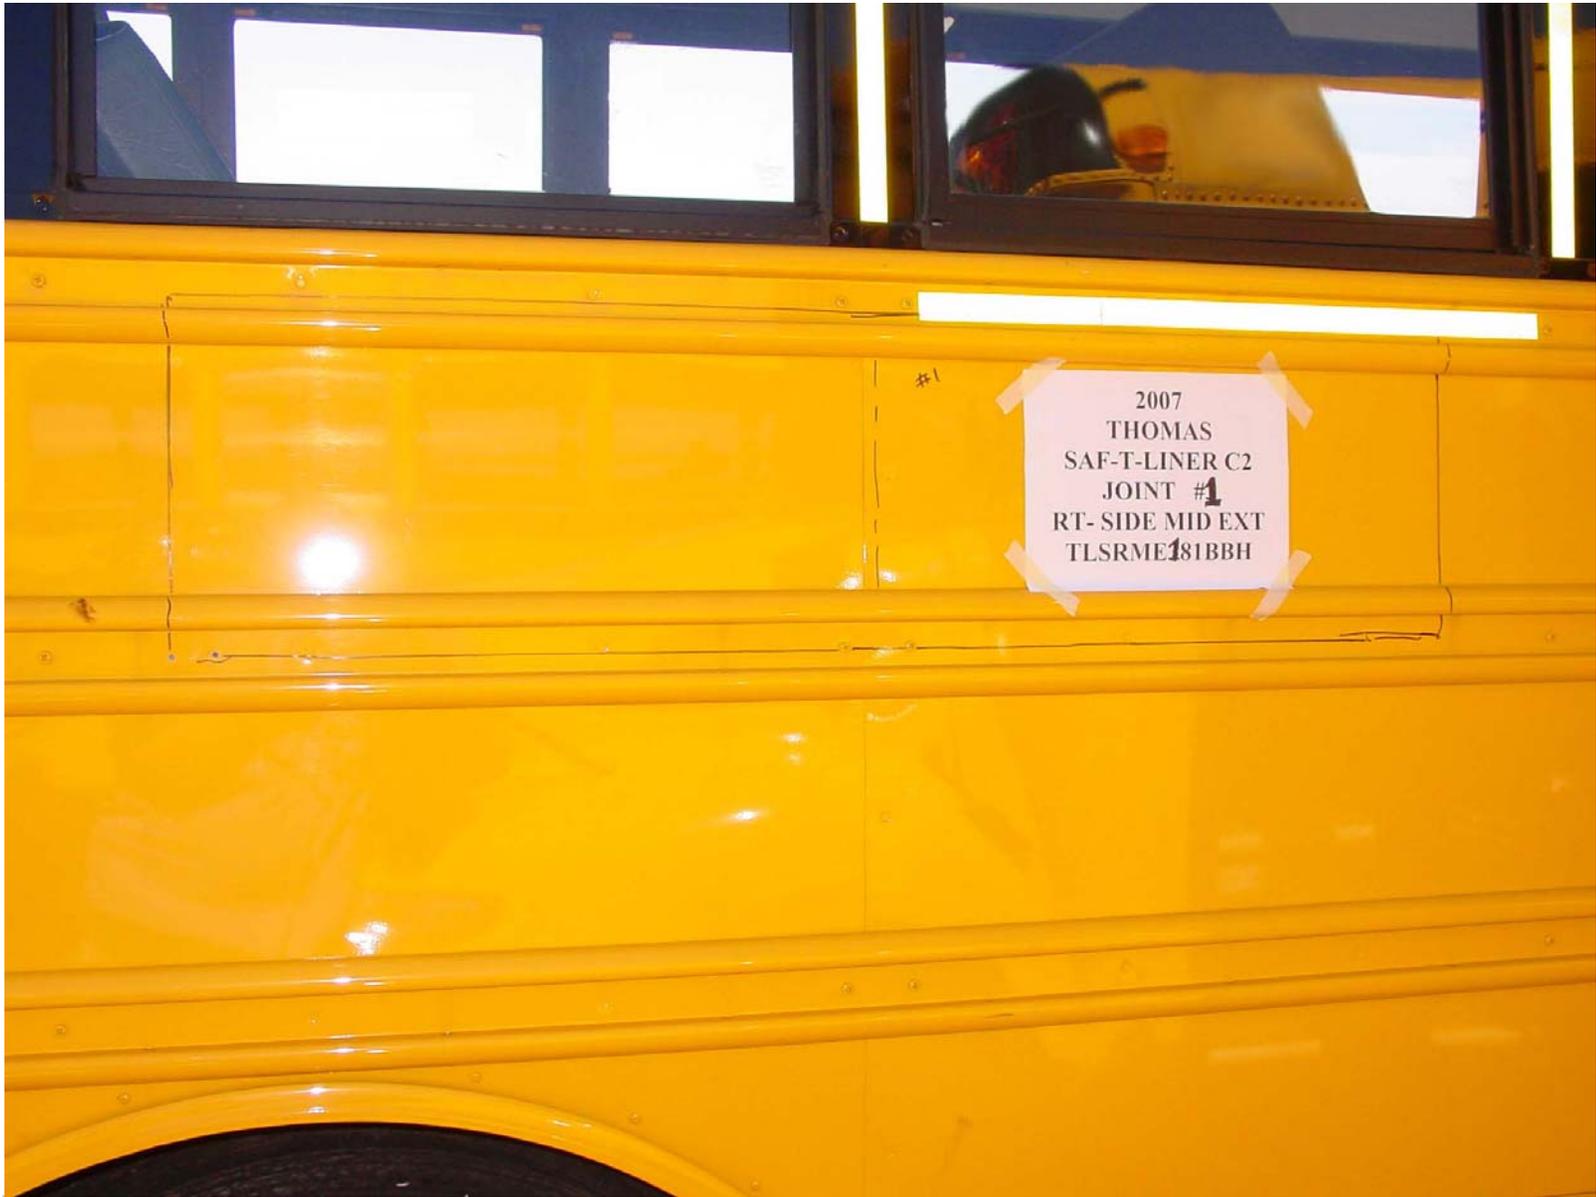
Location of Joint #1

Specimen Description:	Right Side Mid Exterior		
Joint Number:	TLSRME181BBH	Test Number:	1

Weaker Member	Stronger Member
Material	Galvanized, CS, ASTM A653	N/A
Tensile Strength (MPa)	310.3	N/A
Gage/Thickness (mm)	20 / 0.912	N/A
Fastener Holes (No./Diameter – mm.)	1 / 5.13	N/A
Net Area (Sq. mm.)	180.6	N/A
Material Strength (N)	56037.2	N/A
60% of Material Strength (N)	33622.3	N/A
Maximum Load From Tensile Test of Joint (N)	66803.6	N/A
PASS/FAIL	PASS	N/A

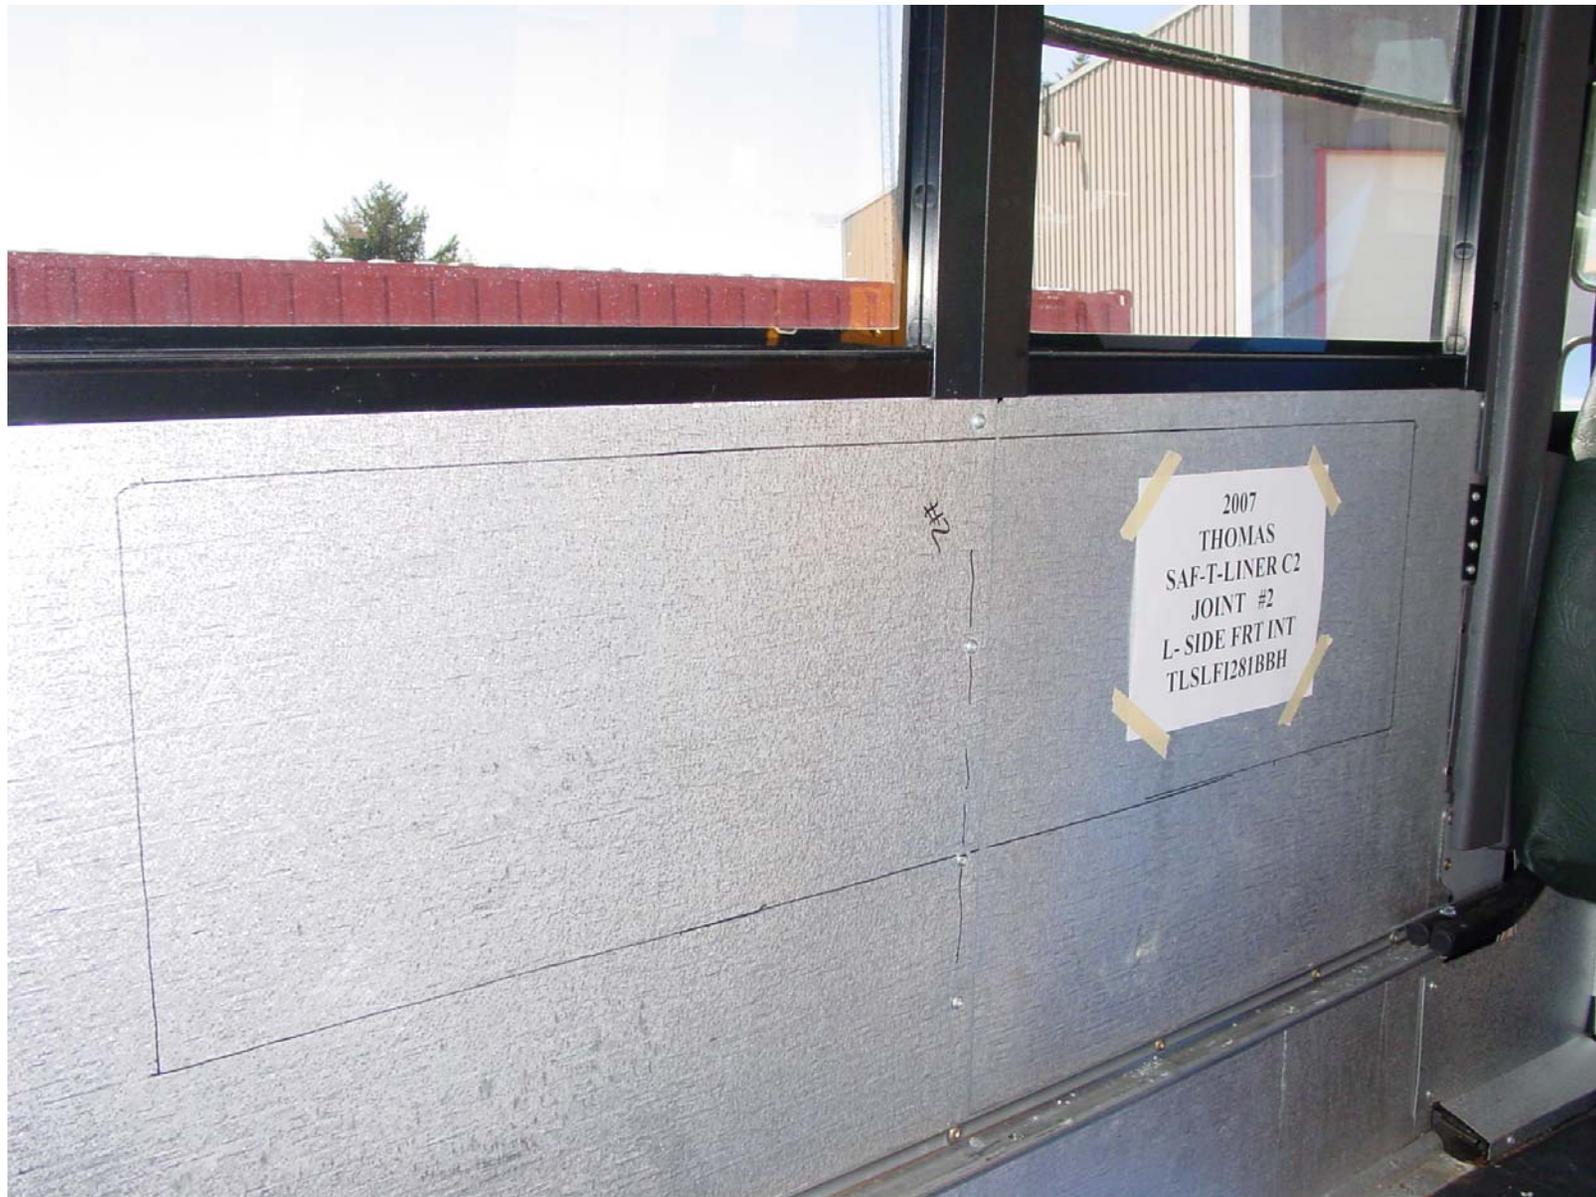
Location of Joint #2

Specimen Description:	Left Side Front Interior		
Joint Number:	TLSLFI281BBH	Test Number:	2

Weaker Member	Stronger Member
Material	Embossed Galvalume, ASTM, A792	N/A
Tensile Strength (MPa)	310.3	N/A
Gage/Thickness (mm)	24 / 0.589	N/A
Fastener Holes (No./Diameter – mm.)	1 / 3.99	N/A
Net Area (Sq. mm.)	117.4	N/A
Material Strength (N)	36422.4	N/A
60% of Material Strength (N)	21853.5	N/A
Maximum Load From Tensile Test of Joint (N)	36826.1	N/A
PASS/FAIL	PASS	N/A

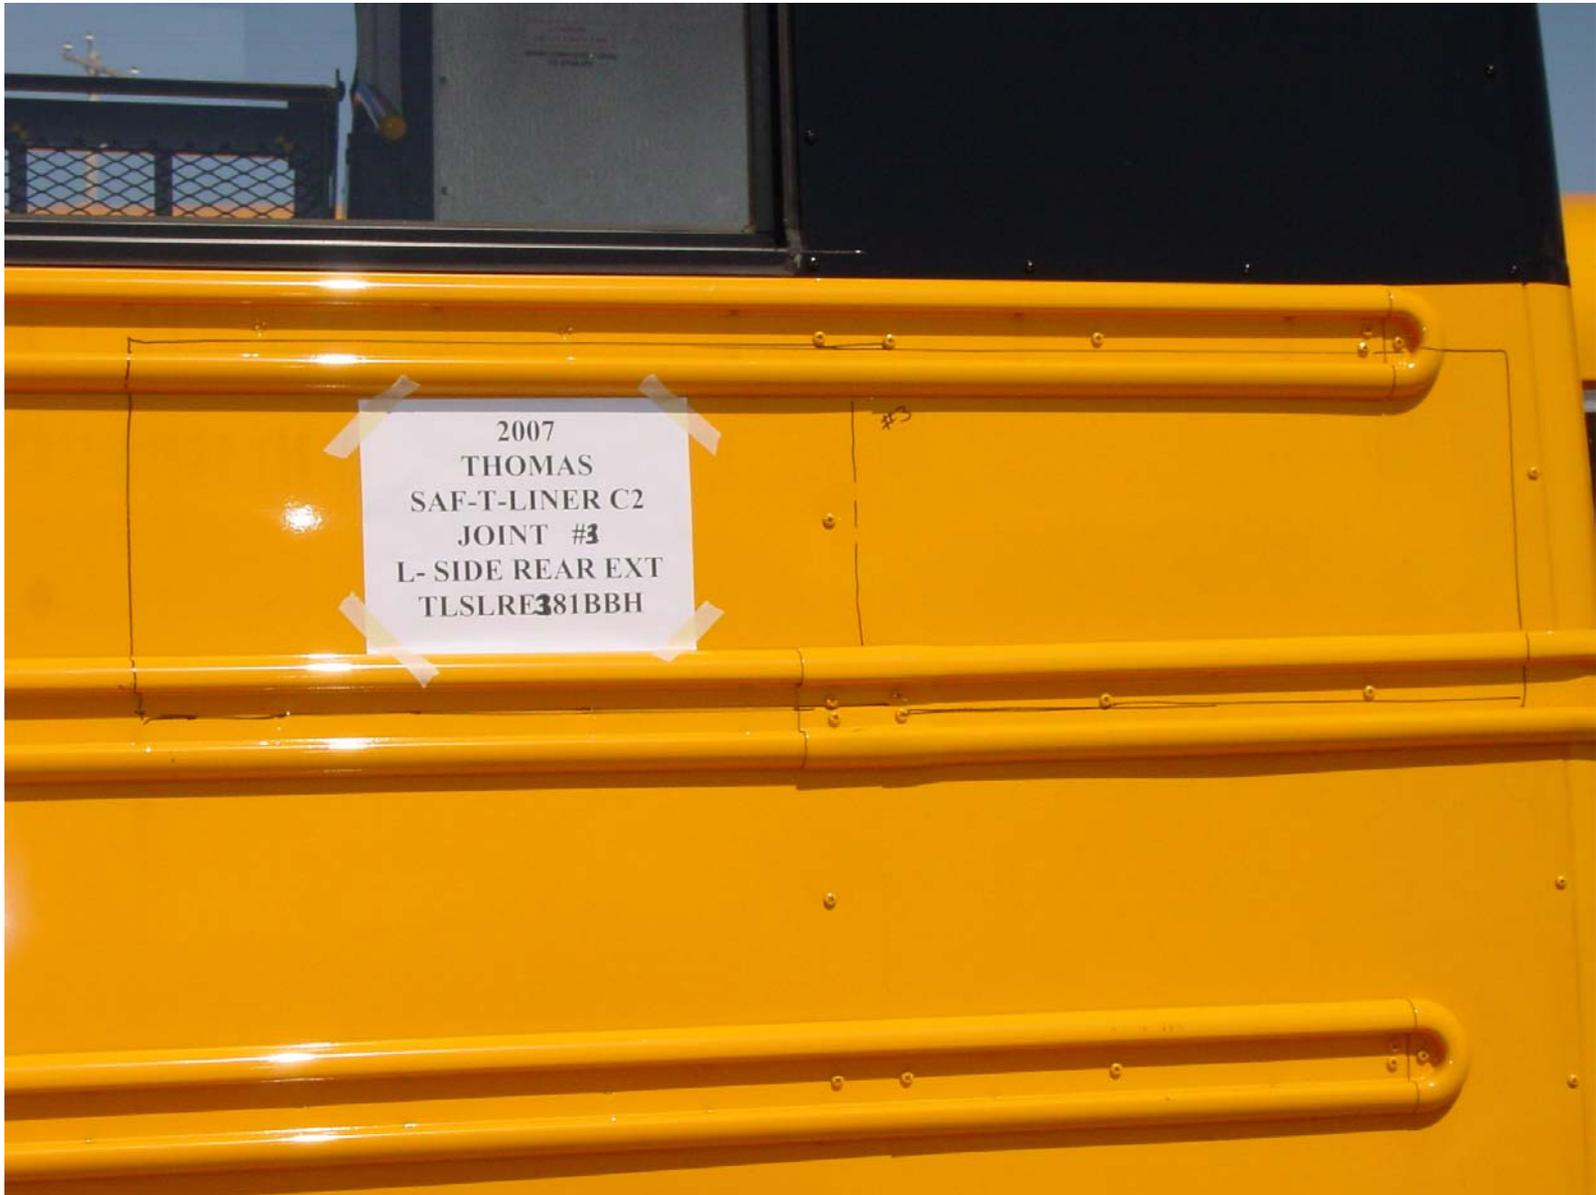
Location of Joint #3

Specimen Description:	Left Side Rear Exterior		
Joint Number:	TLSLRE381BBH	Test Number:	3

Weaker Member	Stronger Member
Material	Galvanized, CS, ASTM, A653	N/A
Tensile Strength (MPa)	310.3	N/A
Gage/Thickness (mm)	20 / 0.912	N/A
Fastener Holes (No./Diameter – mm.)	1 / 4.70	N/A
Net Area (Sq. mm.)	181.0	N/A
Material Strength (N)	56159.4	N/A
60% of Material Strength (N)	33695.6	N/A
Maximum Load From Tensile Test of Joint (N)	63416.8	N/A
PASS/FAIL	PASS	N/A

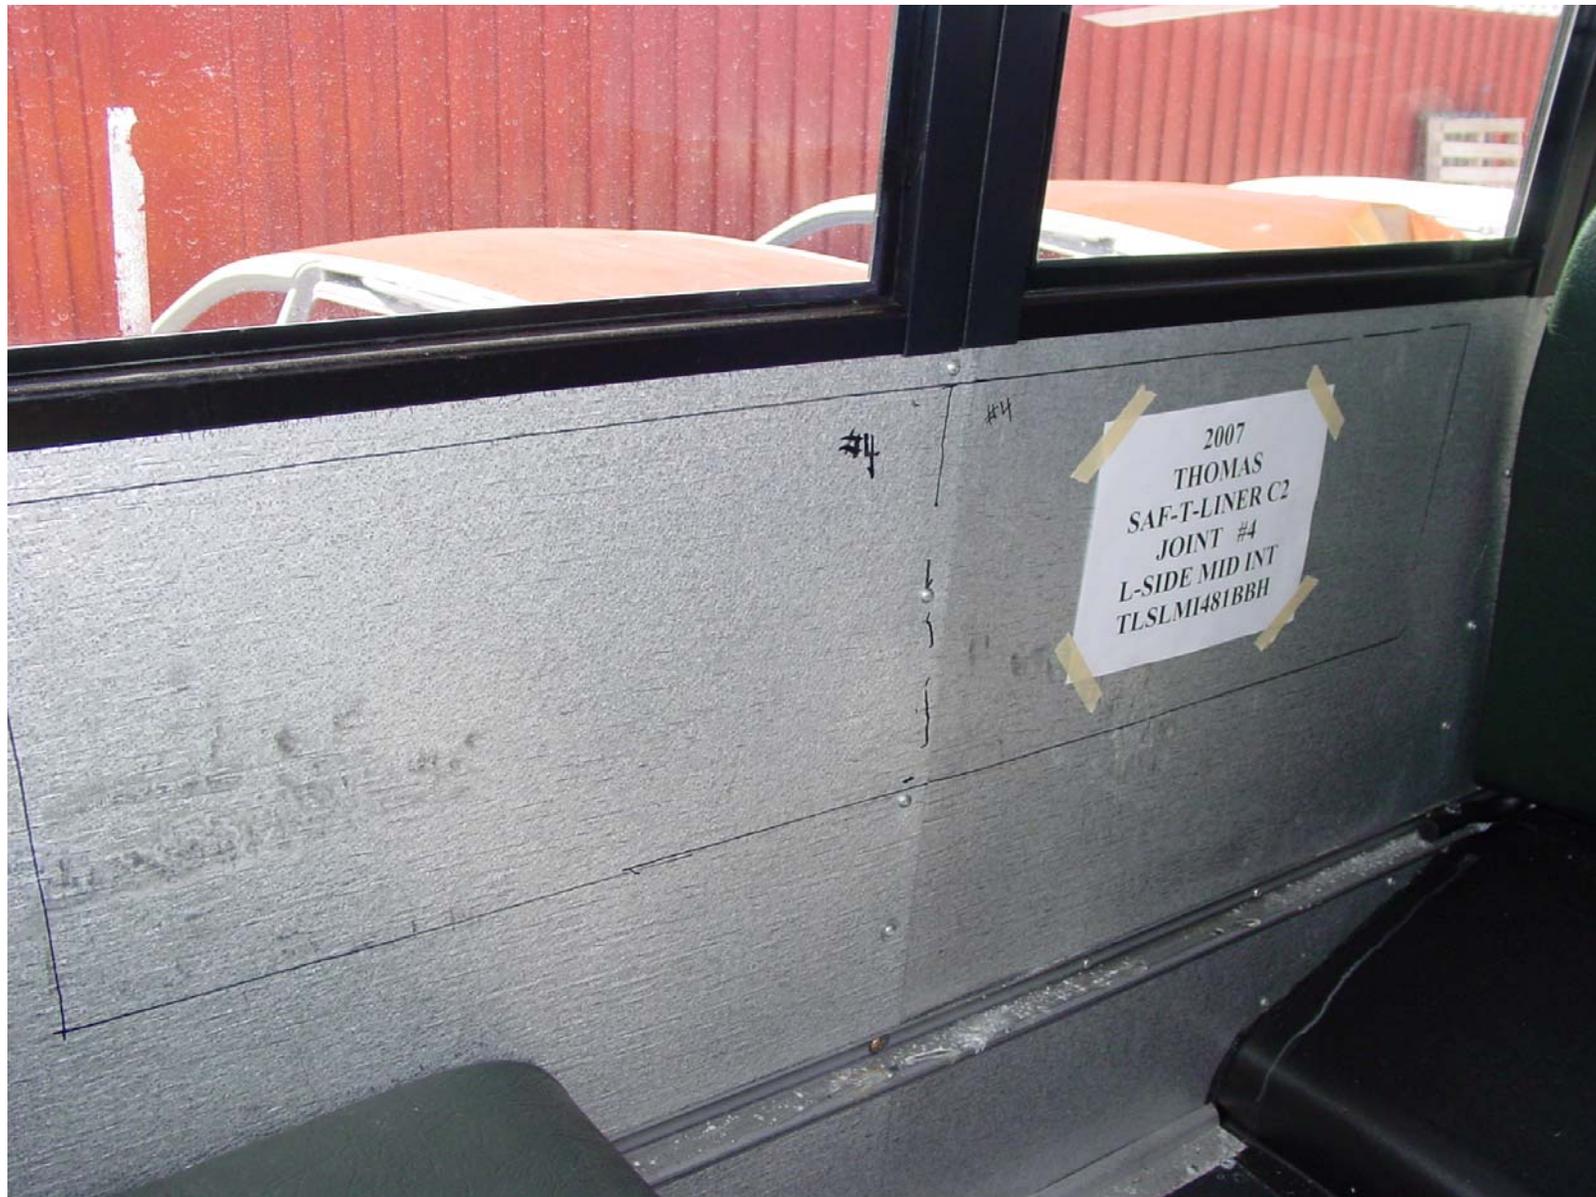
Location of Joint #4

Specimen Description:	Left Side Mid Interior		
Joint Number:	TLSLMI481BBH	Test Number:	4

Weaker Member	Stronger Member
Material	Embossed Galvalume, ASTM, A792	N/A
Tensile Strength (MPa)	310.3	N/A
Gage/Thickness (mm)	24 / 0.589	N/A
Fastener Holes (No./Diameter – mm.)	1 / 3.99	N/A
Net Area (Sq. mm.)	117.4	N/A
Material Strength (N)	36422.4	N/A
60% of Material Strength (N)	21853.5	N/A
Maximum Load From Tensile Test of Joint (N)	45409.7	N/A
PASS/FAIL	PASS	N/A

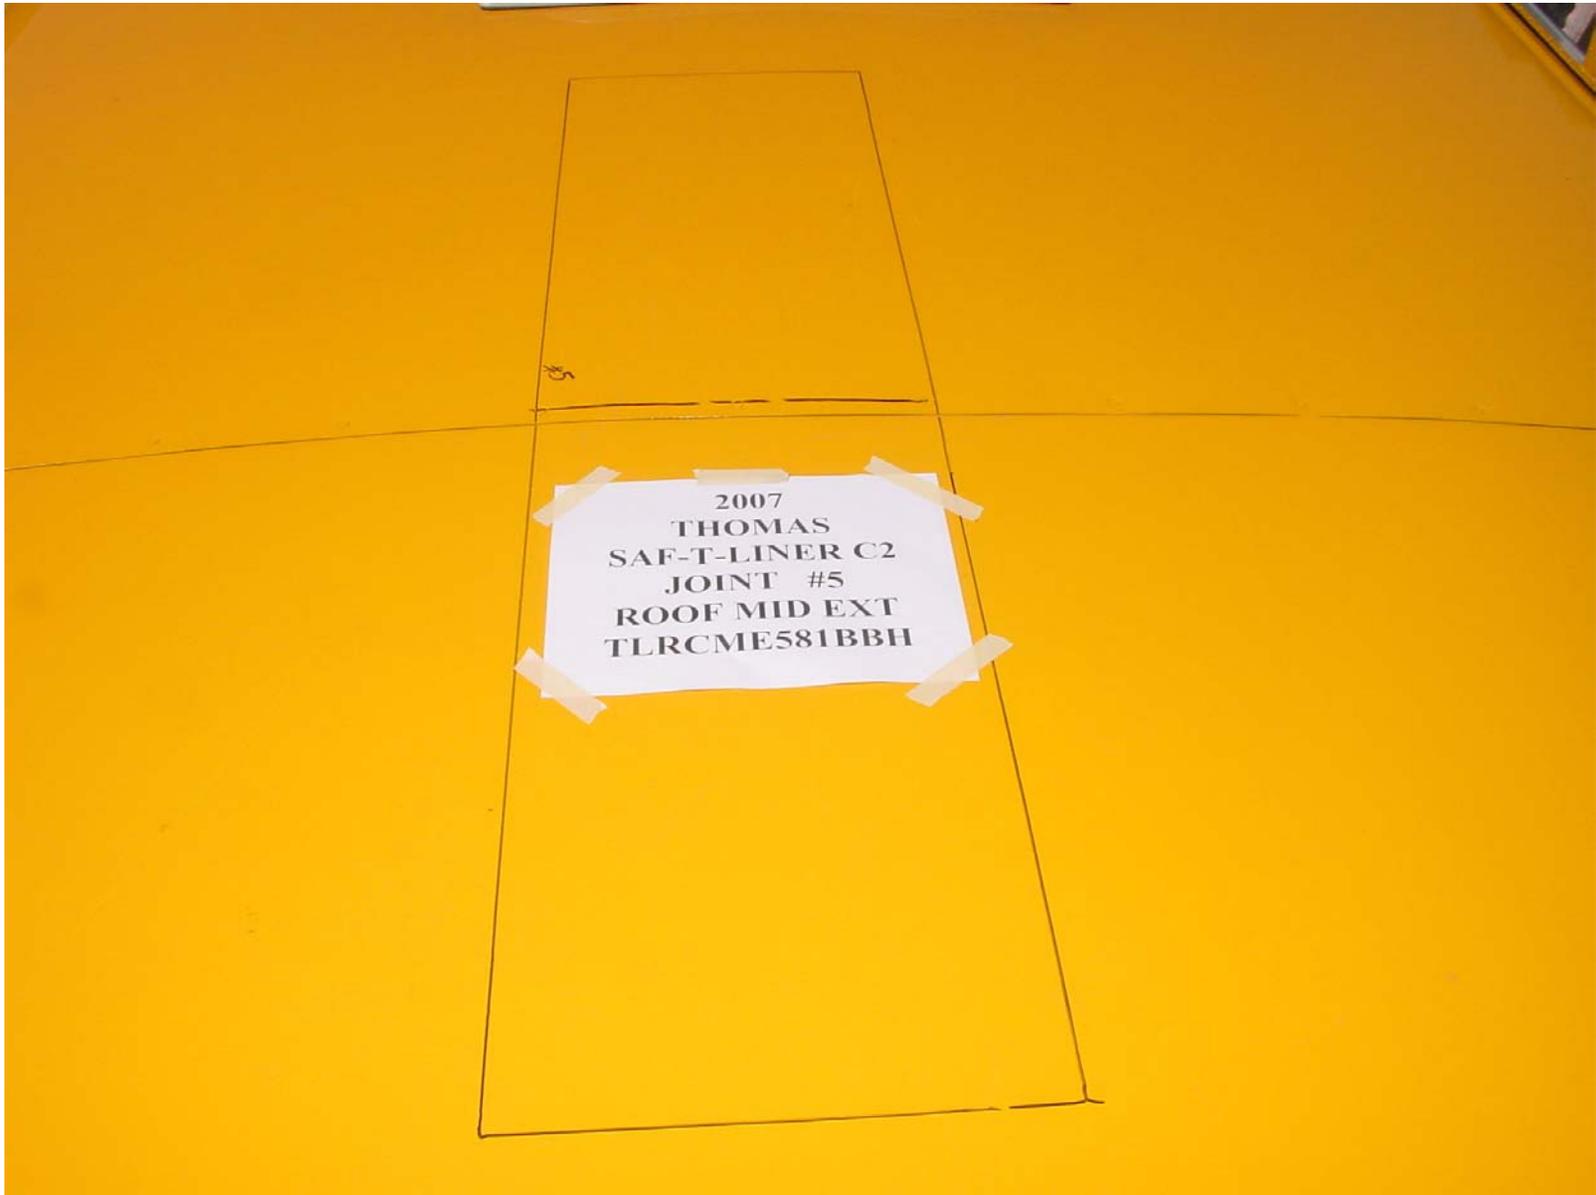
Location of Joint #5

Specimen Description:	Roof Mid Exterior		
Joint Number:	TLRCME581BBH	Test Number:	5

Weaker Member	Stronger Member
Material	Galvanized, CS, ASTM, A653	N/A
Tensile Strength (MPa)	310.3	N/A
Gage/Thickness (mm)	20 / 0.912	N/A
Fastener Holes (No./Diameter – mm.)	1 / 5.13	N/A
Net Area (Sq. mm.)	180.6	N/A
Material Strength (N)	56037.2	N/A
60% of Material Strength (N)	33622.3	N/A
Maximum Load From Tensile Test of Joint (N)	68527.8	N/A
PASS/FAIL	PASS	N/A

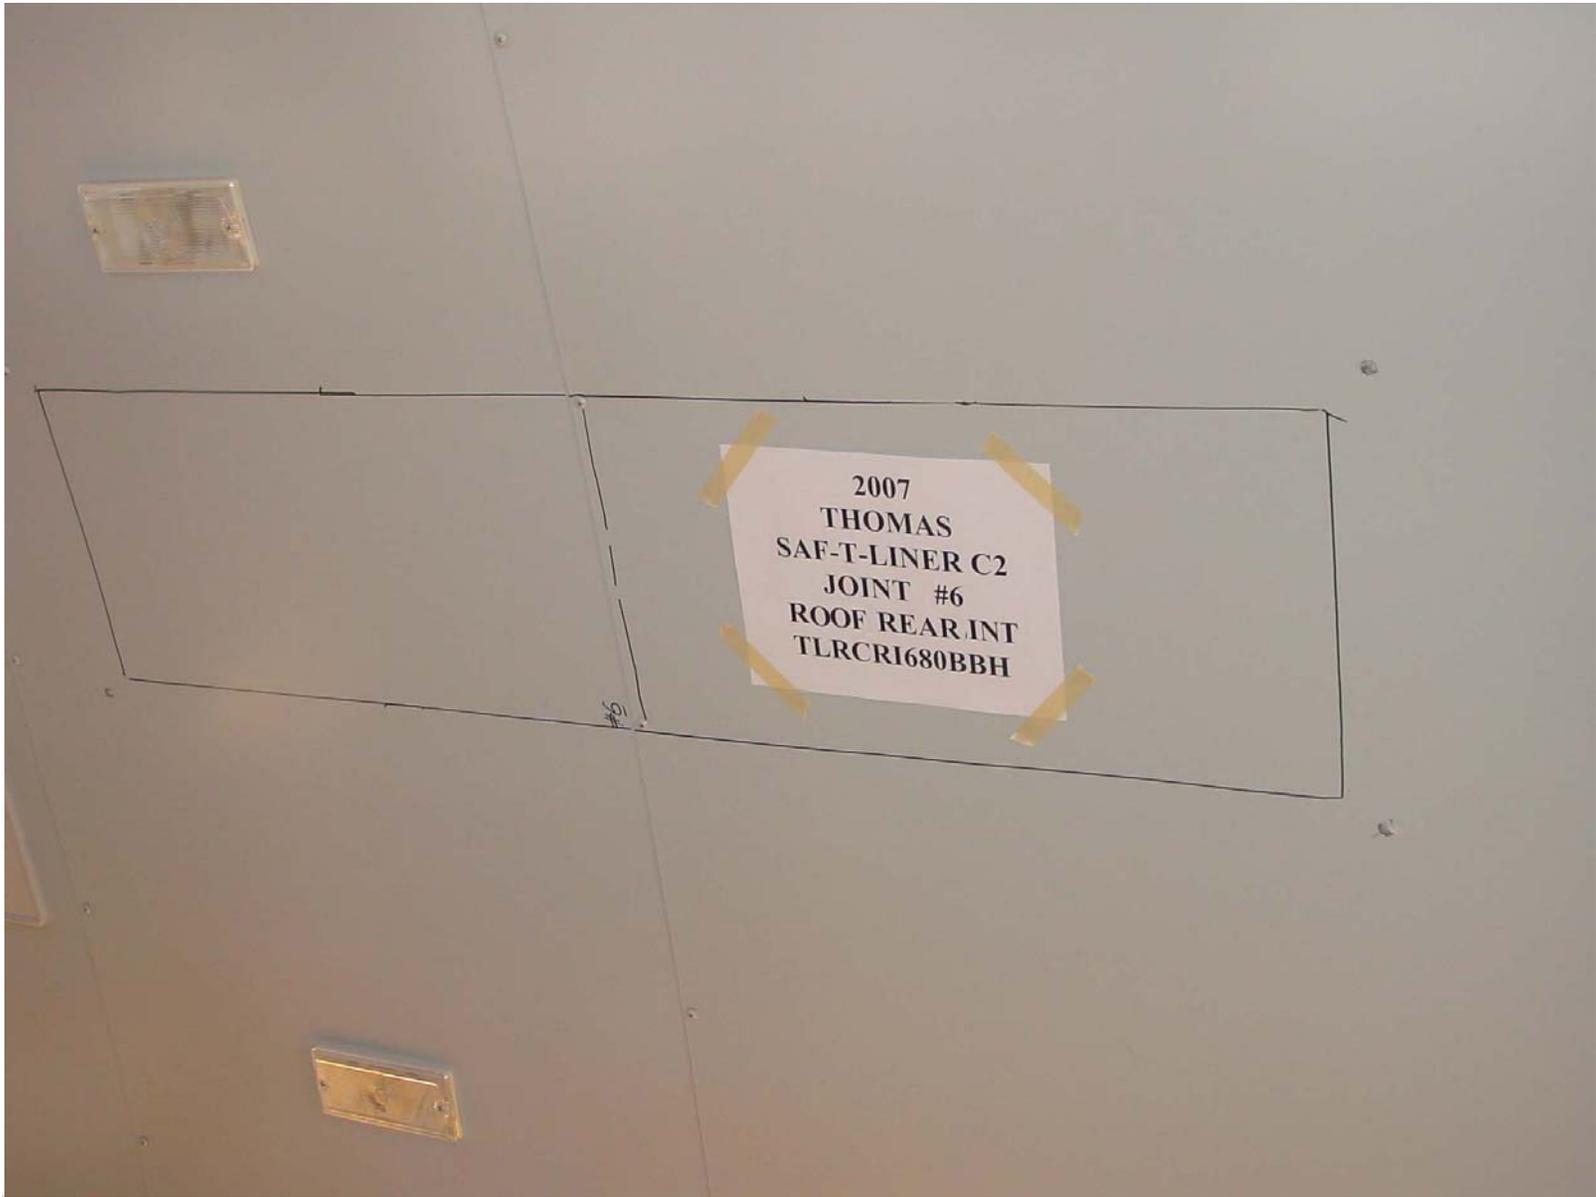
Location of Joint #6

Specimen Description:	Roof Rear Interior		
Joint Number:	TLRCRI680BBH	Test Number:	6

Weaker Member	Stronger Member
Material	Galvanized, SS, ASTM, A653	N/A
Tensile Strength (MPa)	310.3	N/A
Gage/Thickness (mm)	22 / 0.0253	N/A
Fastener Holes (No./Diameter – mm.)	0 / 0	N/A
Net Area (Sq. mm.)	130.6	N/A
Material Strength (N)	40514.4	N/A
60% of Material Strength (N)	24308.6	N/A
Maximum Load From Tensile Test of Joint (N)	60562.3	N/A
PASS/FAIL	PASS	N/A

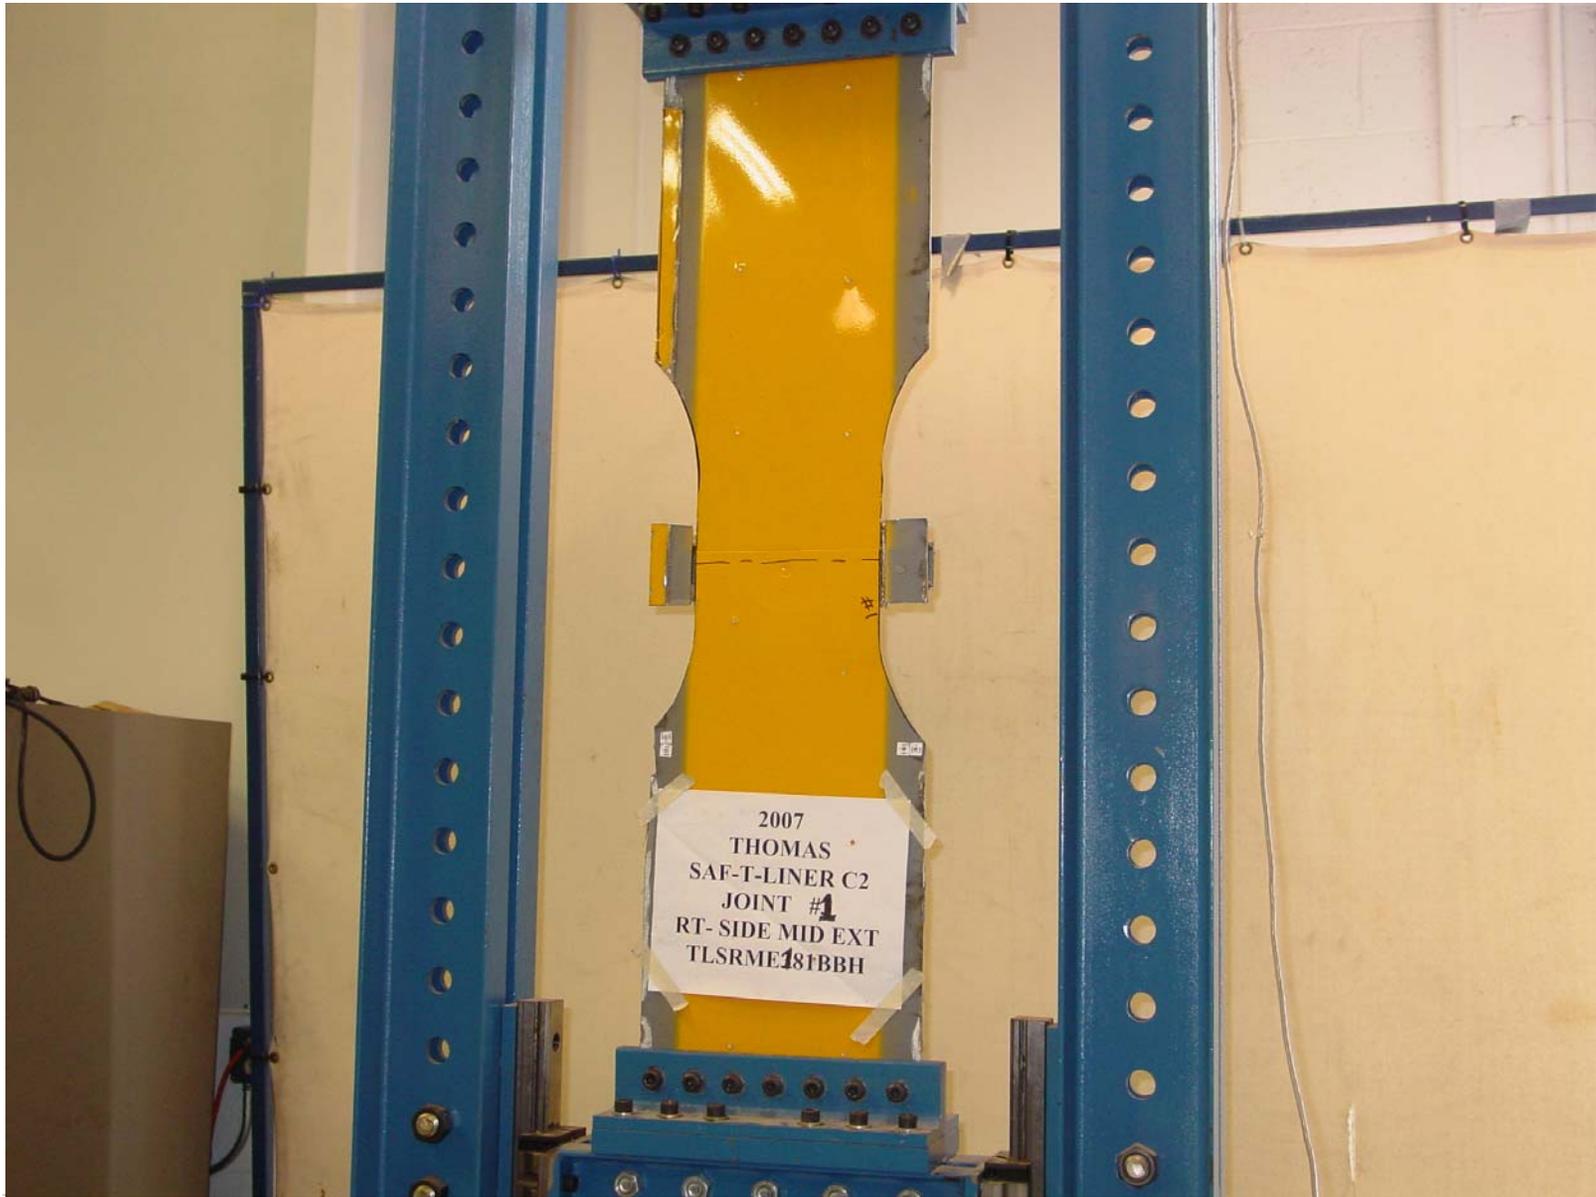
Pre-Test of Joint #1

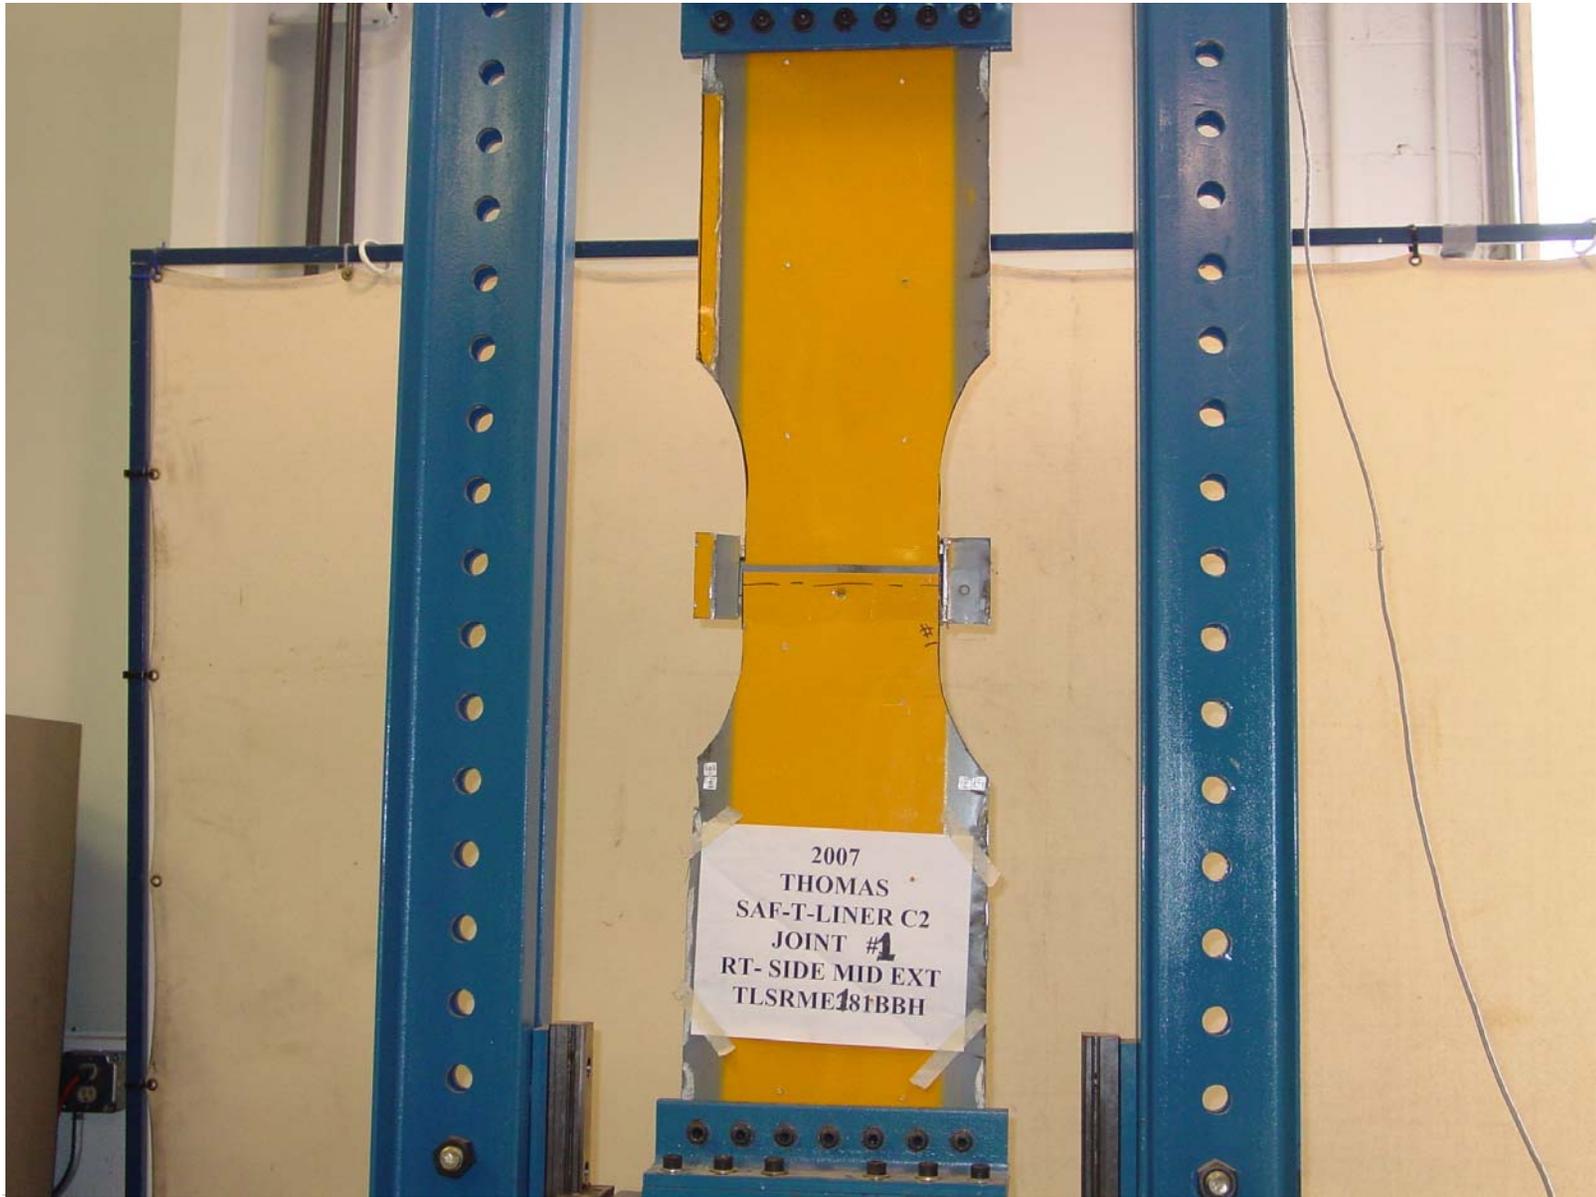
Post-Test of Joint #1

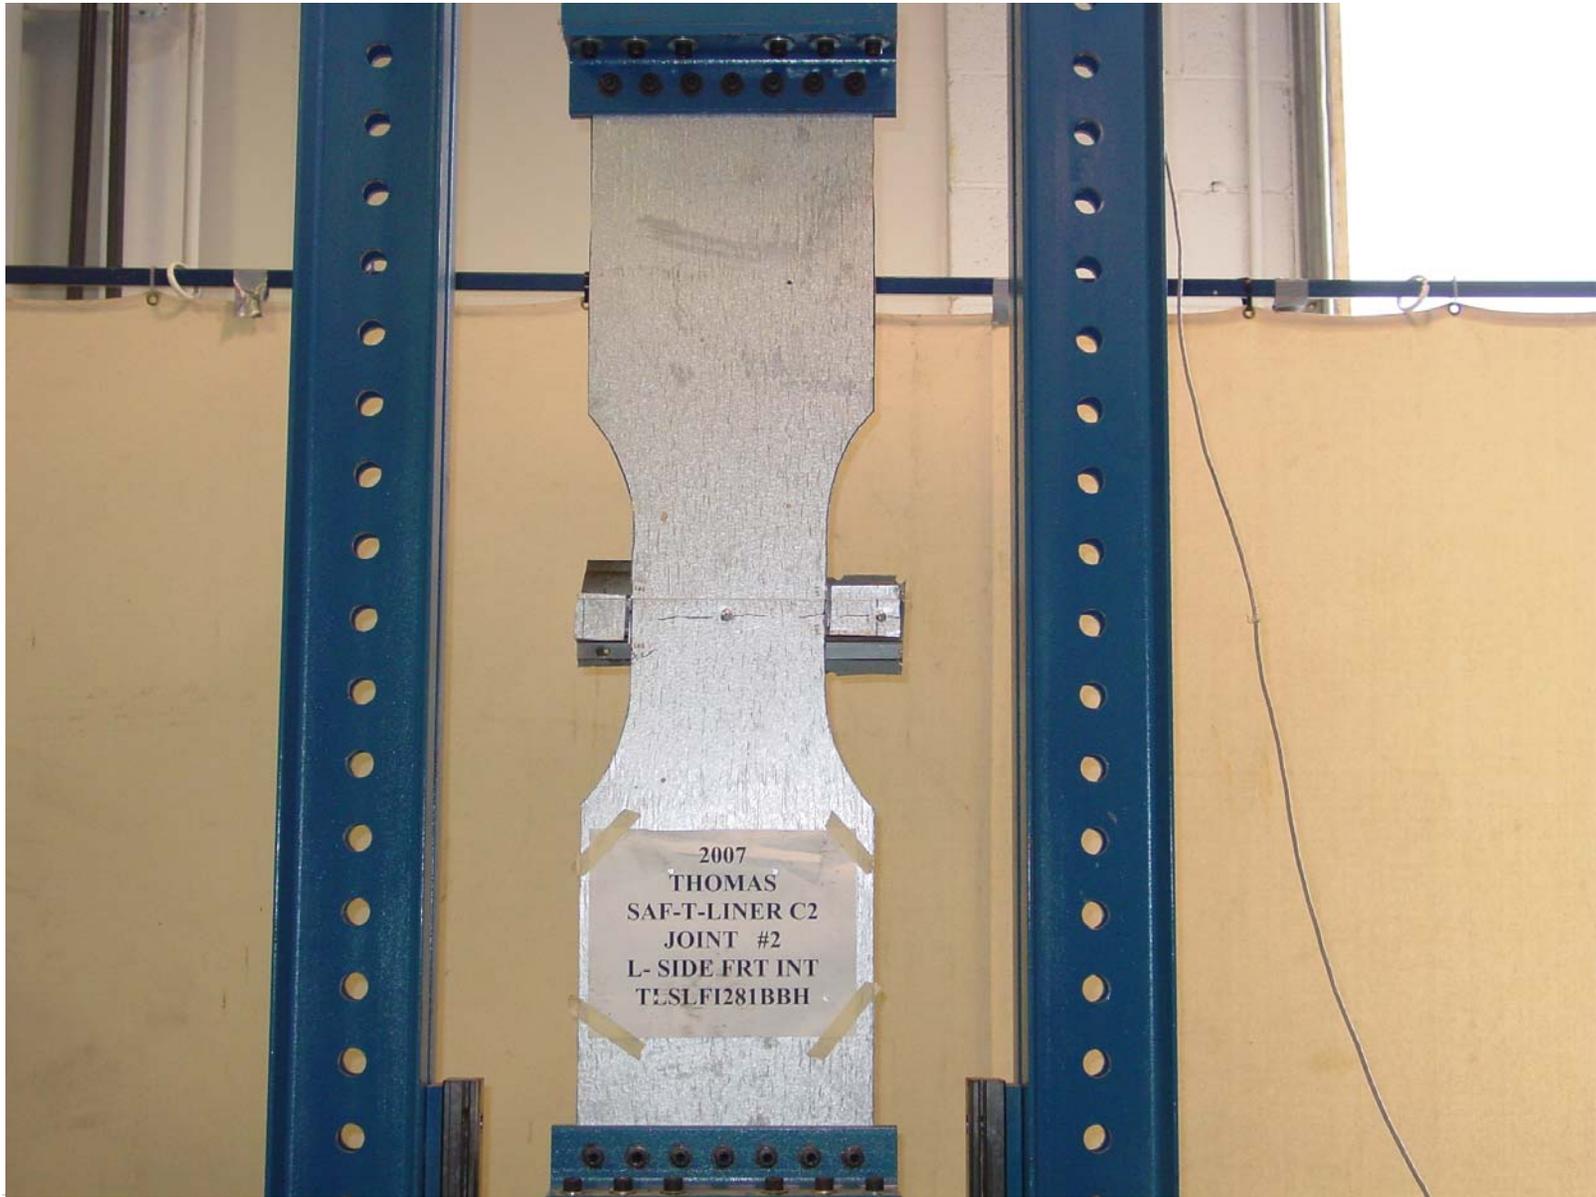
Pre-Test of Joint #2

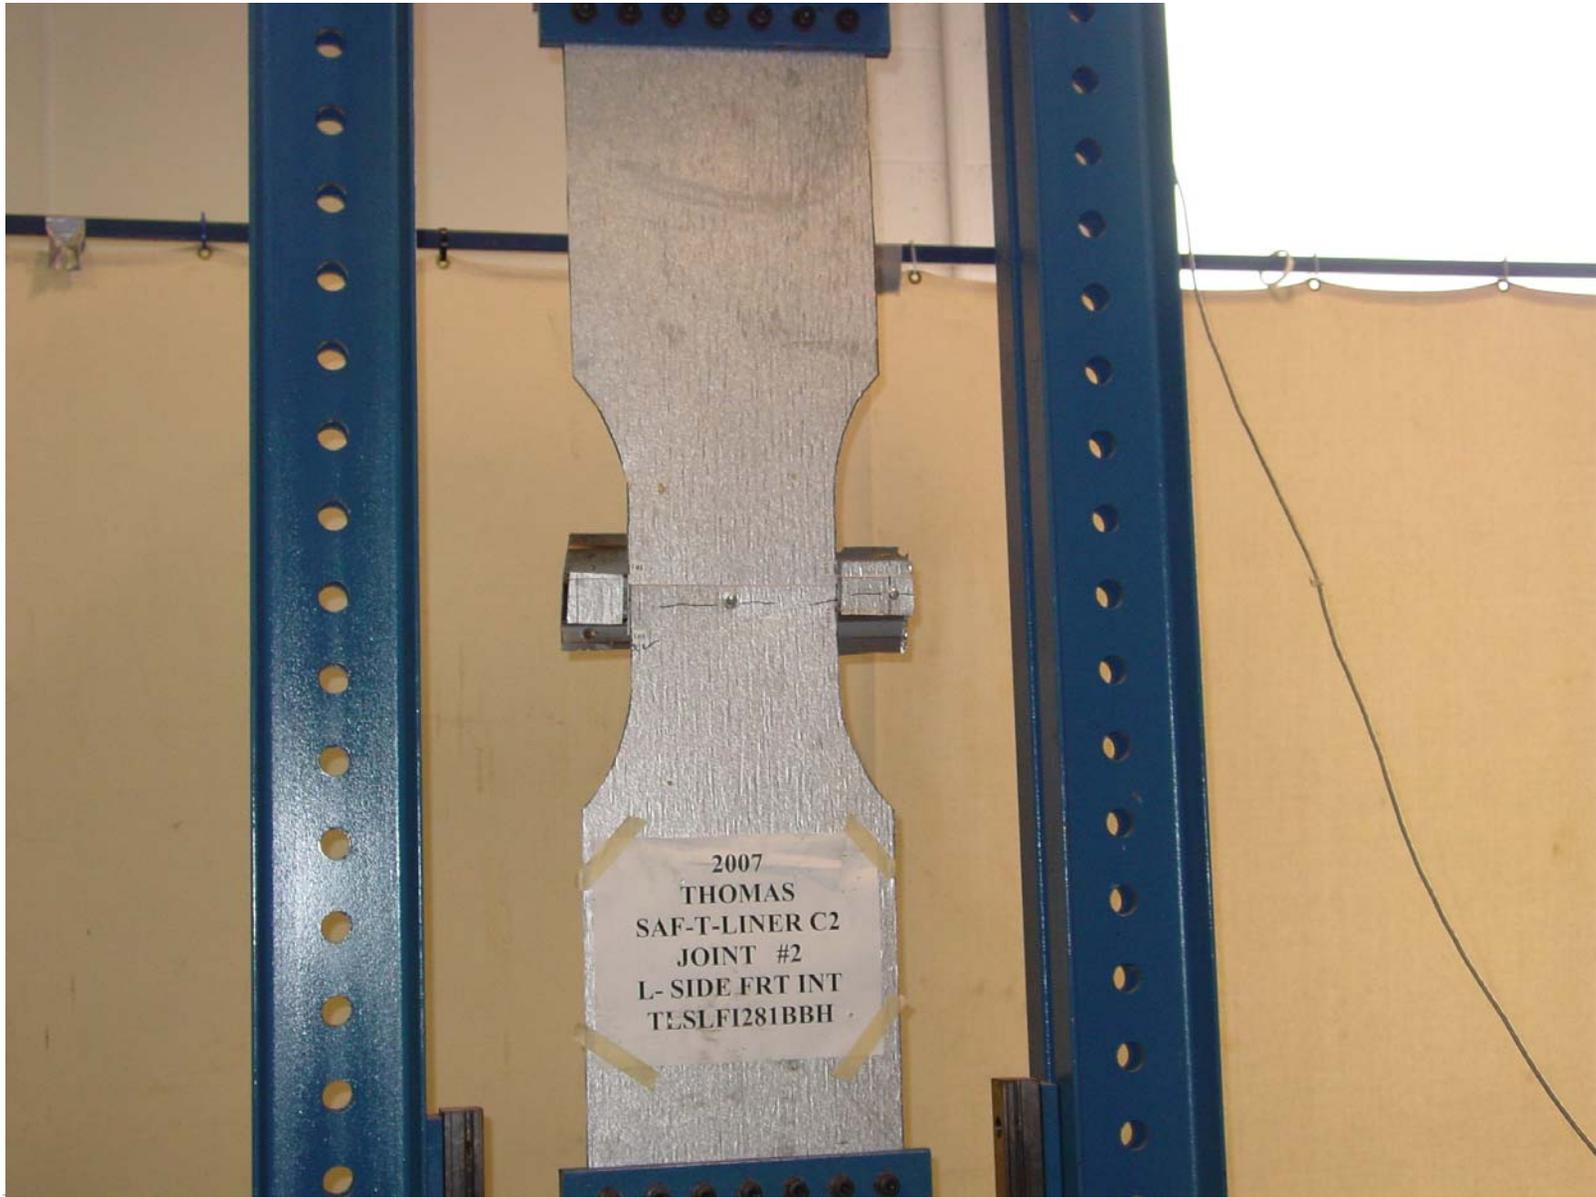
Post-Test of Joint #2

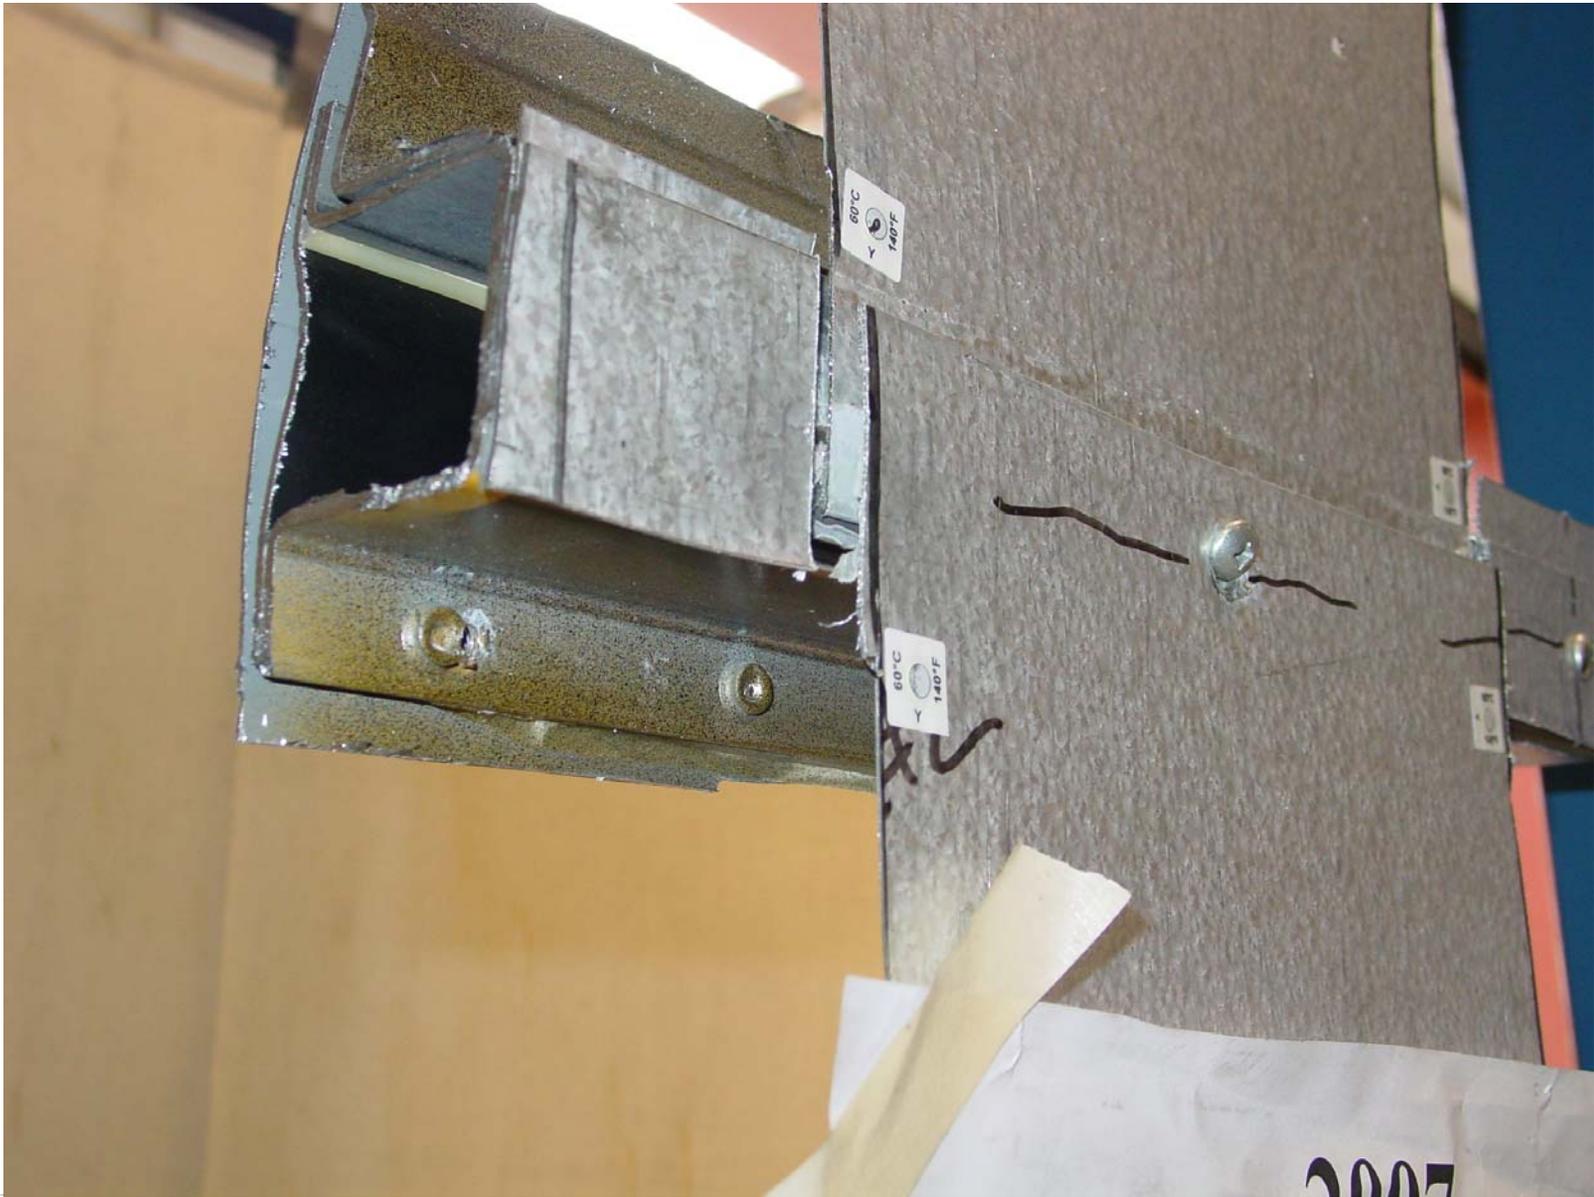
Post-Test of Joint #2 view 2
